Dilapidation Survey Report

NHM Exhibition Road Subway
15th November 2025

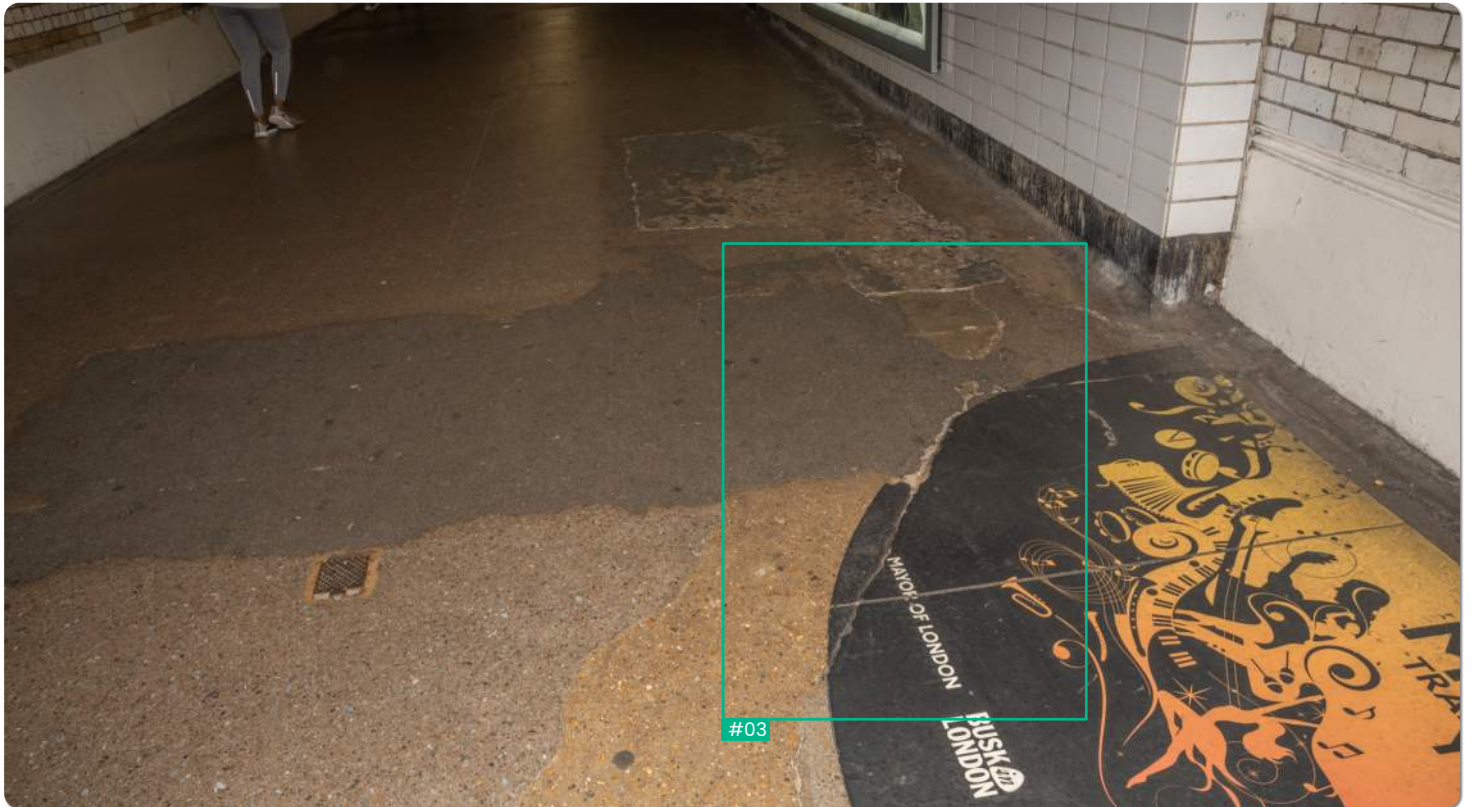
#03

Asphalt floor surface shows patch repairs with visible cracking, uneven surfacing and differentiated textures indicating multiple reinstatements over time. Edge deterioration around decorative floor graphic suggests wear from pedestrian traffic and adhesion breakdown. No visible trip hazard but aesthetic degradation noted.

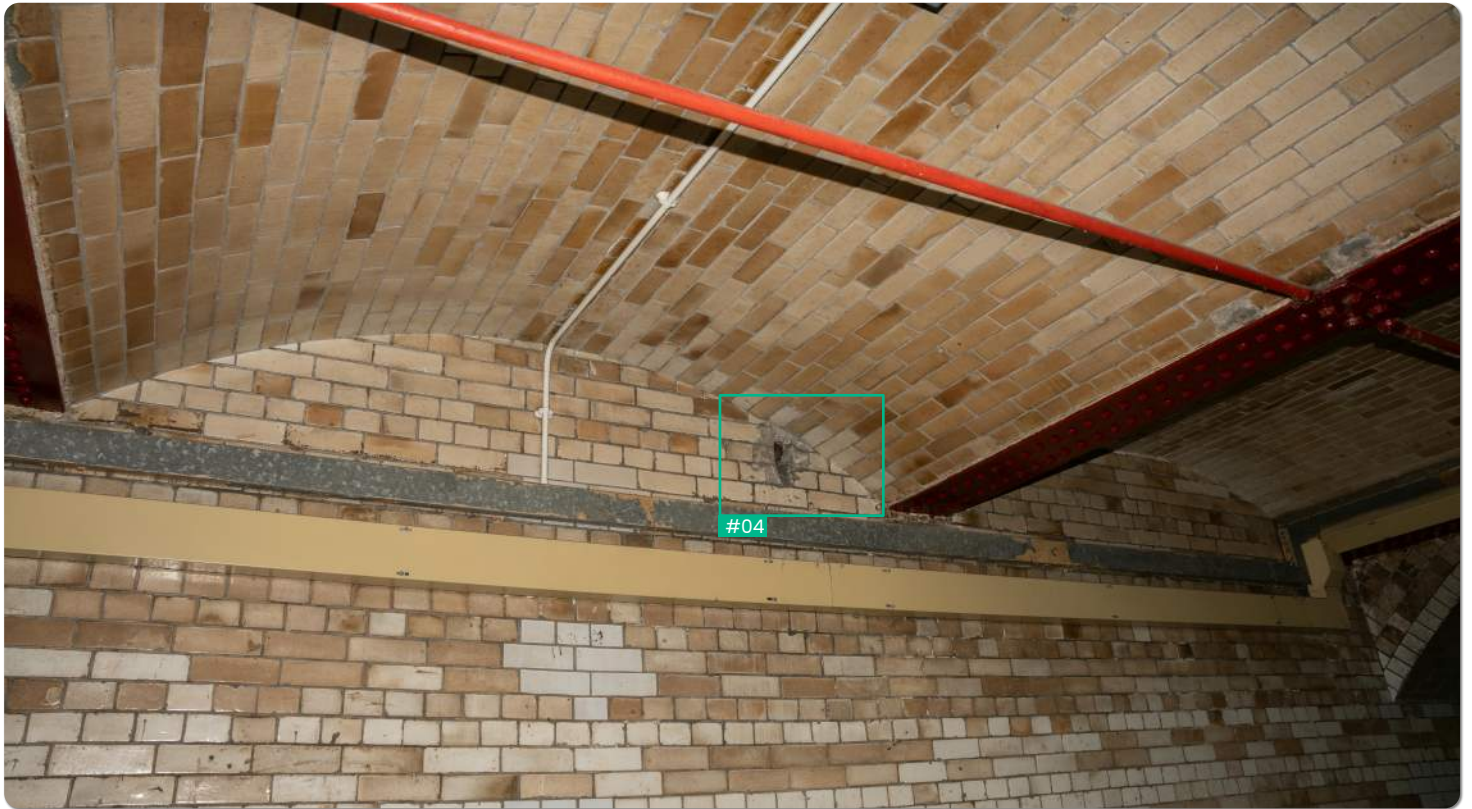
#04

Localised area of brick surface deterioration with material loss and exposed mortar bed. Tile glaze appears missing and surrounding surfaces show staining consistent with water exposure. No active water present at time of survey, but staining suggests historic leaks or condensation.

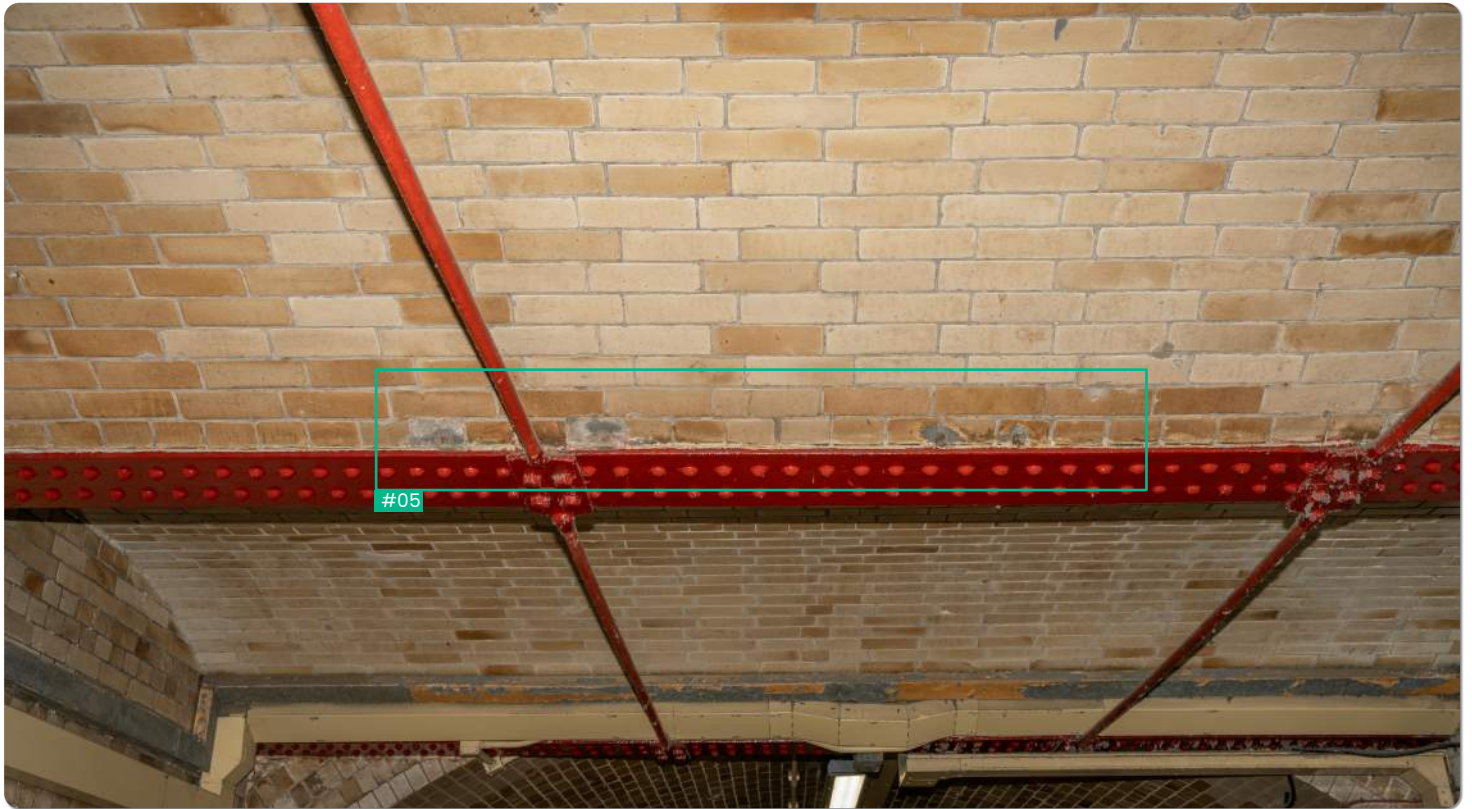
#05

Repair patches observed along the line of a primary structural steel beam fixed into soffit. Damage is linear and follows the fixing points. Surrounding brickwork shows patchy repair attempts and aged grout lines. No deformation to steel noted.

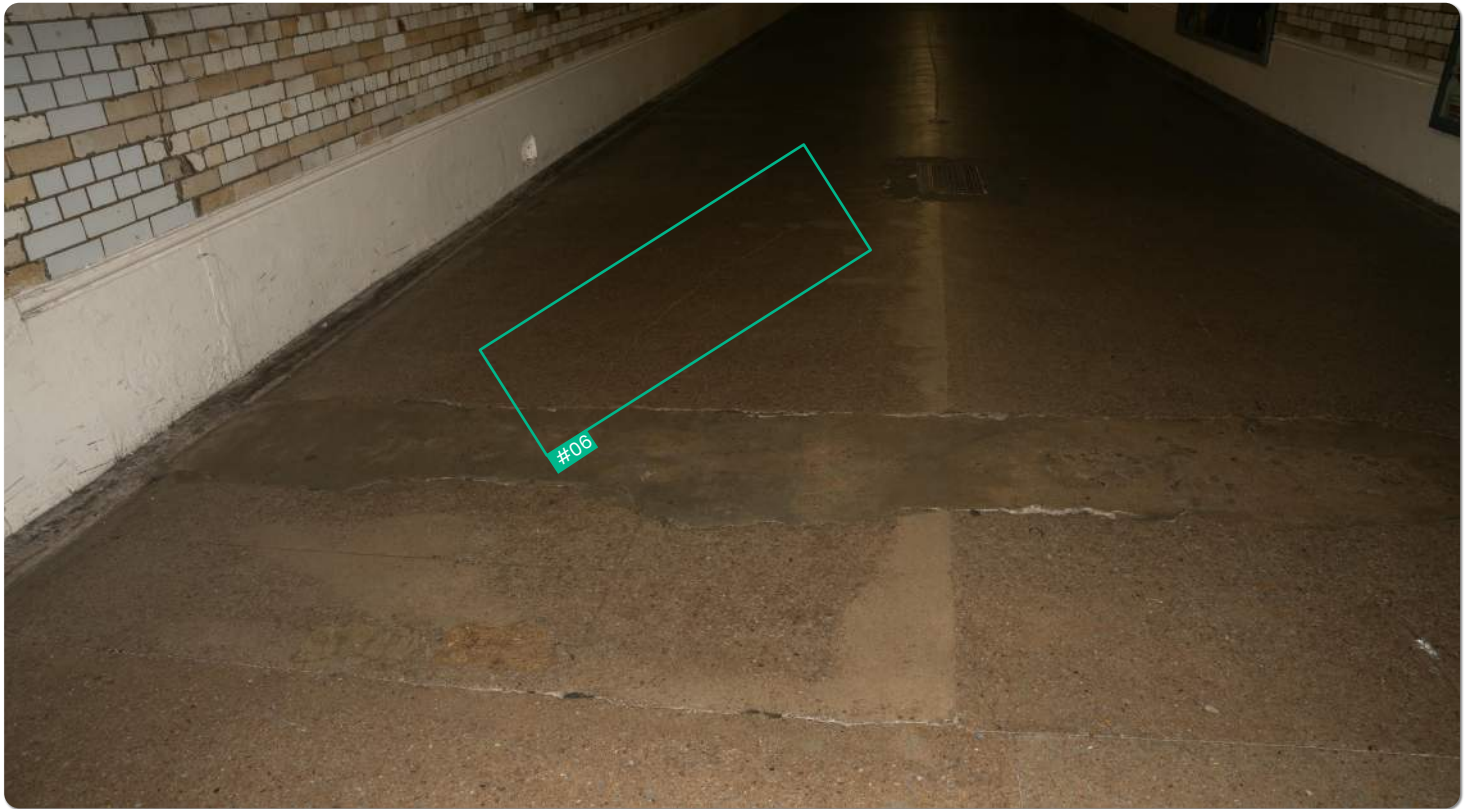
#06

Surface finish remains visually inconsistent with adjacent areas. Edges show minor cracking and settlement marks indicating possible differential wear.

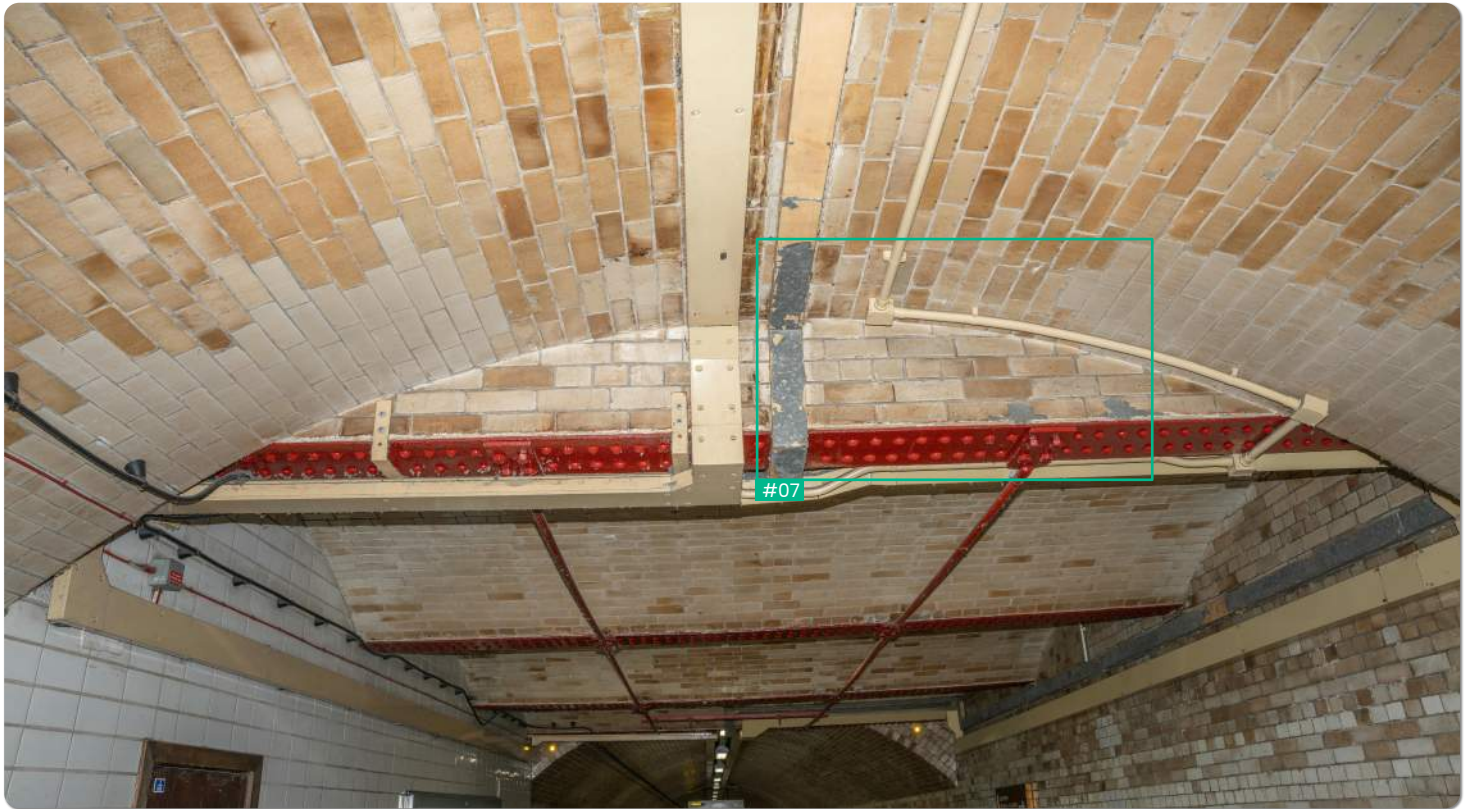
#07

Disturbed brick alignment above steel beam with visible offset between rows, cracking, and filler patches. Also trunking paint flaking/peeling off.

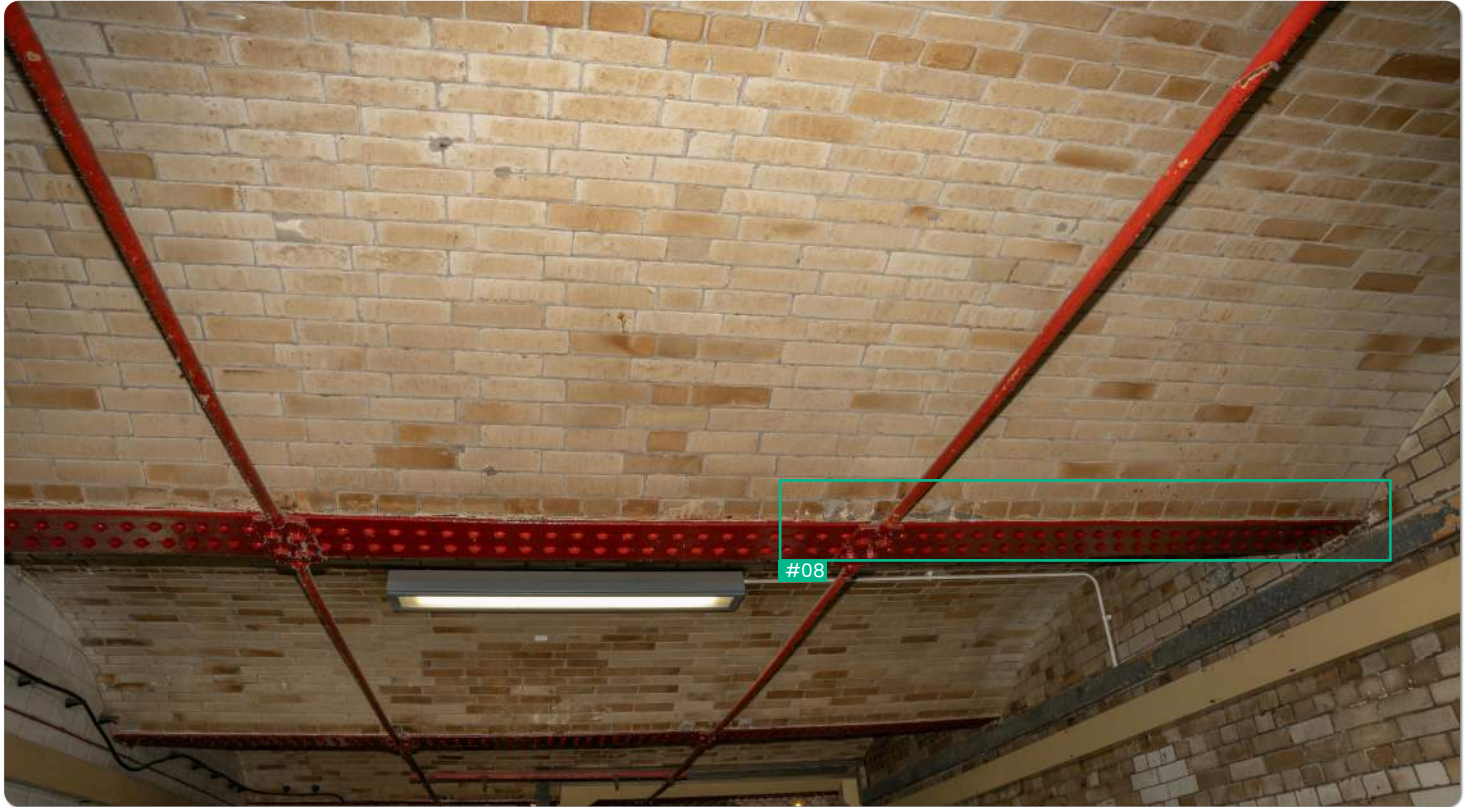
#08

Staining and discolouration across ceiling brickwork, concentrated near service brackets and lighting. . No active leak visible. There is noticeable deterioration where the glazed tile/brick face has broken away, exposing the rough substrate beneath.

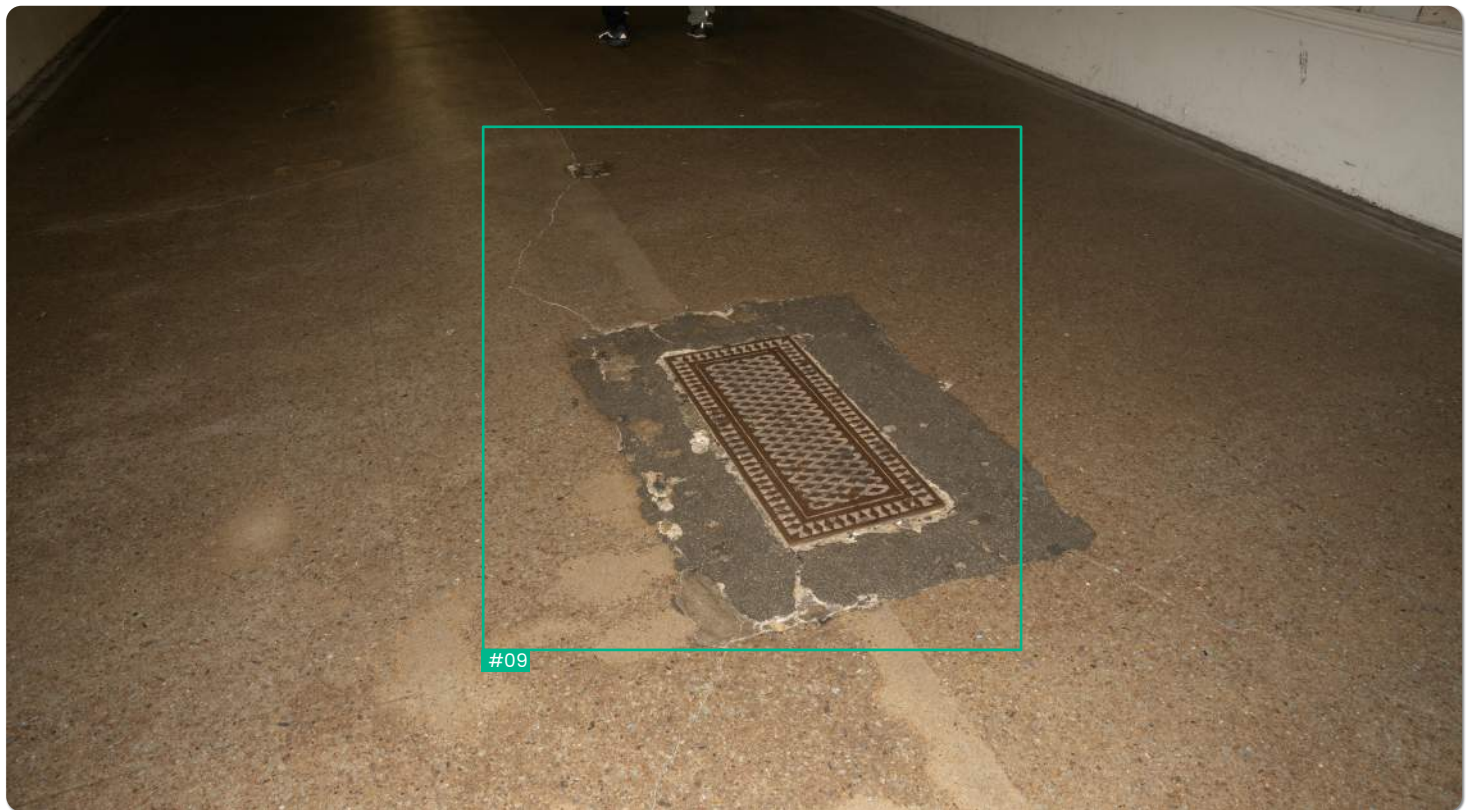
#9

Surrounding surface deterioration around cast iron service cover; asphalt patching is cracked, irregular, and separating from frame edges. Cover itself appears intact but seating substrate deteriorated

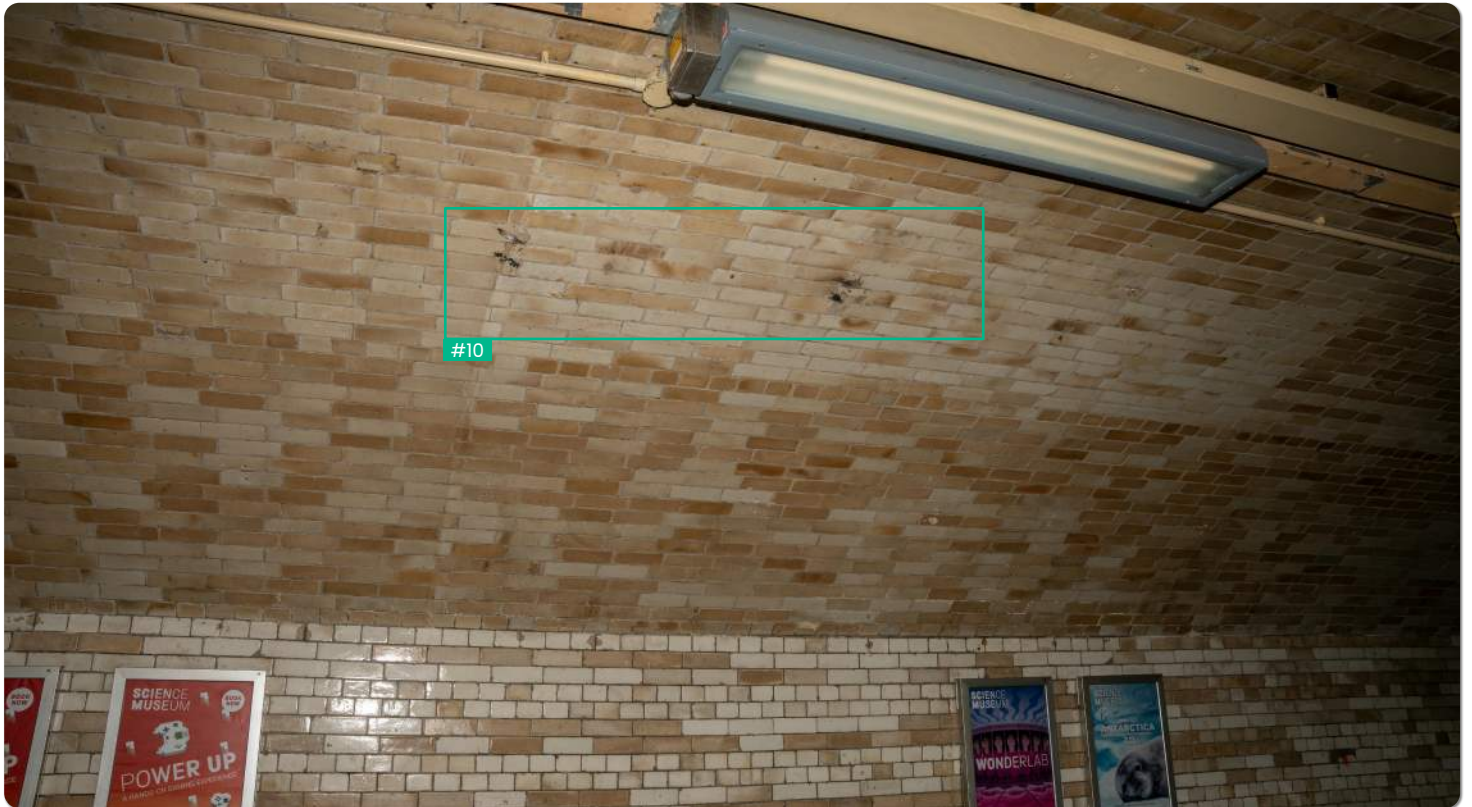
#10

Multiple penetrations and historic fixings visible on ceiling tiles with dark staining around drilled holes. Brick faces show abrasion where equipment appears to have been installed and removed. Staining could relate to moisture residue or corrosion from previous intumescent fixings.

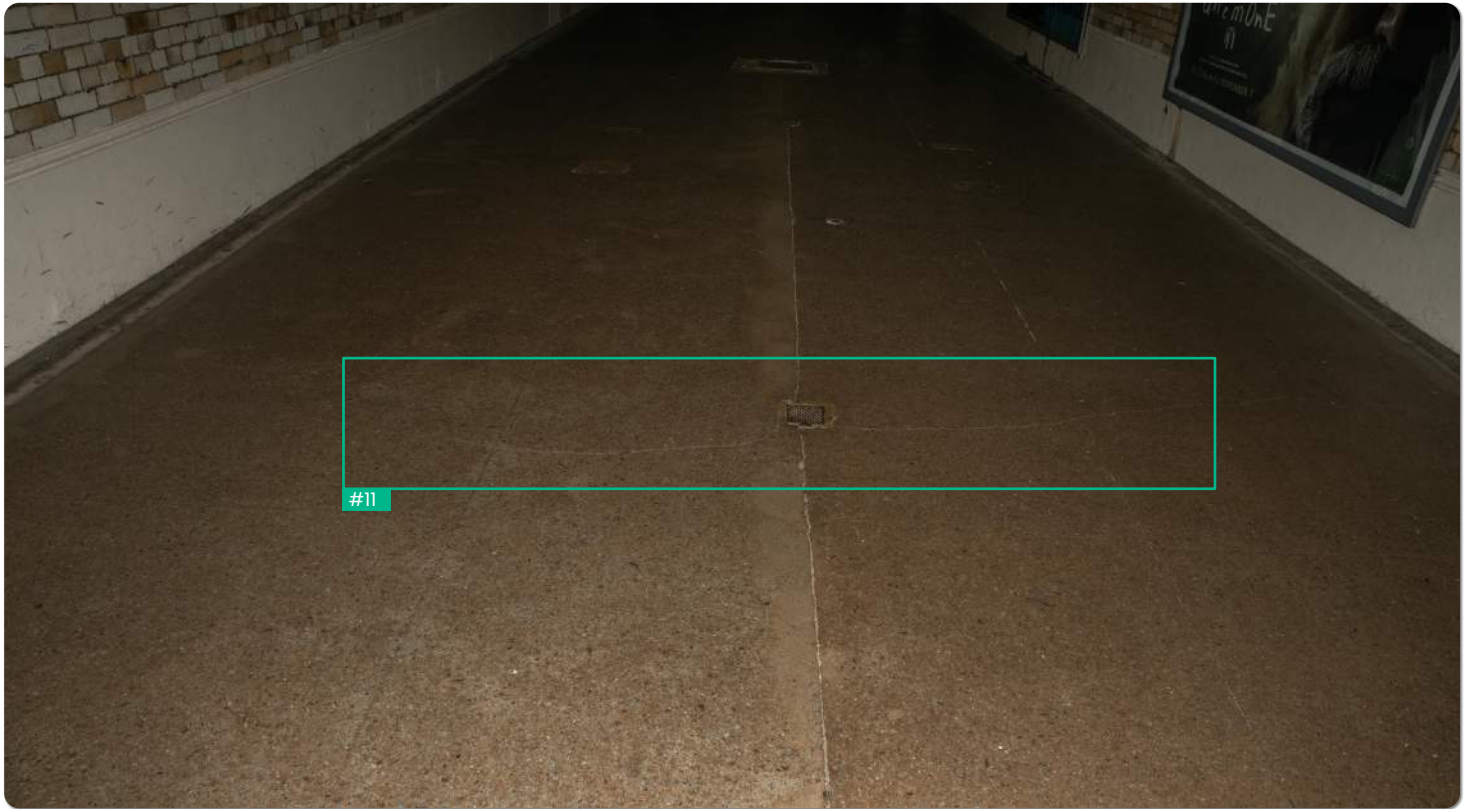
#11

Long straight construction joint visible running along corridor centreline. Minor cracking noted but slab appears generally sound. Surface finish varies either side of joint.

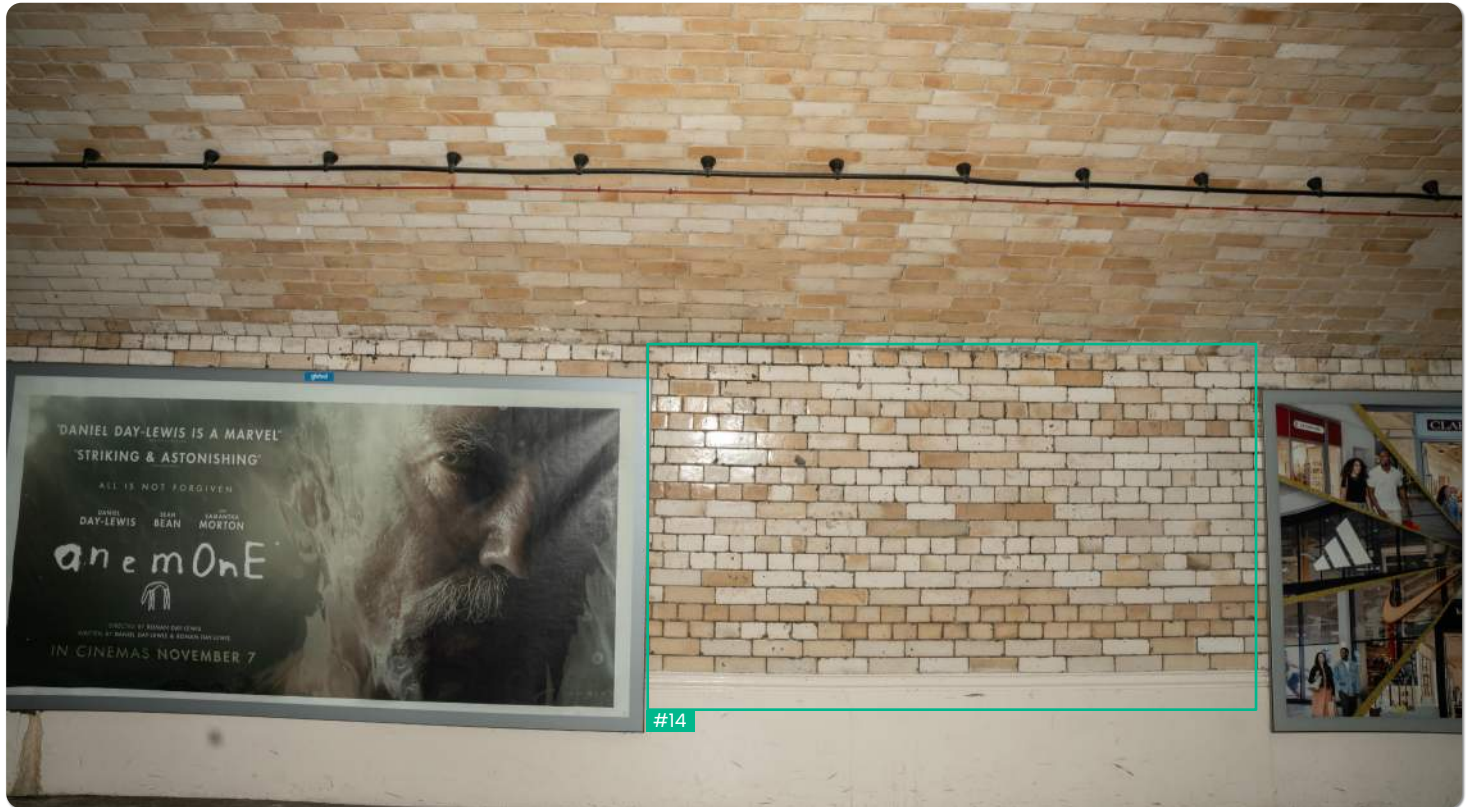
#14

Significant discolouration and variation in tile glazing across wall area; extensive patch repairs visible. No discrete structural cracking but widespread cosmetic degradation, staining, and tile mismatch.

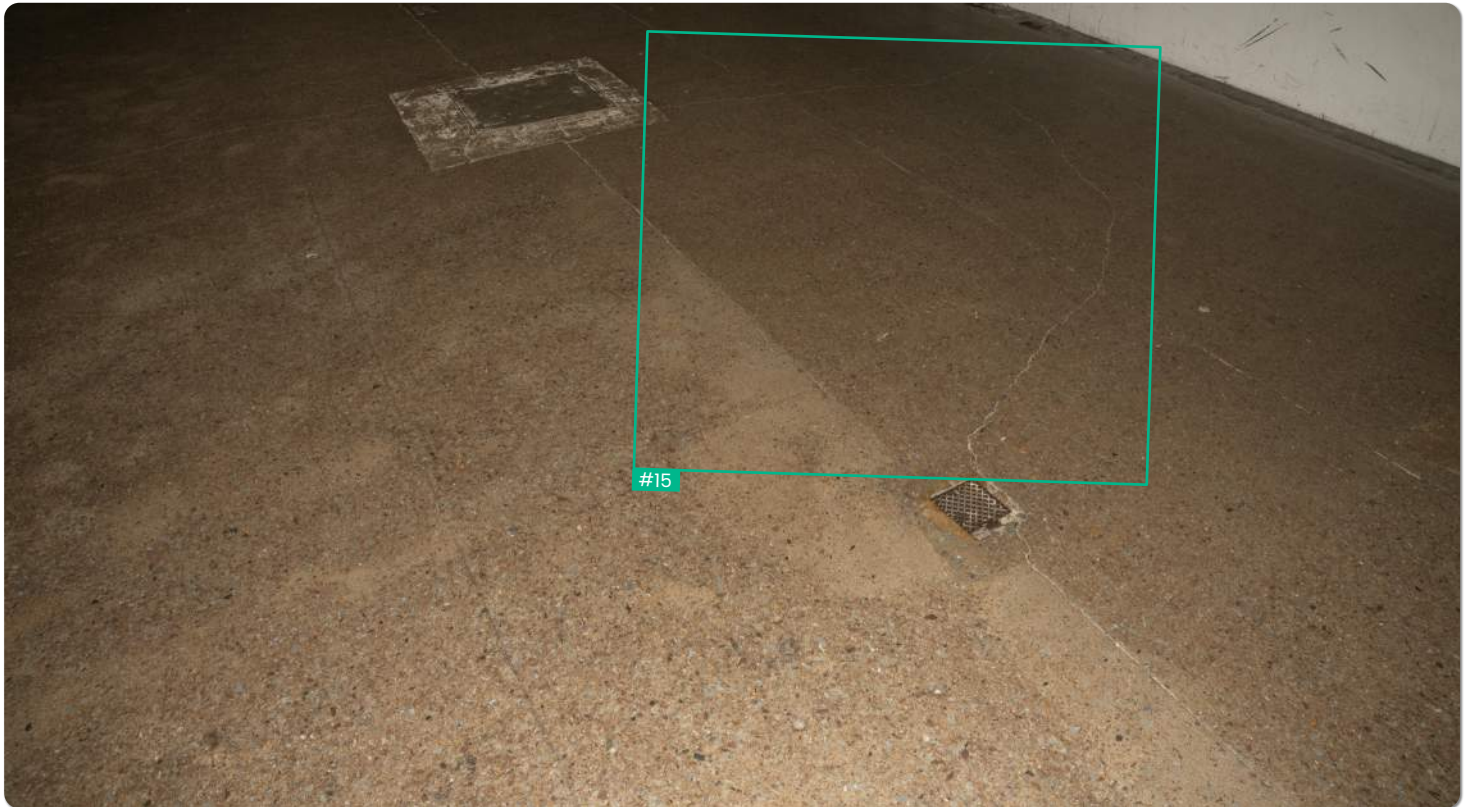
#15

Shrinkage cracks and uneven finish radiating from recessed surface cover. Cracks appear hairline but propagate across surface.

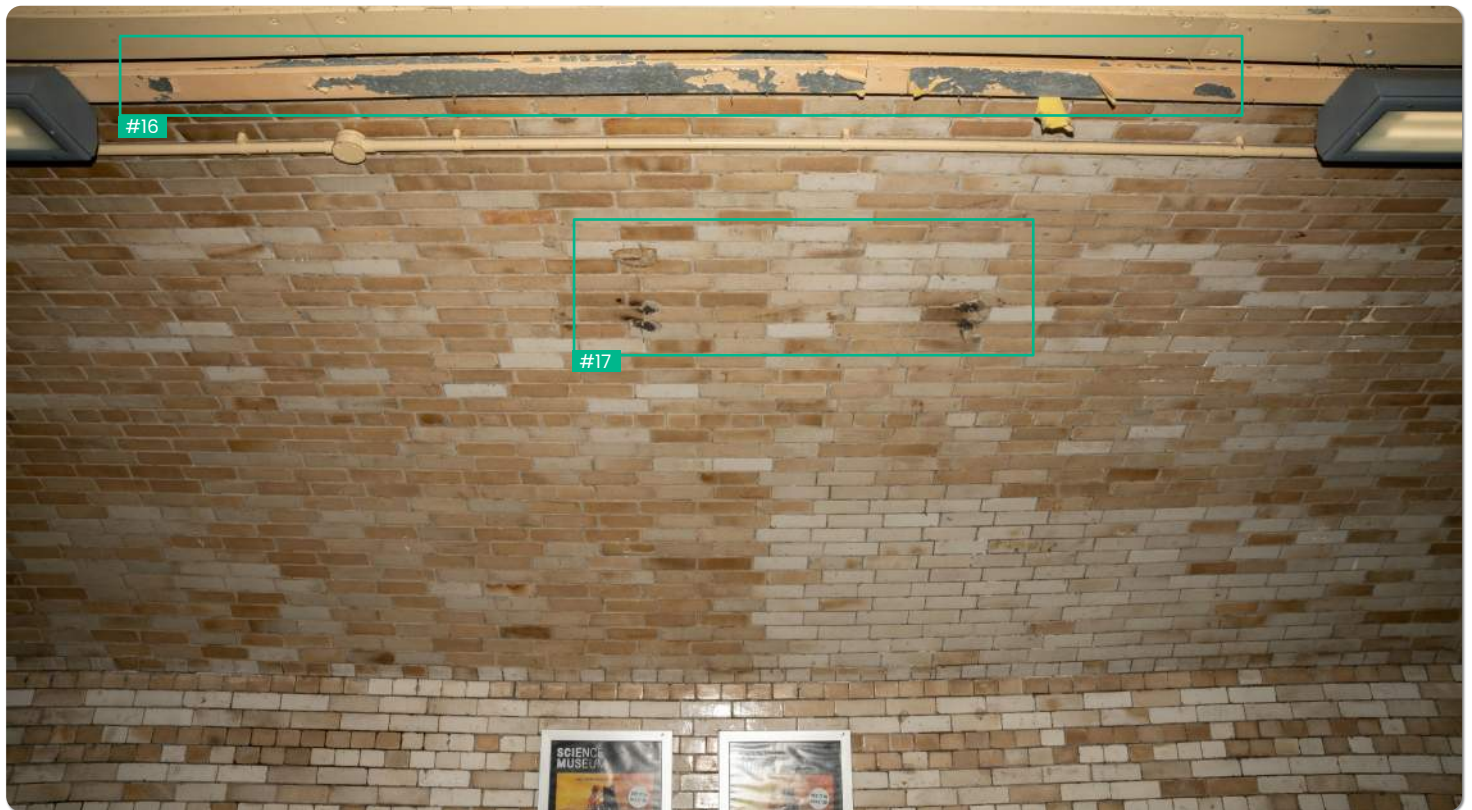
#16

Extensive flaking and deteriorated coating on trunking fixed to ceiling.

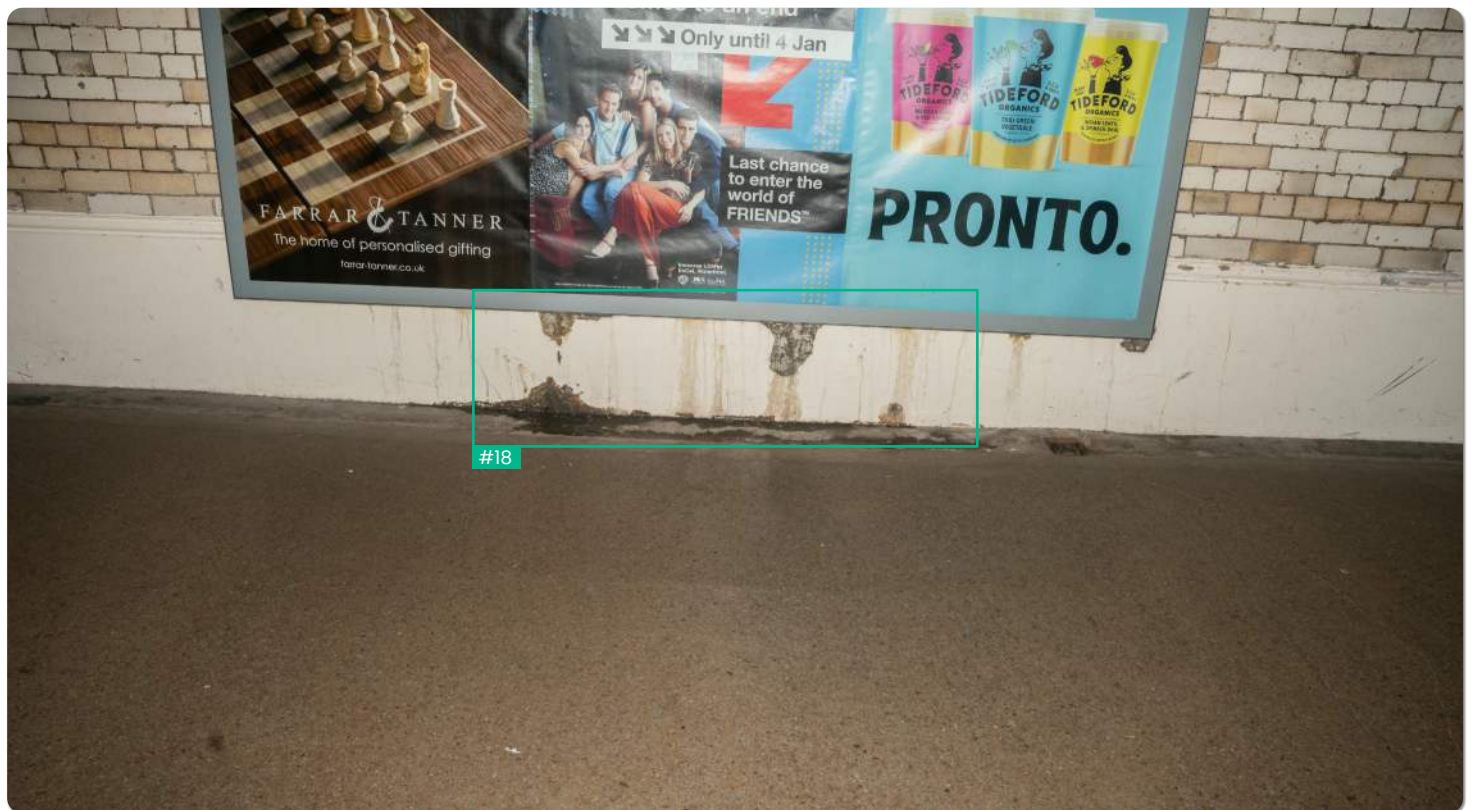
#18

Significant water staining beneath advertising panels along wall base; Lower wall surfaces show material erosion.

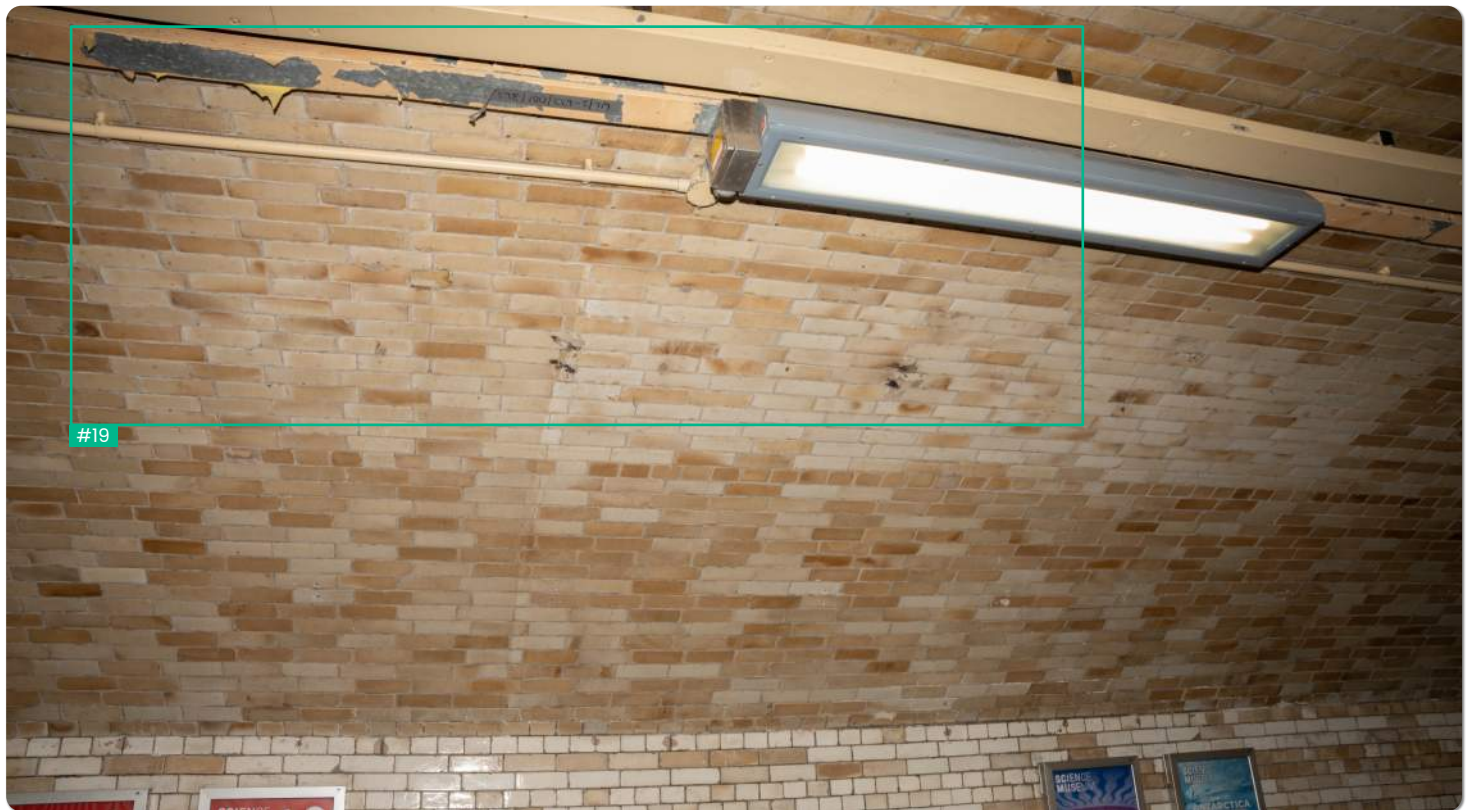
#19

Paint/coating failure along ceiling-mounted cable tray with exposed metal and flaking paint. Adjacent brickwork also exhibits surface deterioration and staining from previous fixings

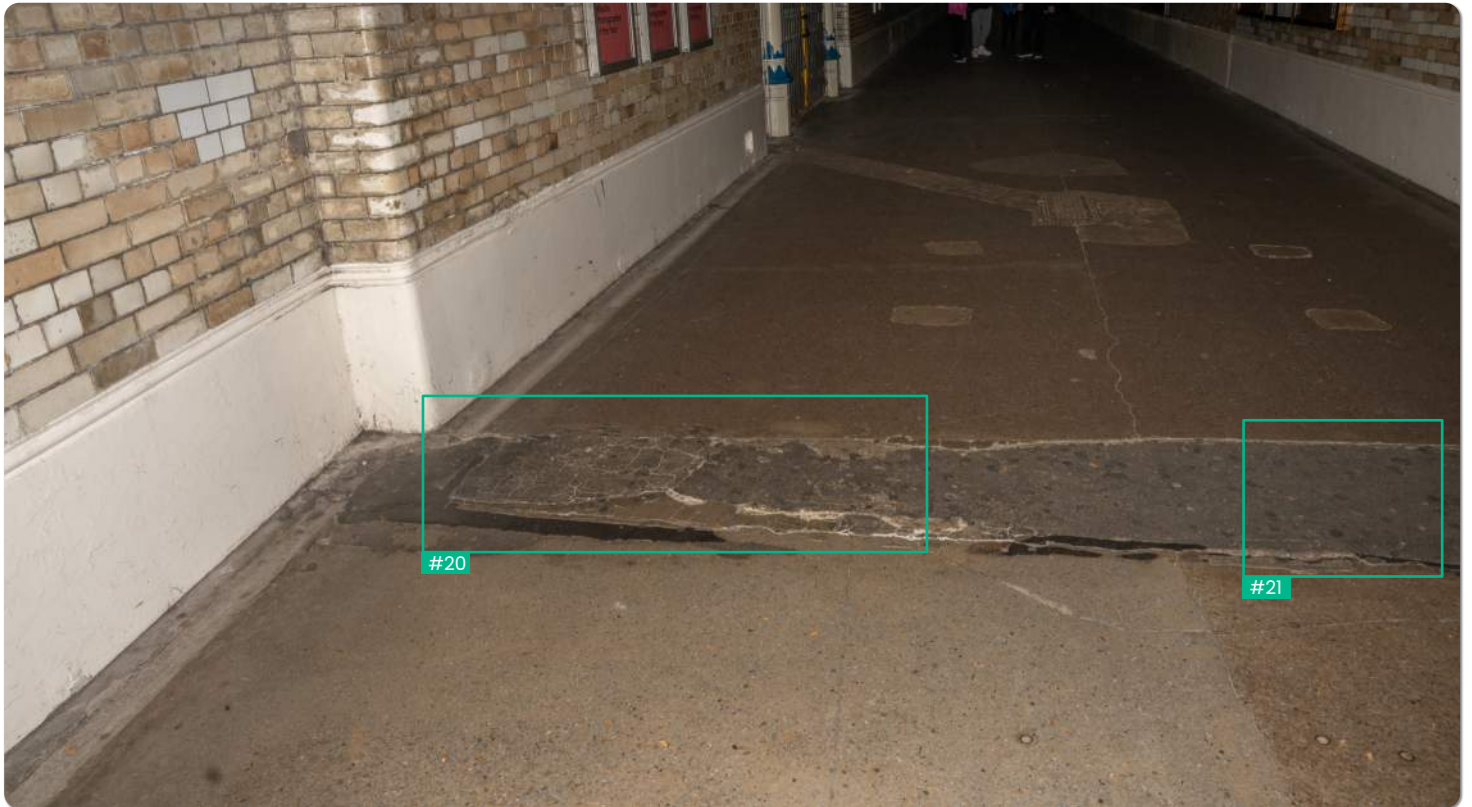
#20

Floor surface break-up along reinstated asphalt strip; significant edge deterioration, uneven height levels, and cracking possibly indicating either failed reinstatement or long-term wear.

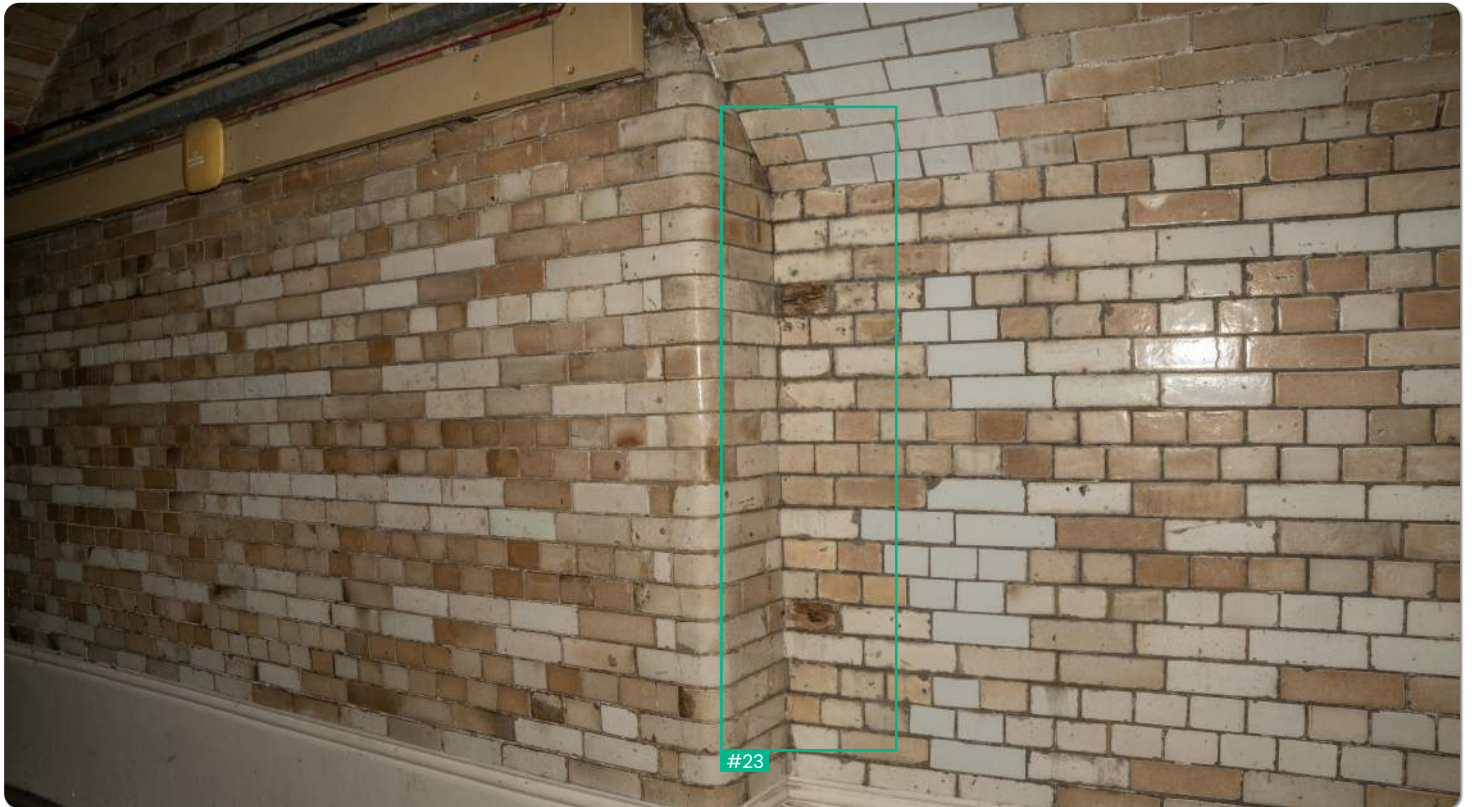
#23

Tiles along the curved corner display noticeable dullness and surface abrasion compared to surrounding wall tiles. The glazed ceramic finish has partially worn away, exposing a more porous underlying surface. Two rectangular areas show clear signs of previous surface fixings or mountings. Glaze has been chipped away and original tile faces removed, leaving unsealed cavities with rough edges

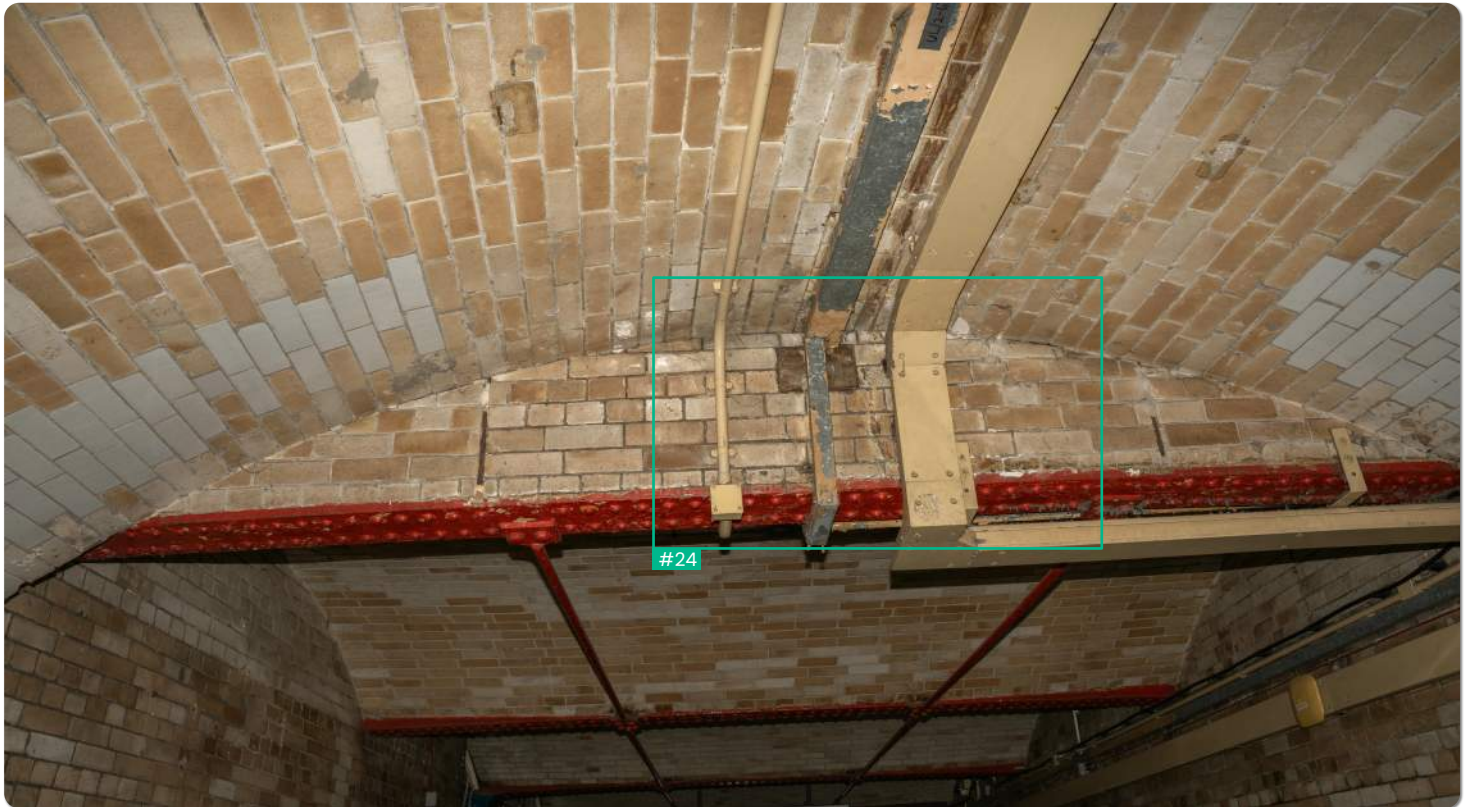
#24

Bricks adjacent to the metal service supports show spalling, chipped edges, and loss of glaze. The damaged edges appear historic and linked to repeated drilling/installation of service hangers. Repair mortar and replacement brick fragments are visible along the beam line and between tiles. These patches vary in tone and finish from original materials,

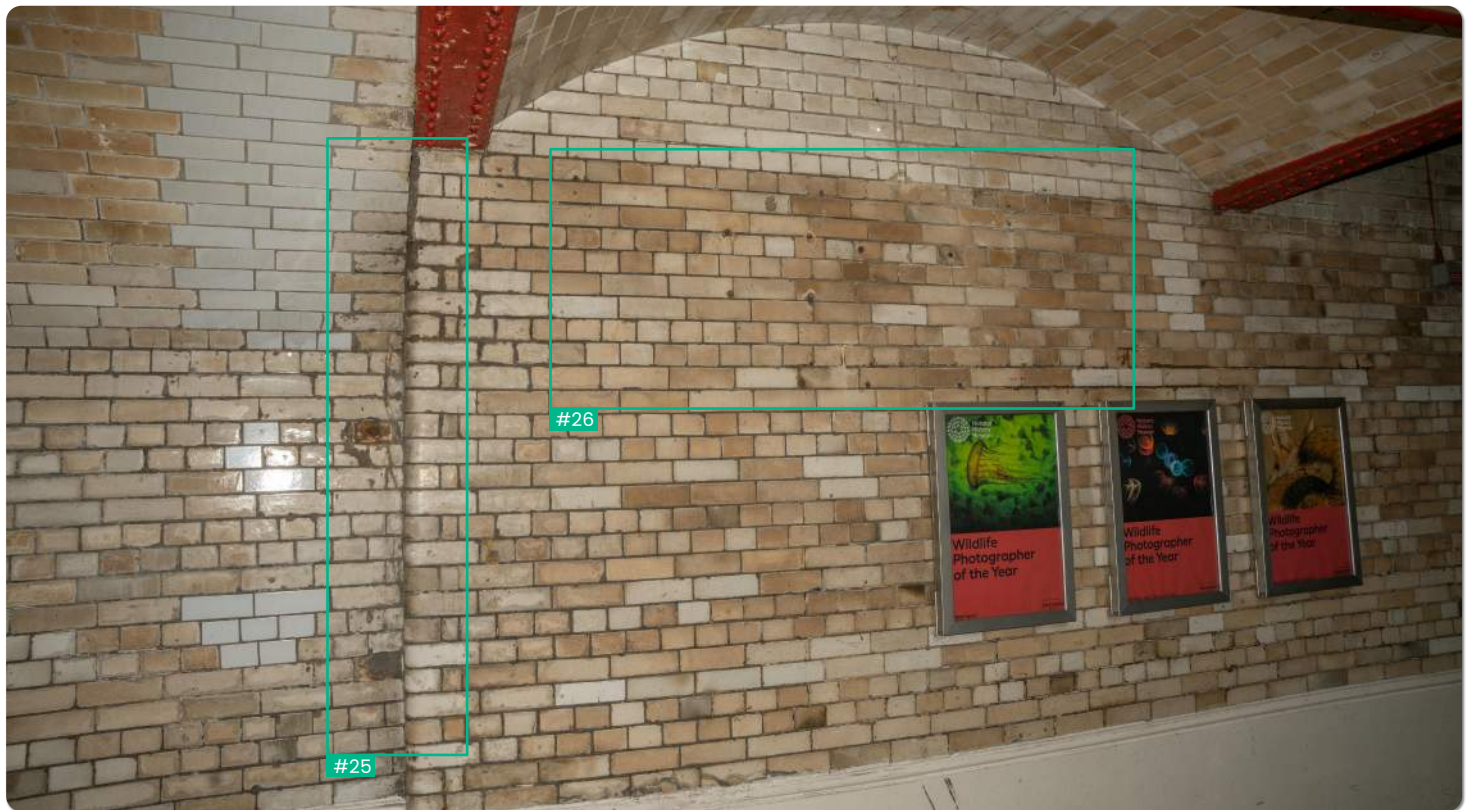
#25

Surface damage to overhead soffit where previous service fixings removed. Exposed mortar and chipped brick finish visible, along with staining. Surrounding areas show further patch repairs and unsealed penetrations.
