Dilapidation Survey Report

NHM Exhibition Road Subway
15th November 2025

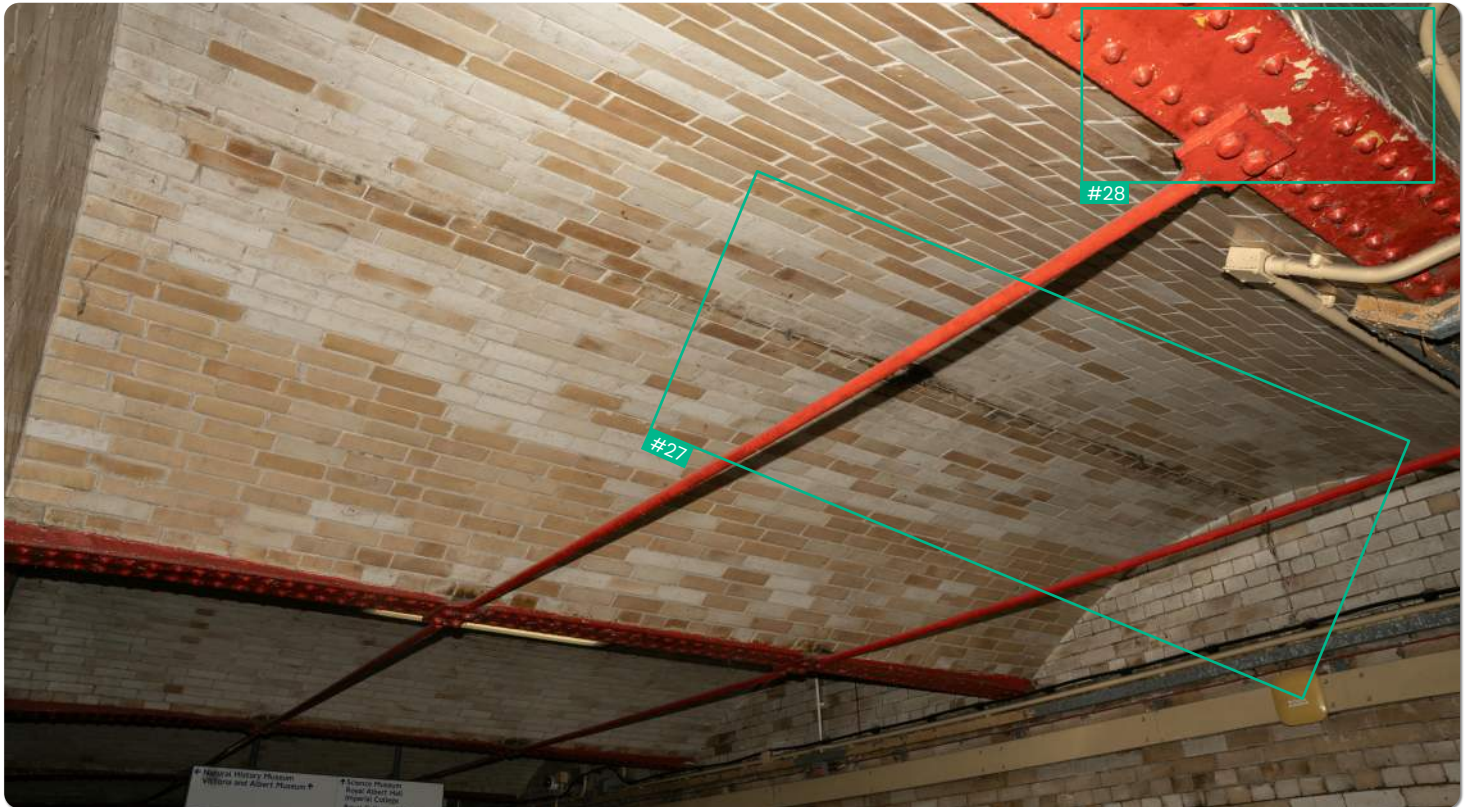
#27

Surface staining and paint failure along horizontal service band. Flaked coating exposes metallic substrate. No active water visible.

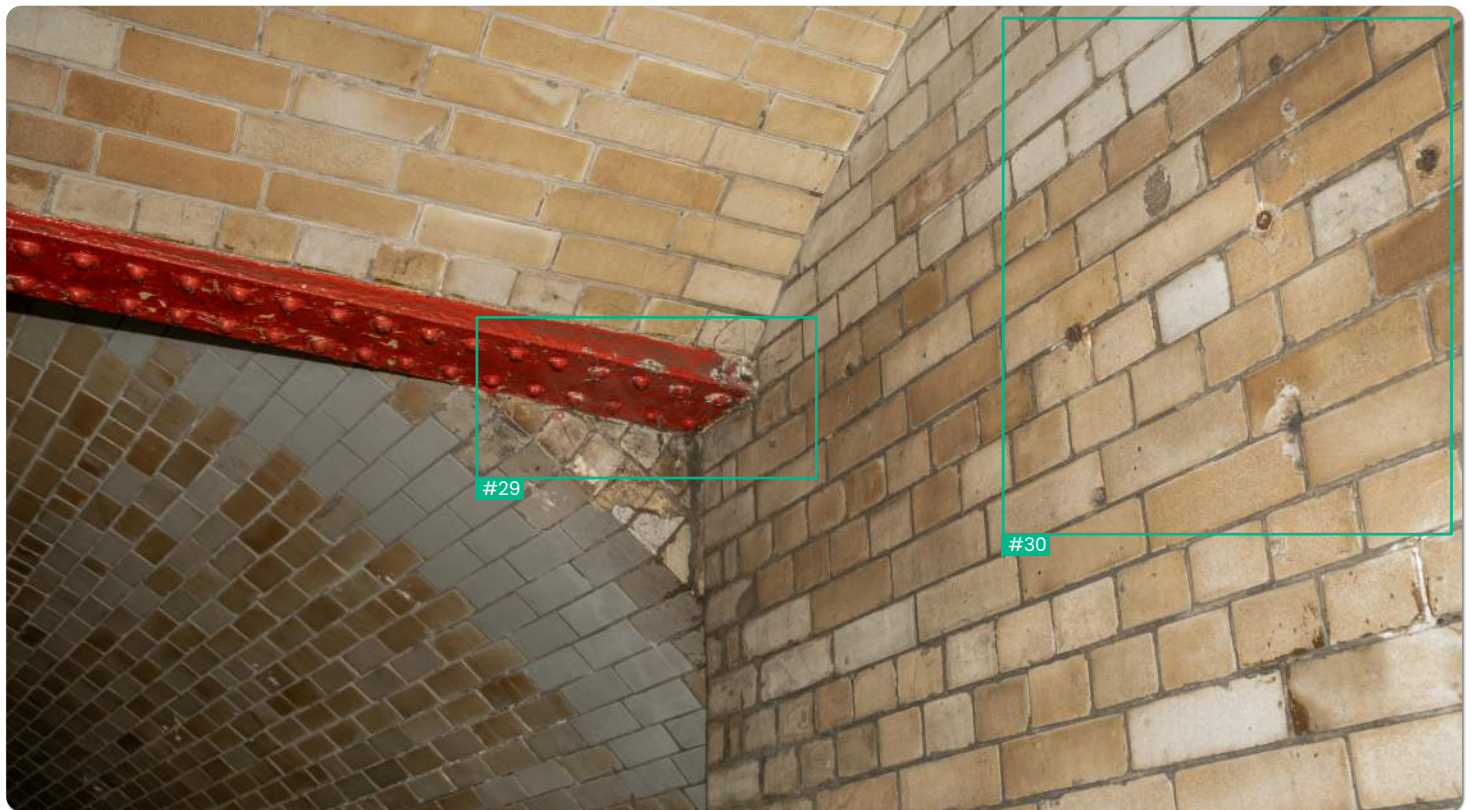
#29

Brickwork deterioration at the interface between soffit and supporting steel beam, including cracking along the springline, surface spalling, and historic patch repairs. The paint on the beam above appears chipped, with partial loss of coating exposing the metal substrate. No severe corrosion is visible.

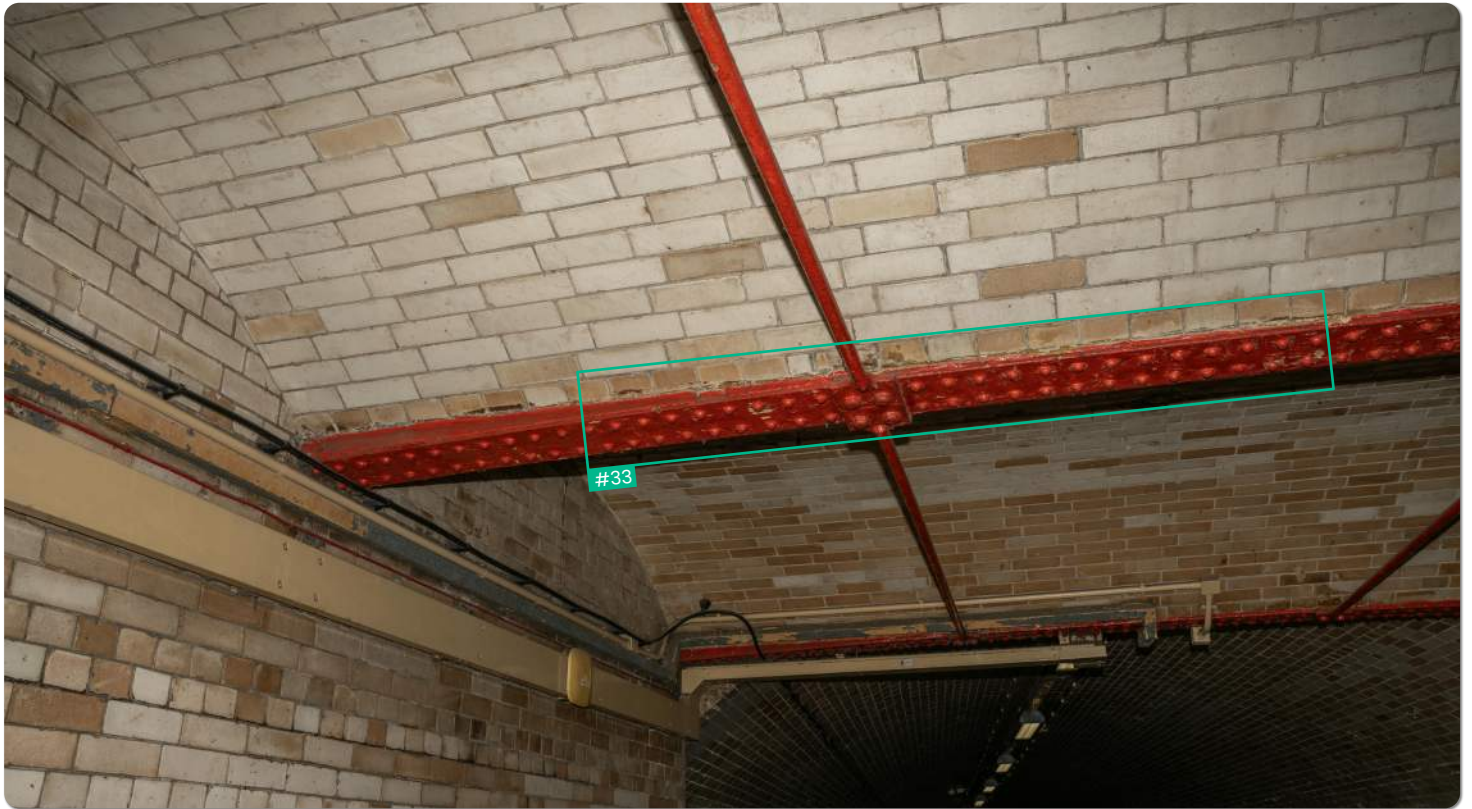
#33

The red beam exhibit visible flaking paint, rust patches, and surface corrosion, particularly around rivets and edges. Protective coating appears to be coming off in several locations, exposing metal to oxidation

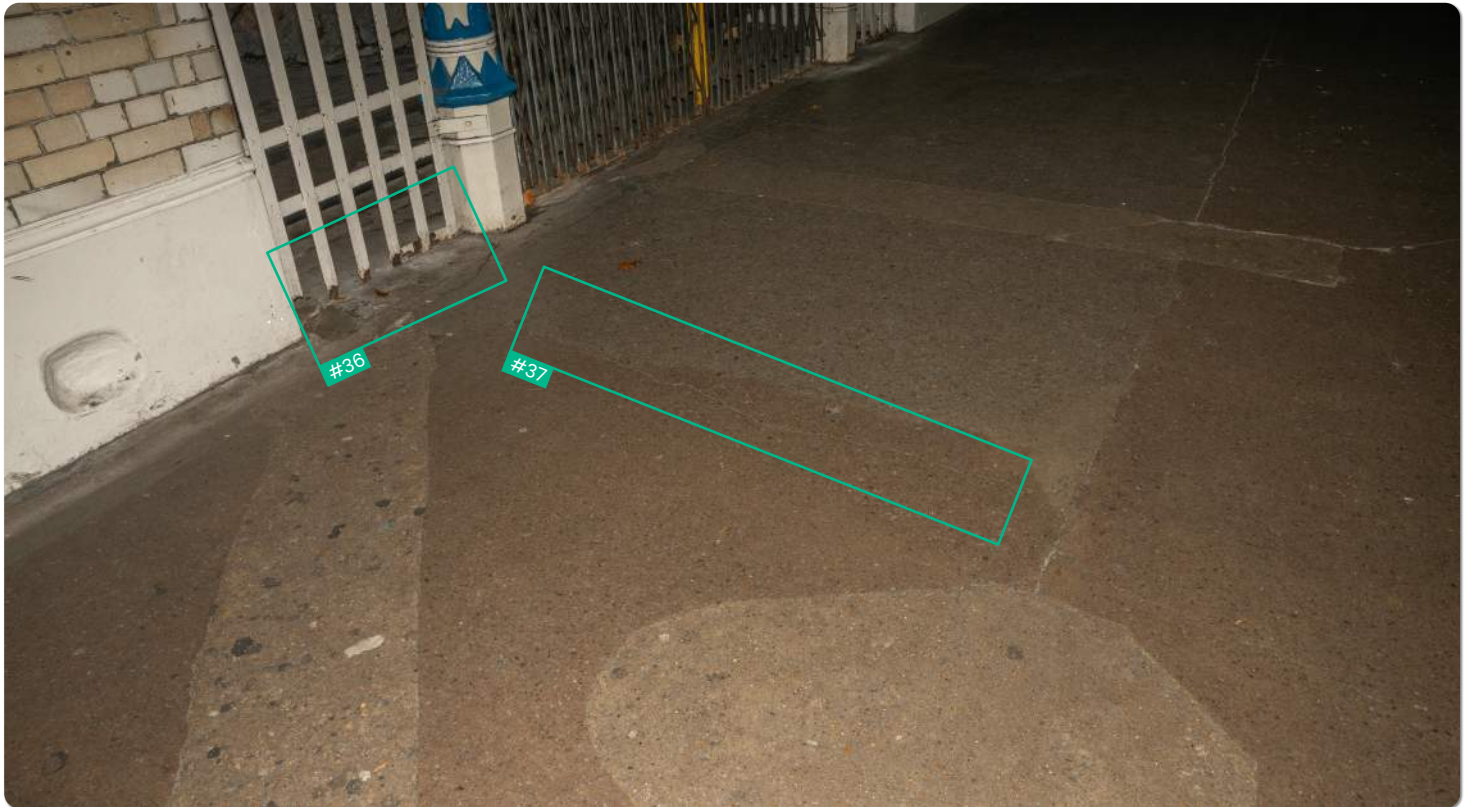
#36

The floor surface adjacent to the gate and column base shows localised surface deterioration, including abrasion, chipping and degradation of the concrete/aggregate finish. Additionally, small cracks and broken surface edges are visible at the threshold where the floor meets the vertical metal gate frame

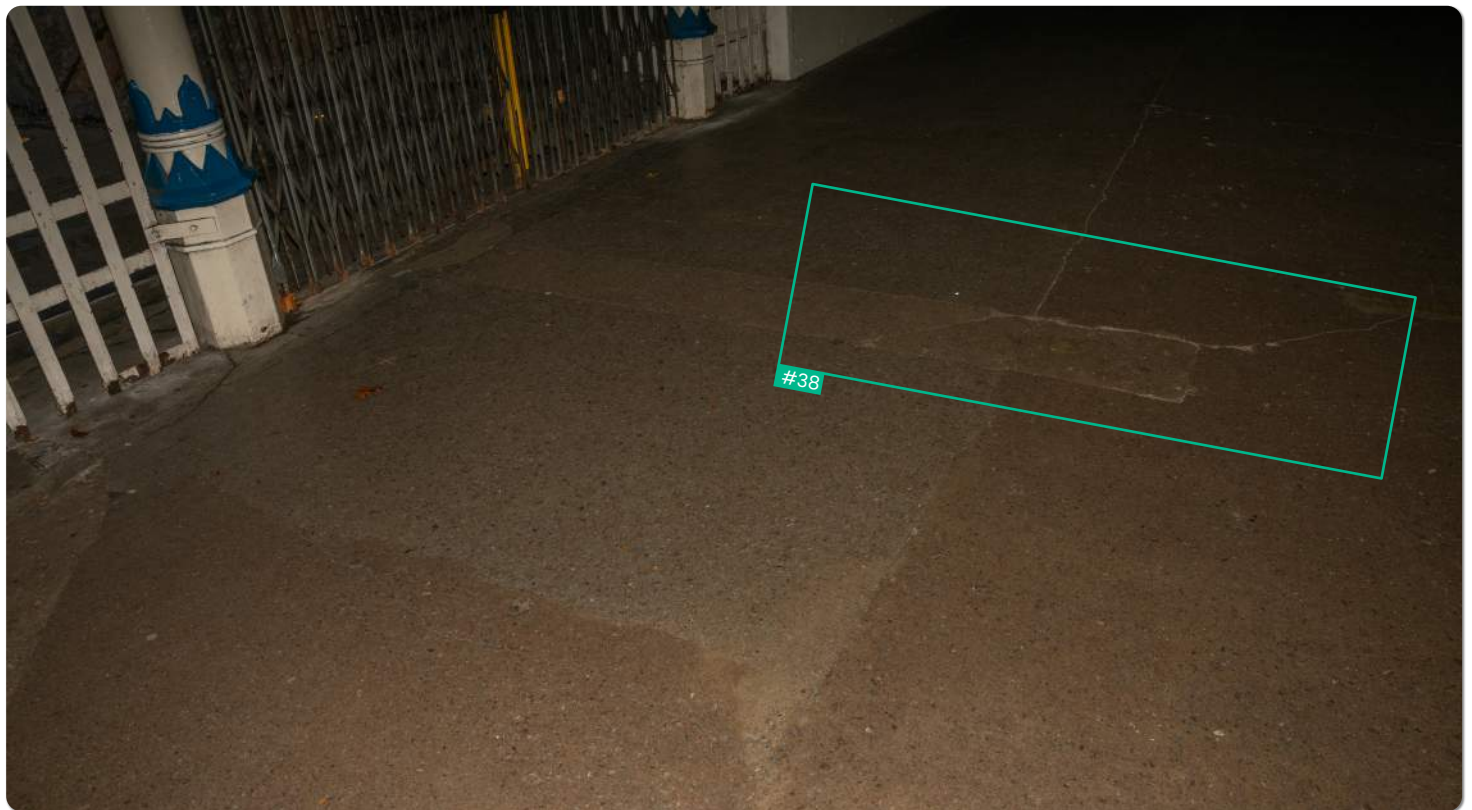
#38

The highlighted section of floor appears to be a large historic repair patch with visible signs of distress, including cracking, uneven surface finish, and mismatched material tone relative to the surrounding original paving.

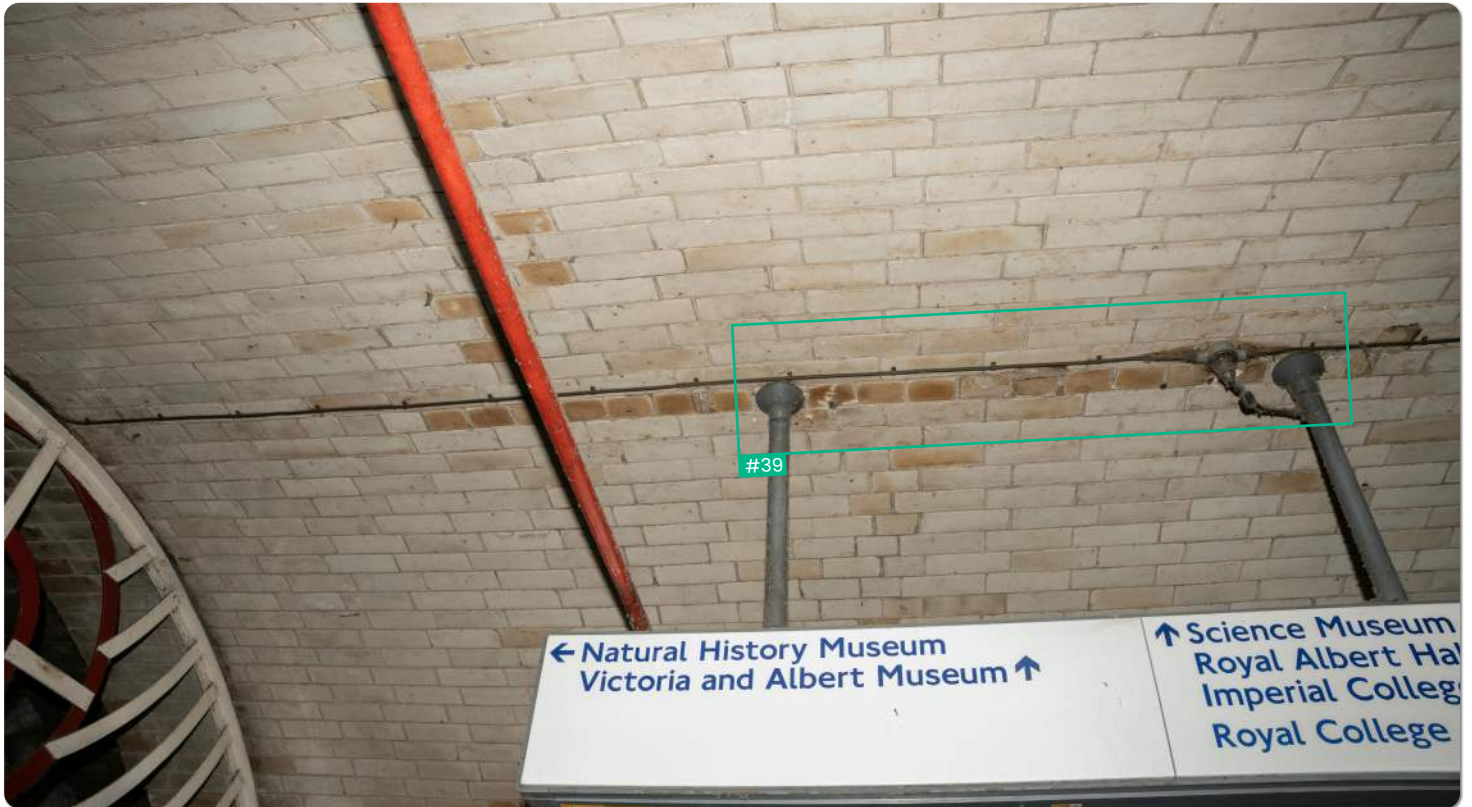
#39

The highlighted brickwork section below the arch curve exhibits surface staining, mortar deterioration, and minor cracking around service conduit fixings. The area appears to be impacted by historic moisture exposure and alteration works related to overhead services.

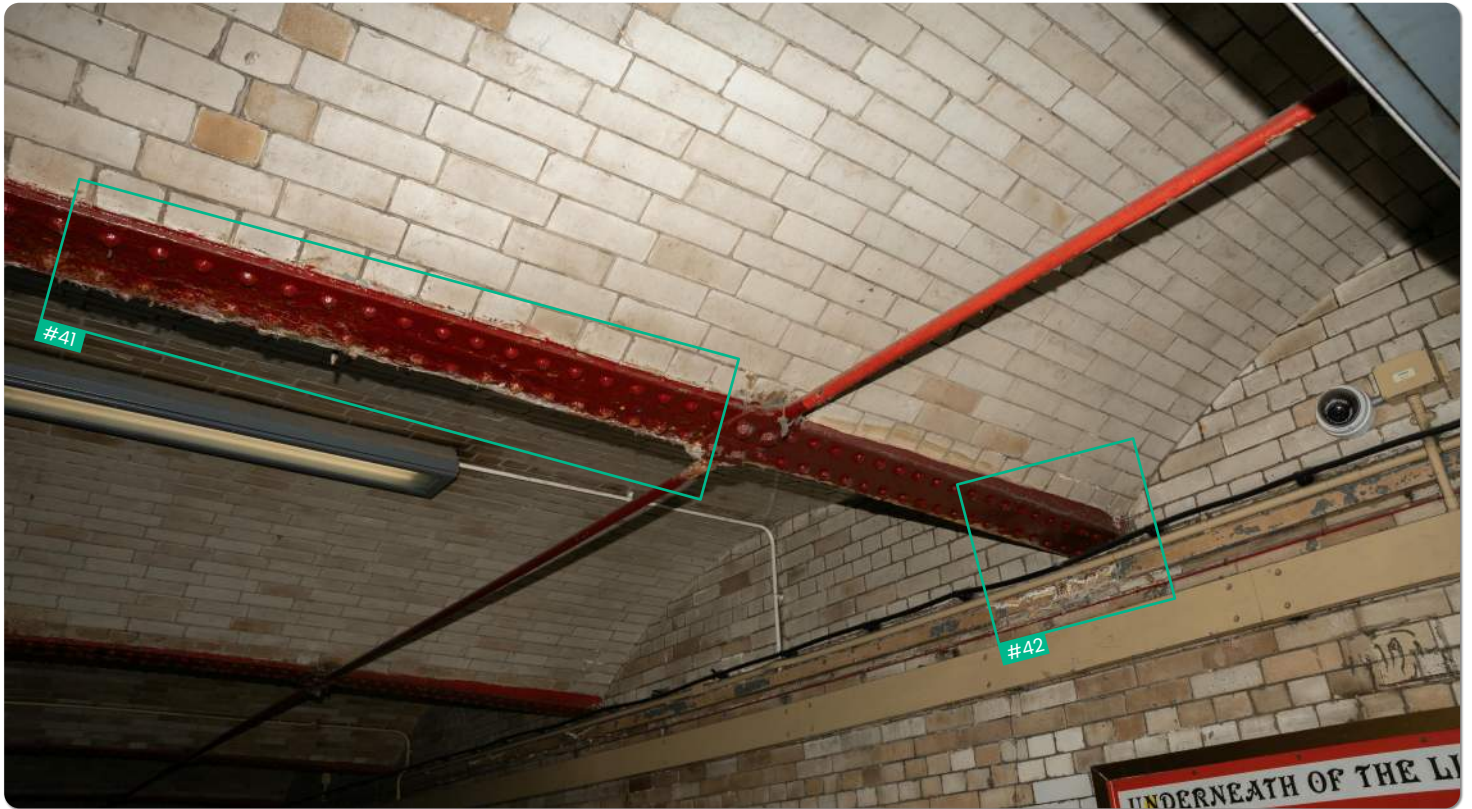
#41

The steel support beam shows extensive paint failure and advanced corrosion along the lower flange and rivet line. The deterioration appears continuous across the span rather than isolated, with the coating having peeled away in strips,

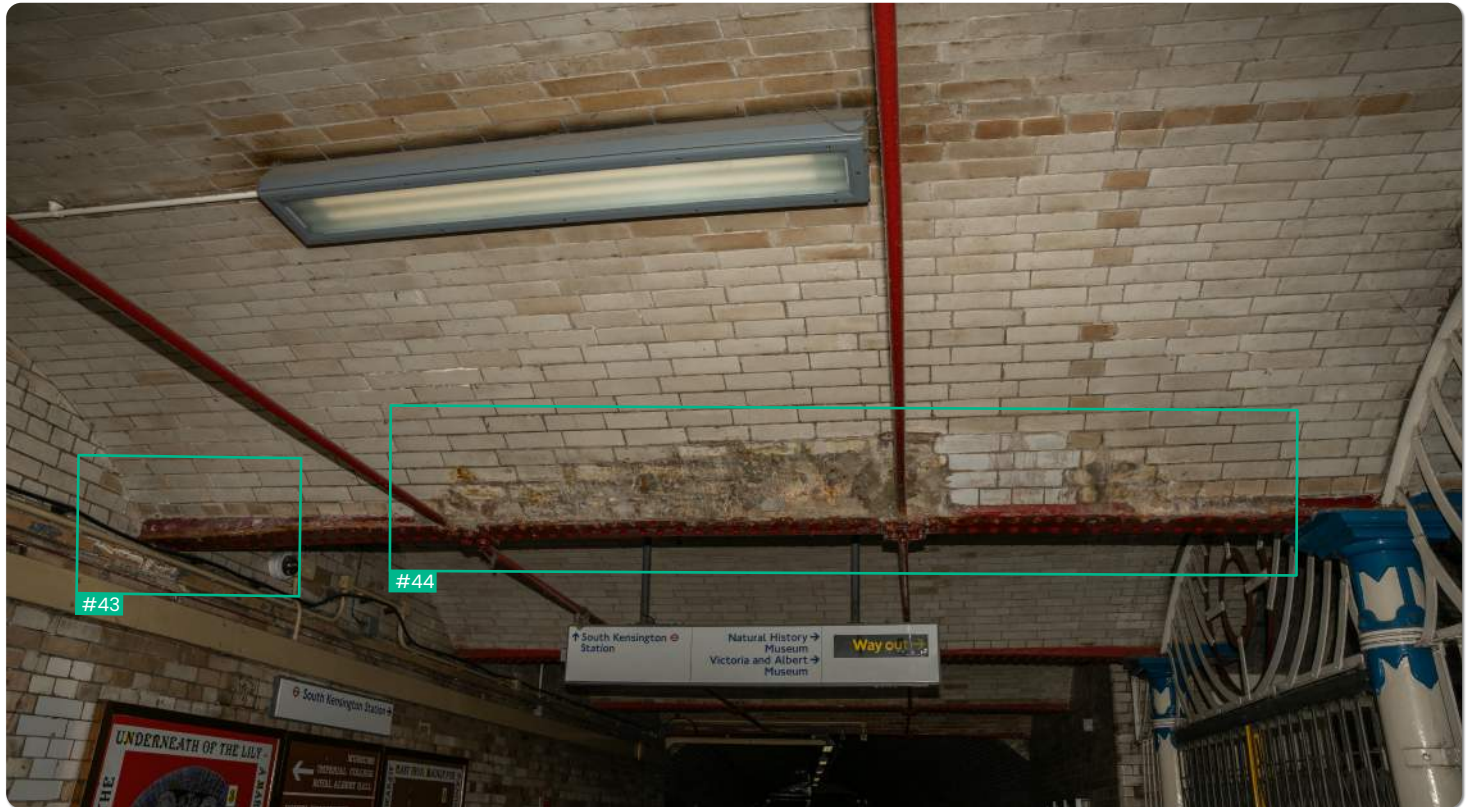
#43

The highlighted section shows degraded surface-mounted trunking with peeling paint, corrosion to metal containment components, and damaged substrate behind the trunking. There is significant deterioration to the existing beam

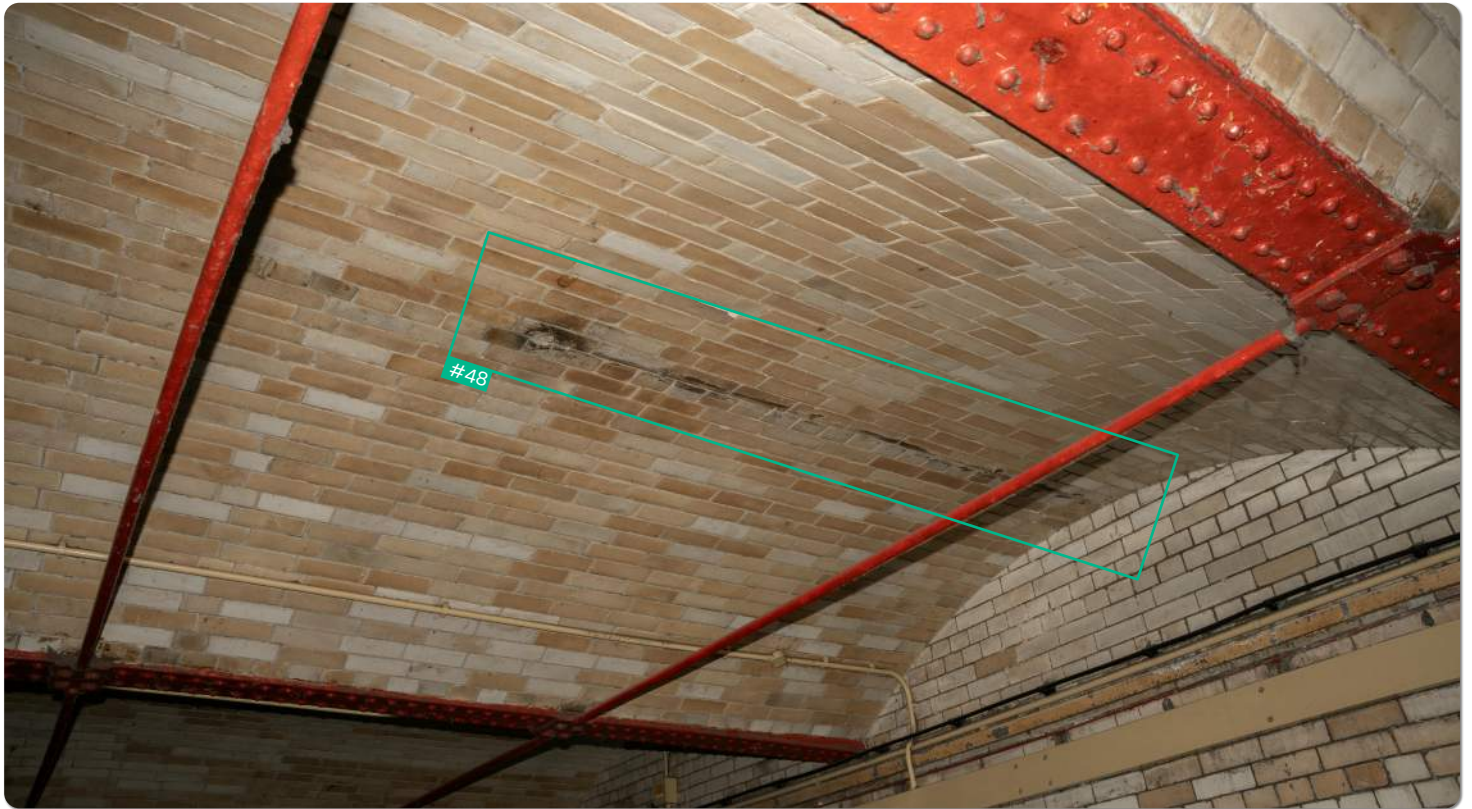
#48

The highlighted section of the vaulted brick ceiling shows localised staining, discolouration, and surface deterioration, concentrated in a linear band across several bricks. The staining is darker than surrounding areas and appears to follow a directional path

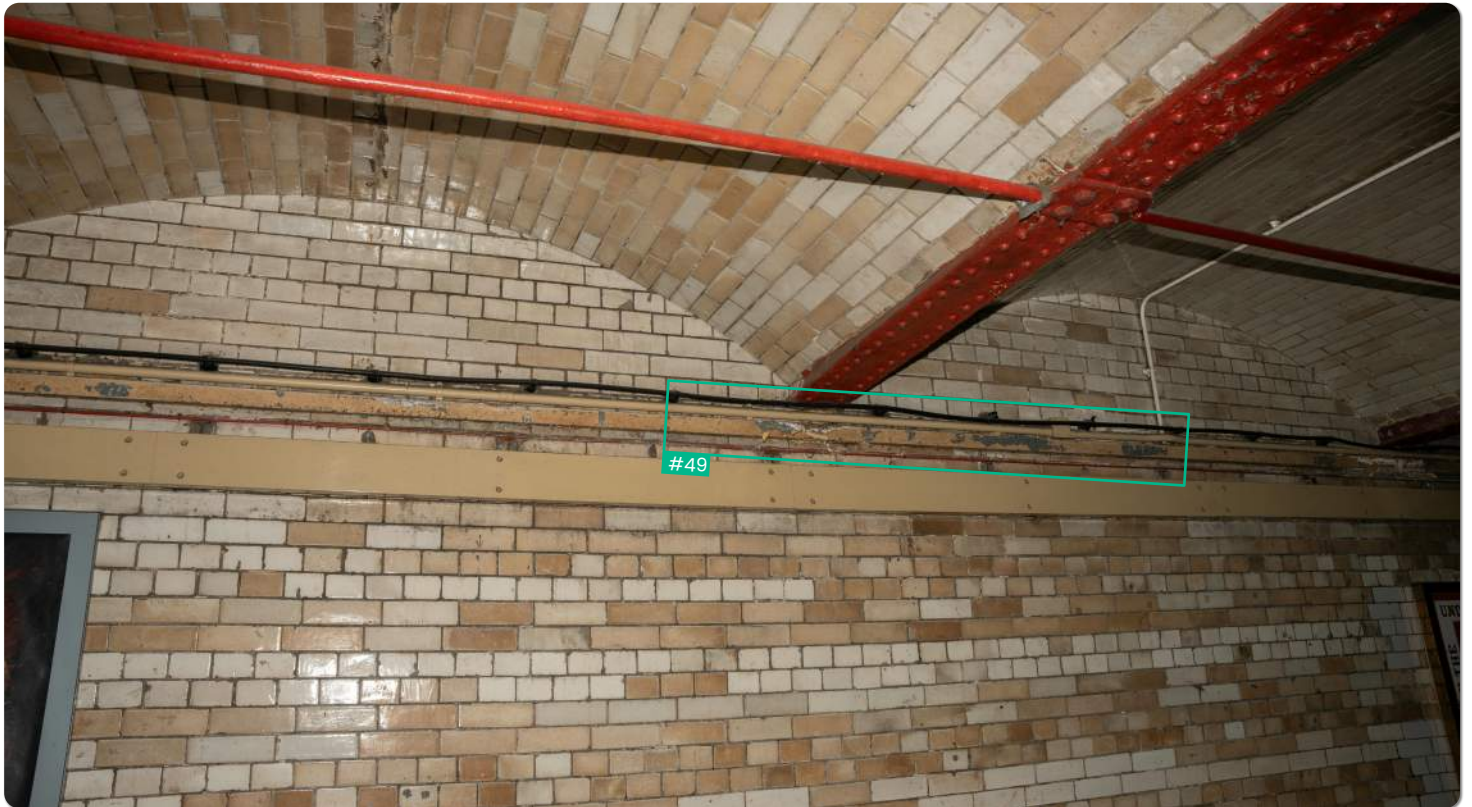
#49

The highlighted section features surface-mounted cabling and containment fixed along the wall beneath a steel beam, with significant deterioration to the mounting surface, patchy repairs, and flaking paint.

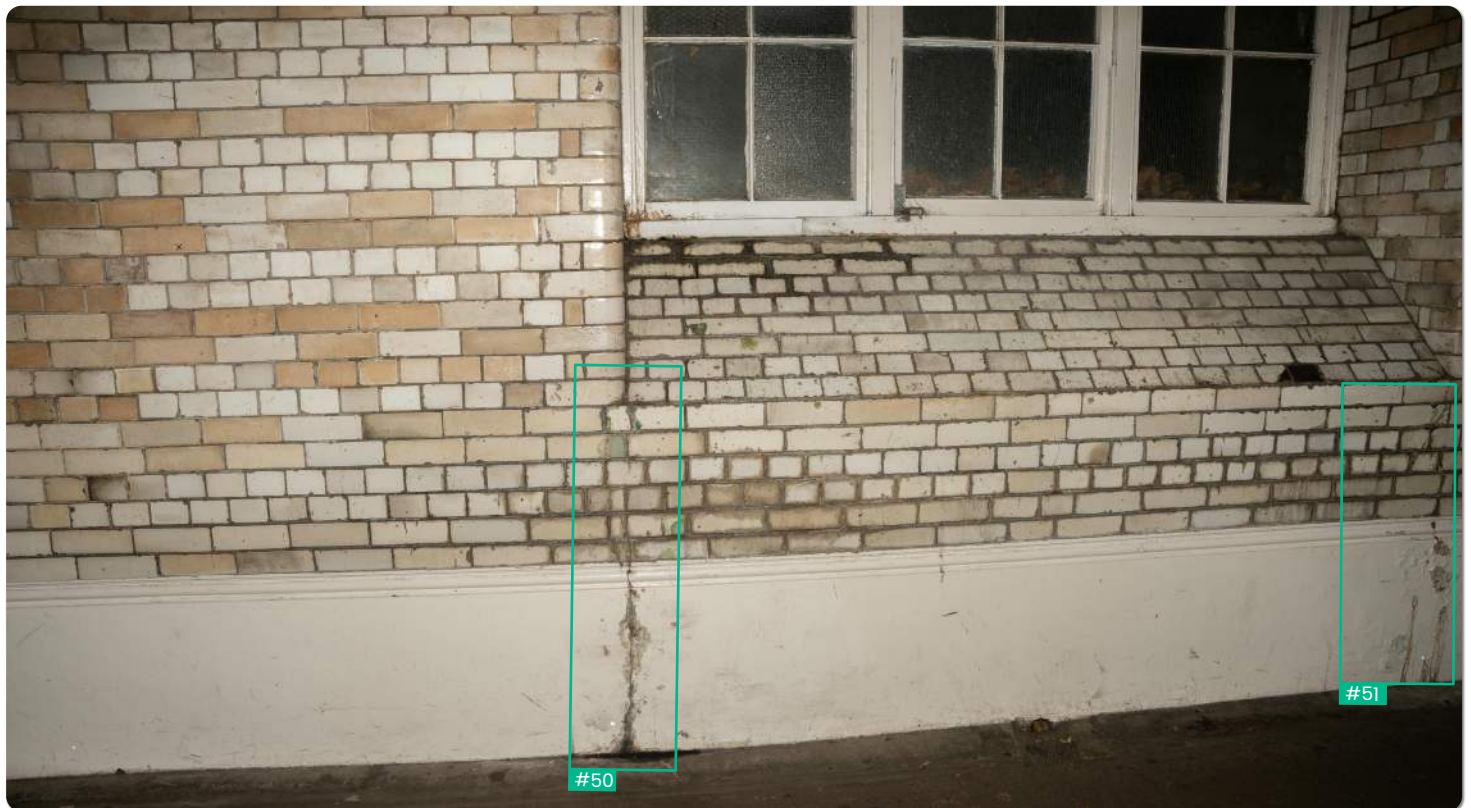
#50

A prominent vertical crack is observed running from the upper brickwork down through the painted lower plinth and terminating at floor level. The defect appears long-standing and has been previously filled, but the filler has deteriorated, resulting in renewed cracking and voiding.

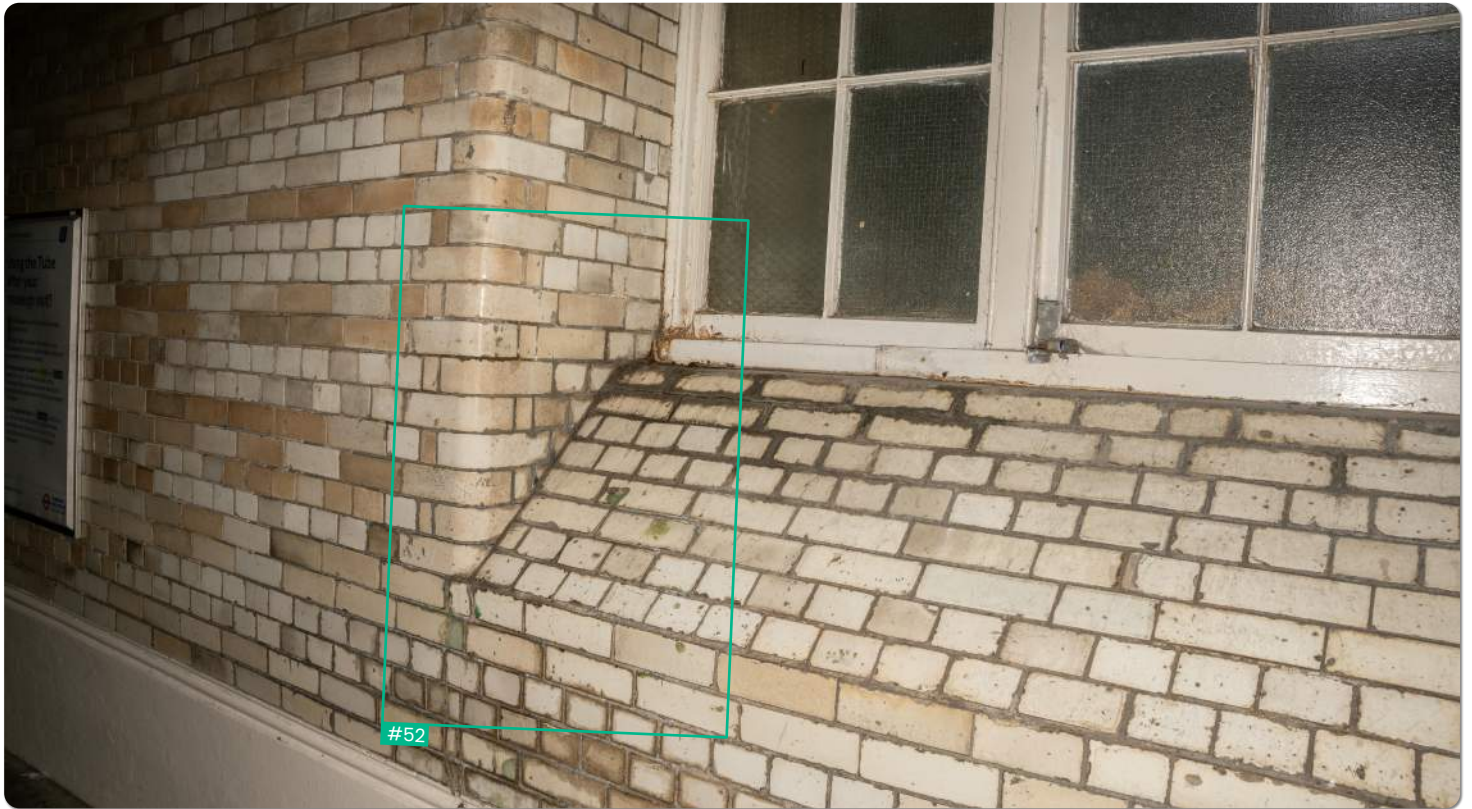
#52

Highlighted area (#52) shows a combination of moisture-related staining, mortar deterioration, and cracking on the brickwork directly below and adjacent to the window junction.

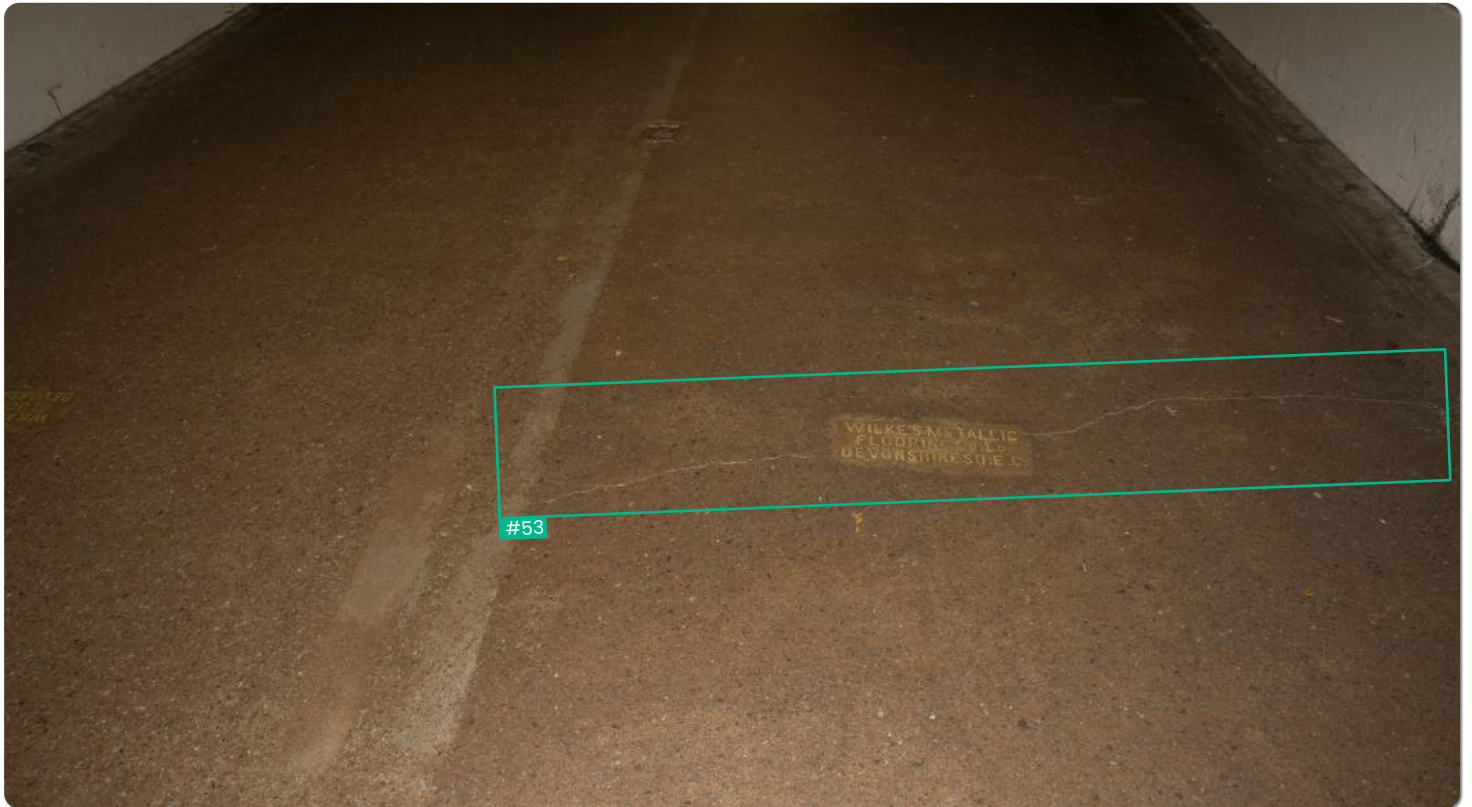
#53

Shows a longitudinal hairline crack forming across the concrete/terrazzo floor finish, accompanied by surface wear associated with heavy foot traffic.

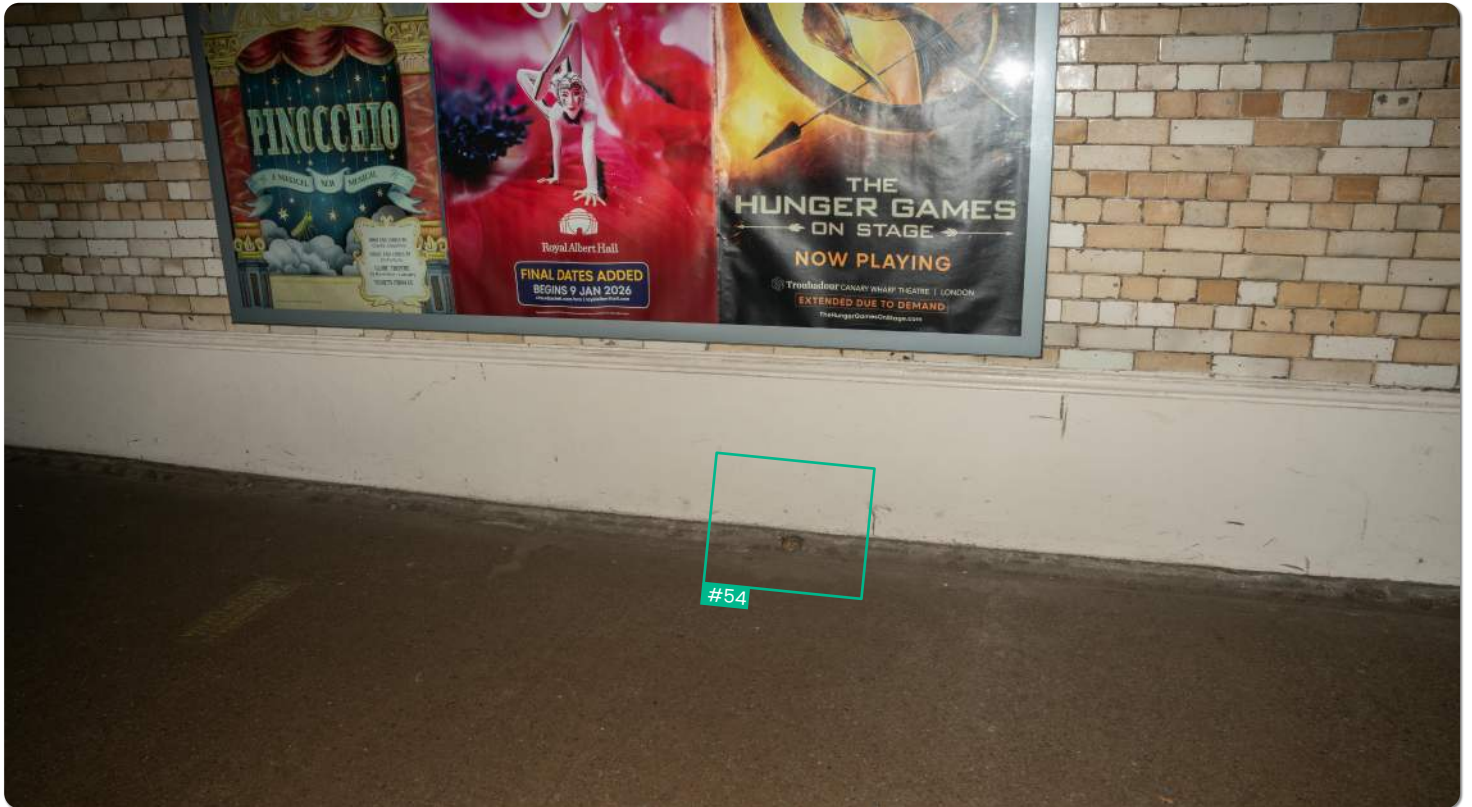
#54

A small cavity approximately few centimetres in size is visible at the lower skirting/plastered wall face. Finish appears to have chipped away, exposing underlying substrate which appears rough and unsealed.

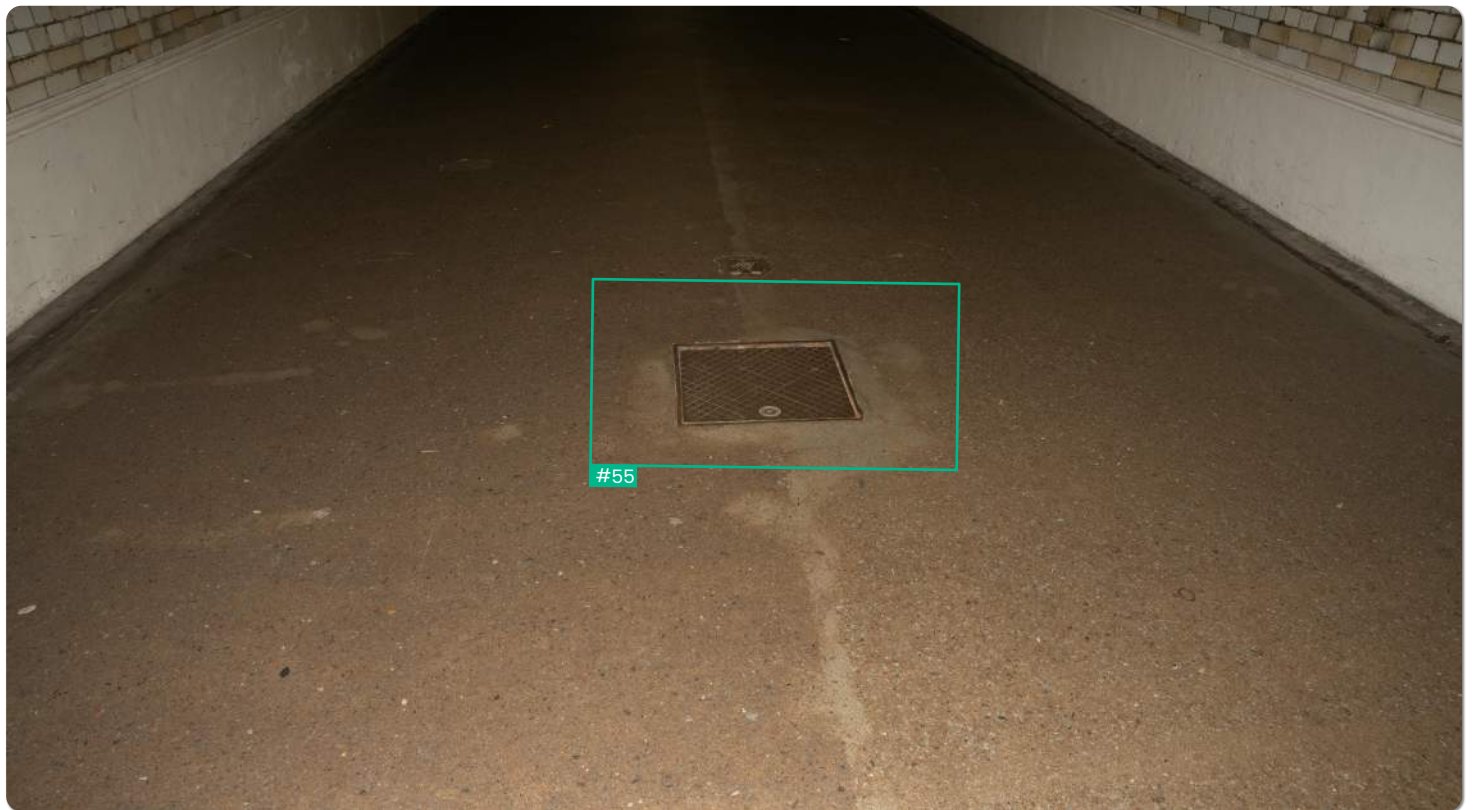
#55

The access cover located centrally within the walkway appears loose and not securely seated within its frame. The cover exhibits slight movement when stepped on, indicating a poor fit or worn seating edge

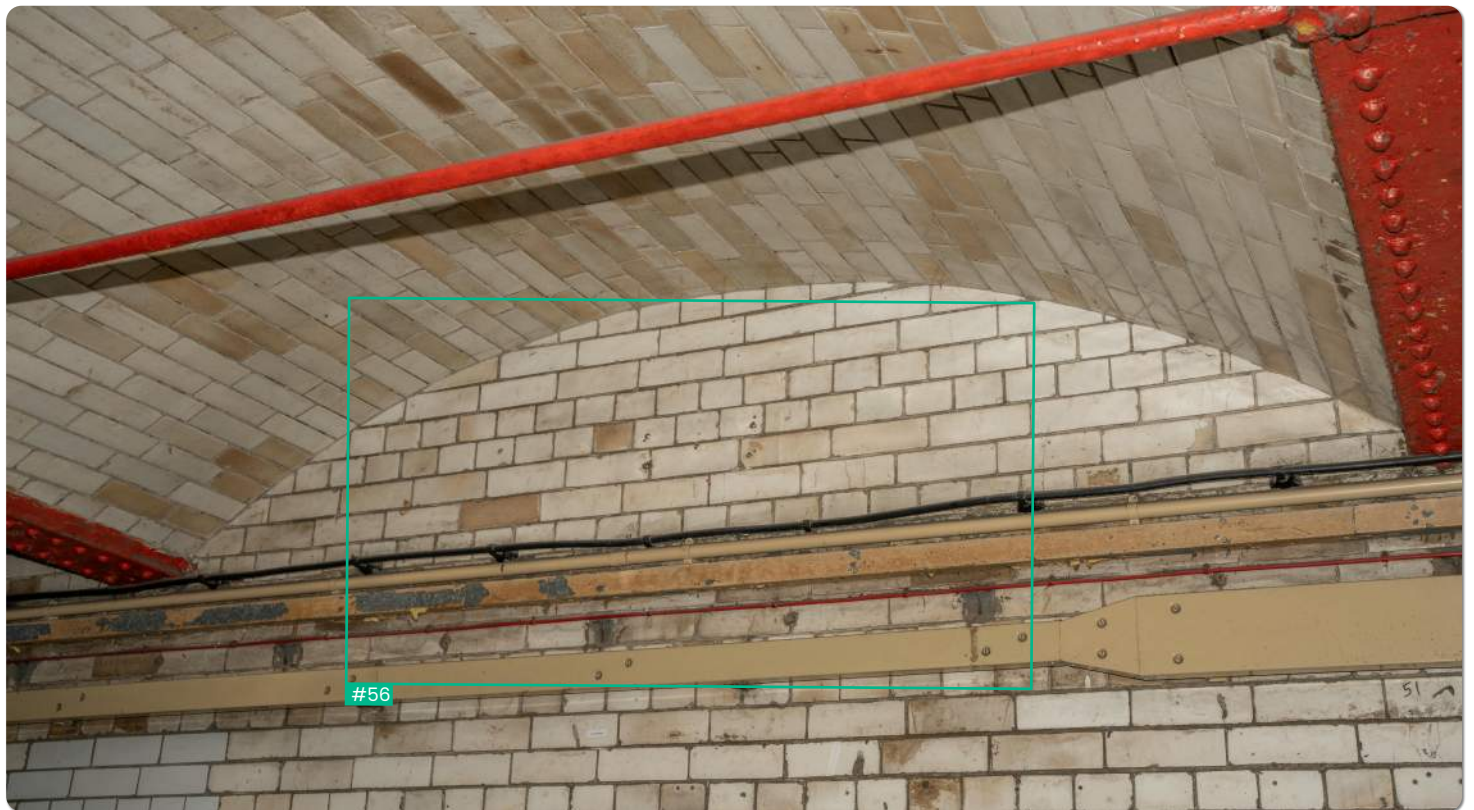
#56

The area highlighted shows deterioration of cable containment components fixed along the wall, along with staining and minor surface damage to the brickwork directly behind and below the services.

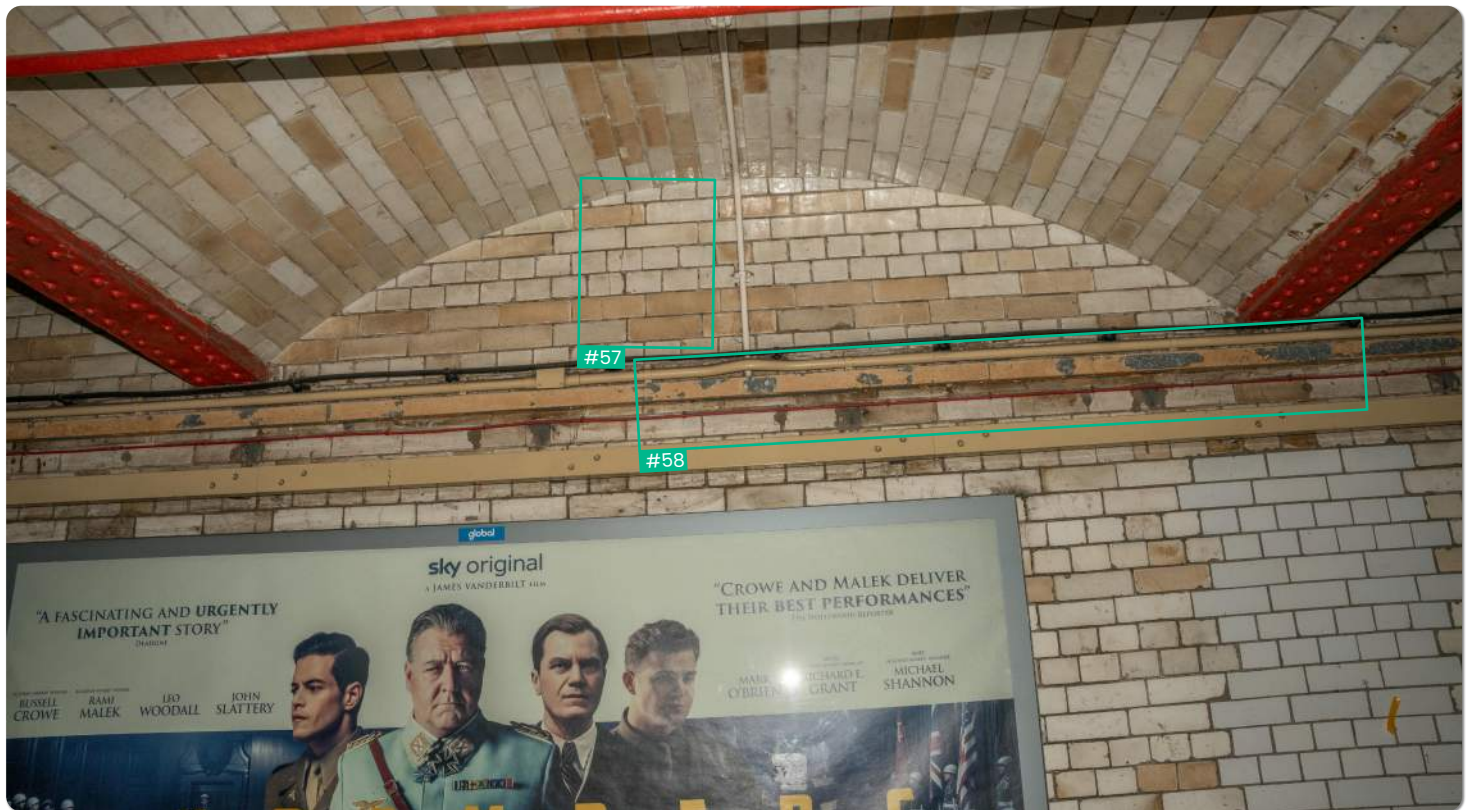
#57

A visible vertical crack is present across the soffit brickwork, running roughly perpendicular to the arch curvature. The crack appears fine-width and follows a stepped path along mortar joints before cutting across brick faces in places

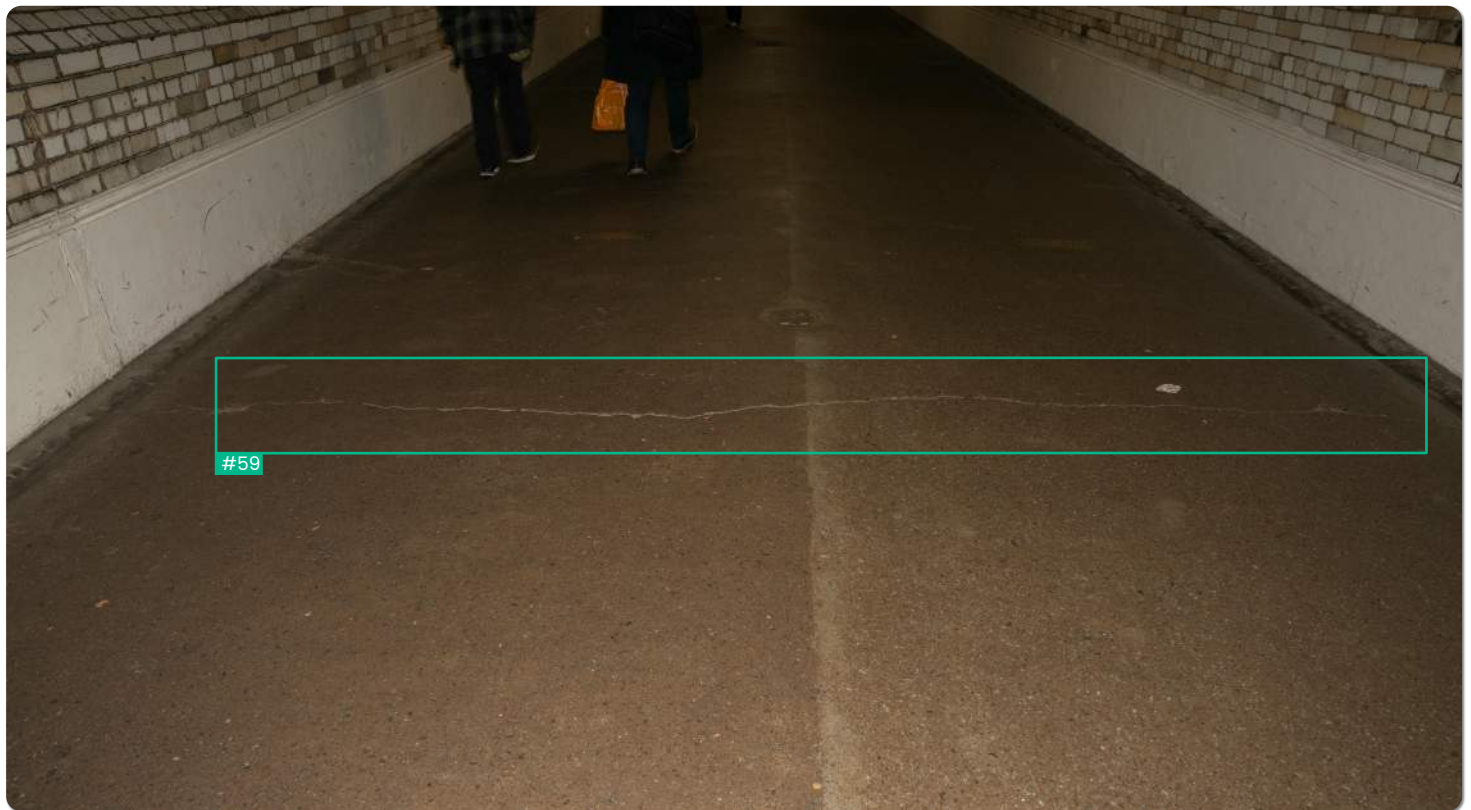
#59

A pronounced continuous linear crack extends along the floor alignment. The crack width appears fine but consistent throughout, with no immediate signs of vertical displacement or material loss. The crack intersects at least one service access plate
