Dilapidation Survey Report

NHM Exhibition Road Subway
15th November 2025

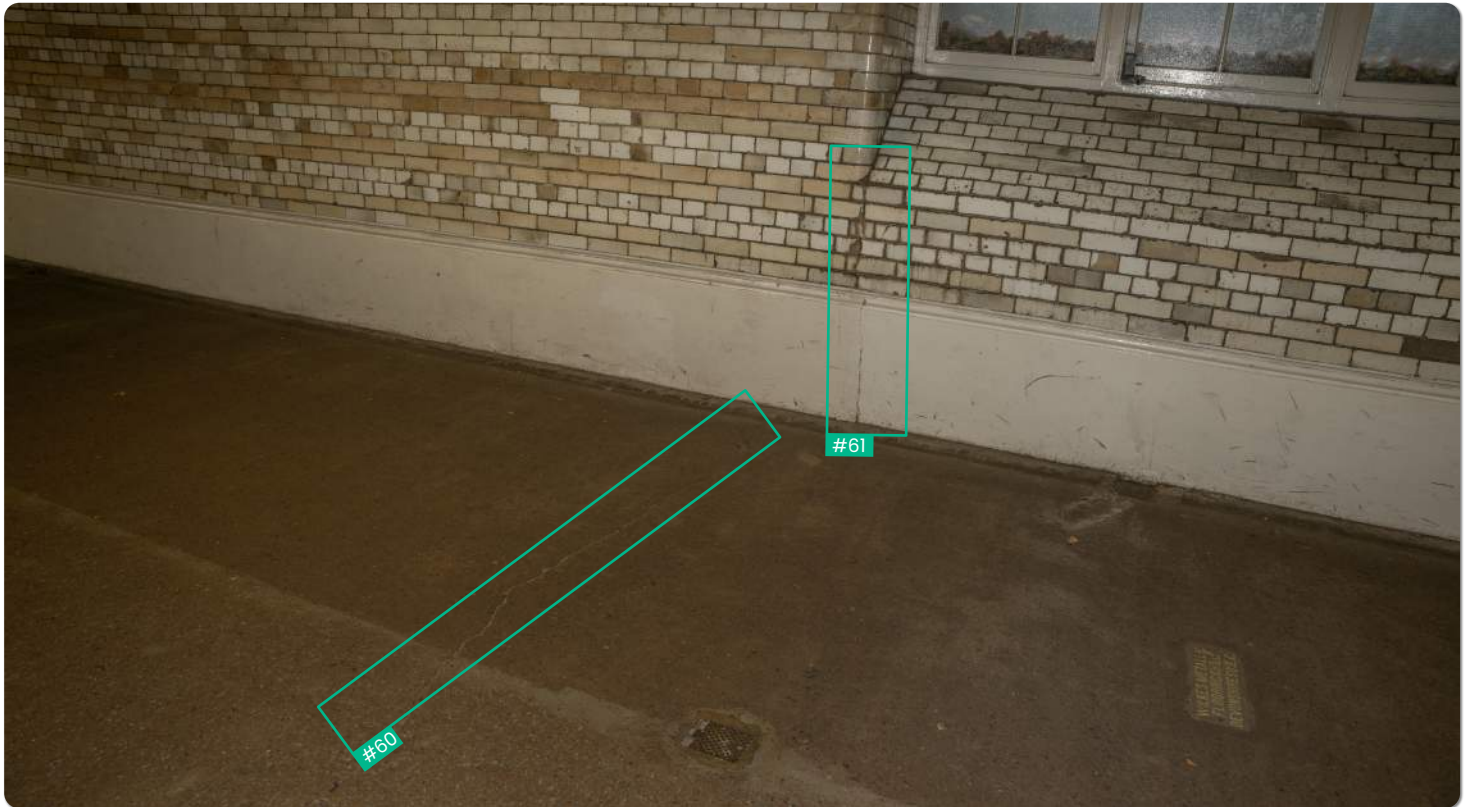
#60

A shorter ancillary crack branches from a joint line towards the drainage feature. The crack shows fine-width fissuring, with gradual feathered wear along its perimeter caused by repeated surface abrasion.

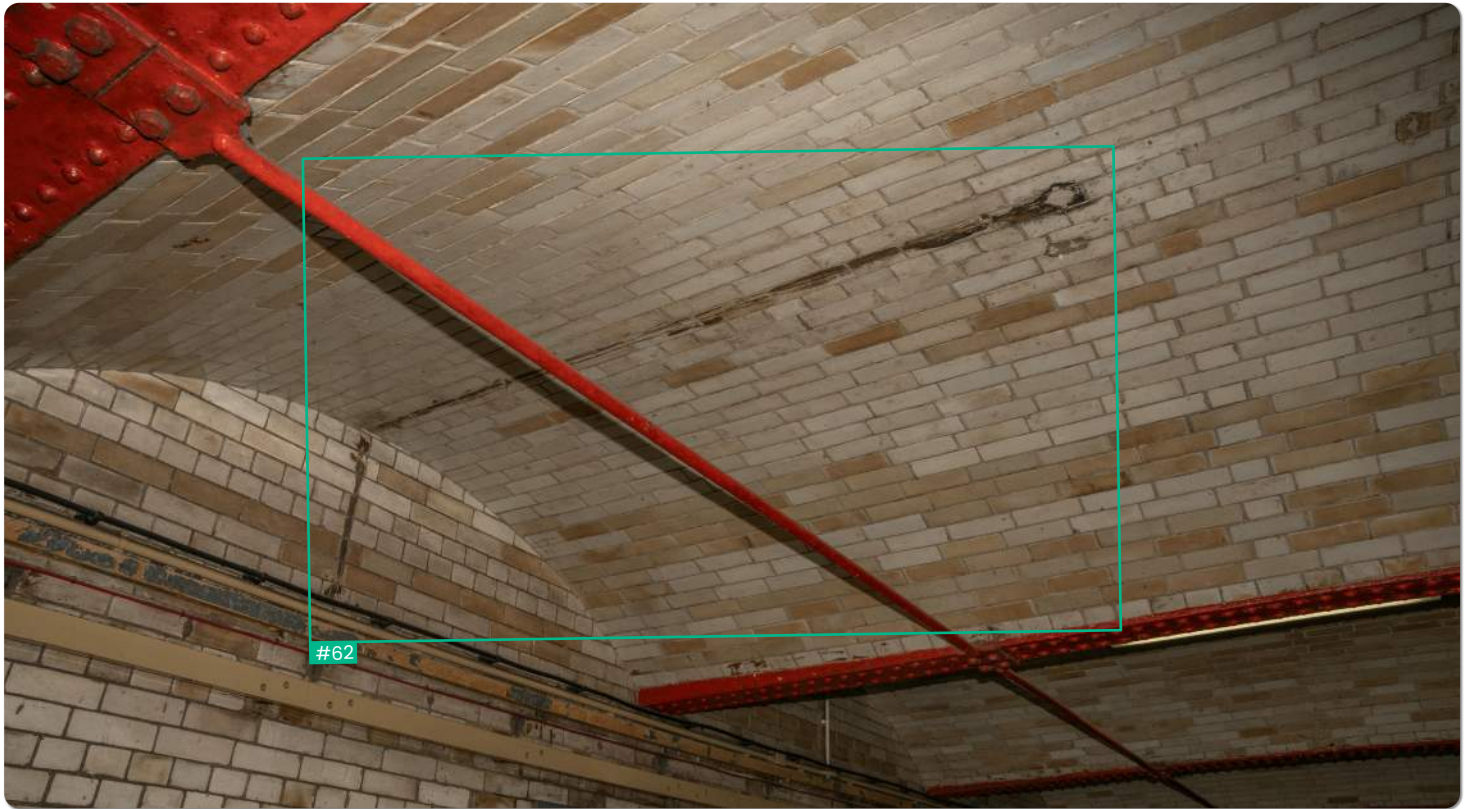
#62

The affected area displays a broad, irregular zone of darkened surface staining, with discolouration extending across multiple brick faces rather than confined to mortar joints. The staining follows a gentle linear path along the curvature of the arch,

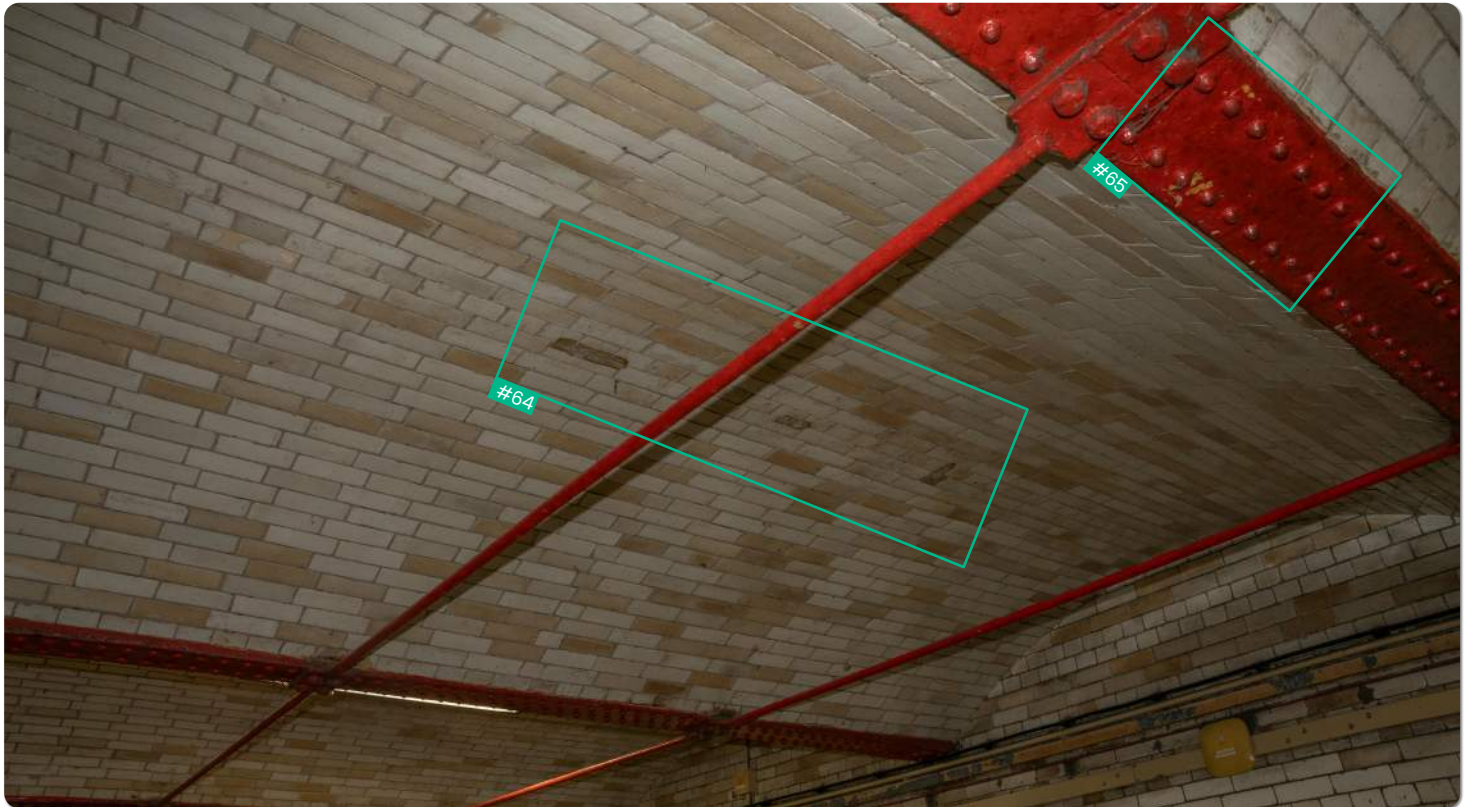
#64

A section of the vaulted ceiling tiles shows noticeable discolouration and darkened staining, concentrated along mortar joints and individual tiles. The affected area spans multiple tiles and appears darker than surrounding surfaces,

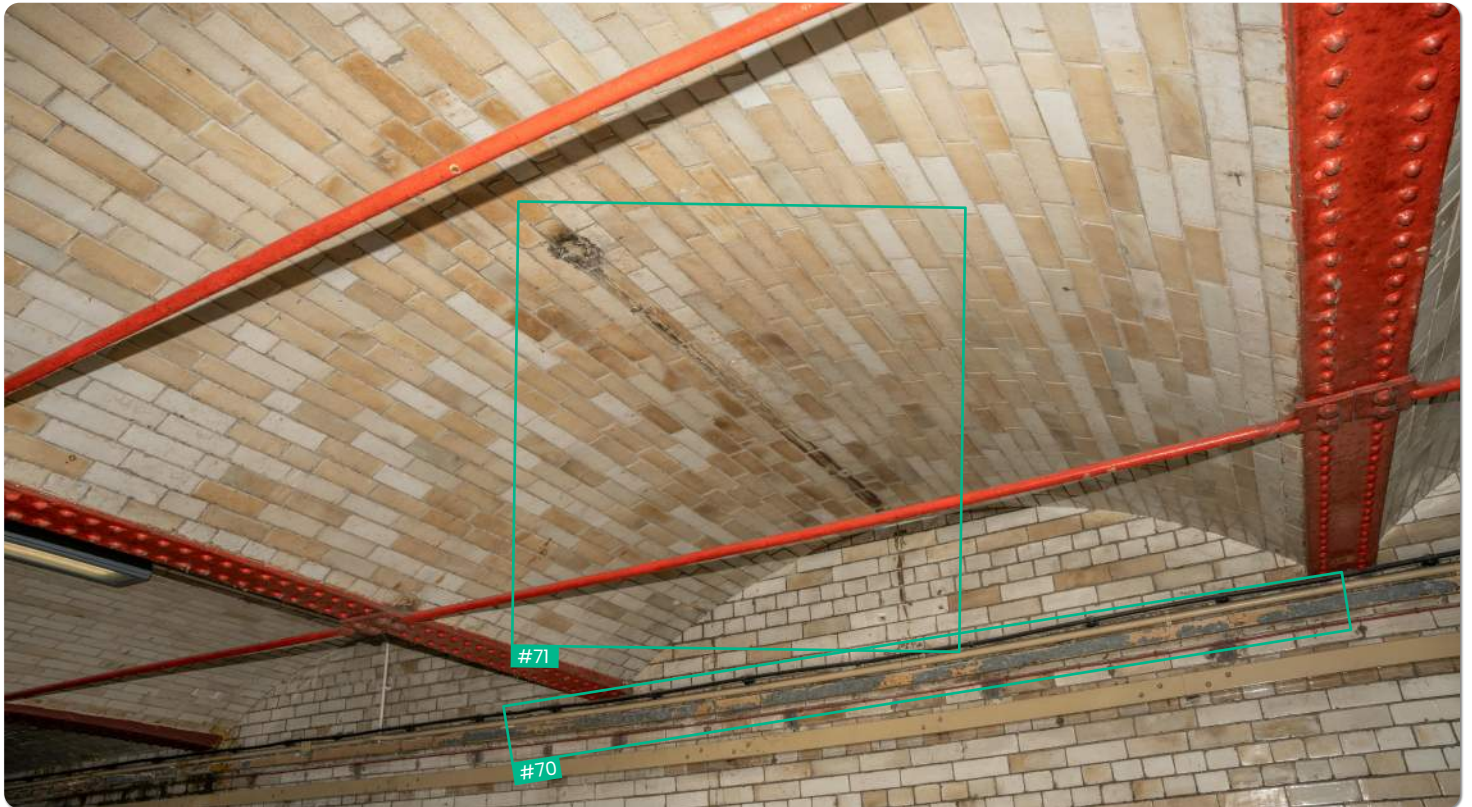
#70

The containment appears to be an older installation, with several redundant fixings, anchor points, and bracket remnants visible along the length of the trunking. Paint coating across the trunking surface is worn, patchy, and flaking, exposing underlying metal in multiple locations. Surface corrosion is visible at several fixing points, with brown/orange oxidised deposits forming along metal edges and around old bolt penetrations.

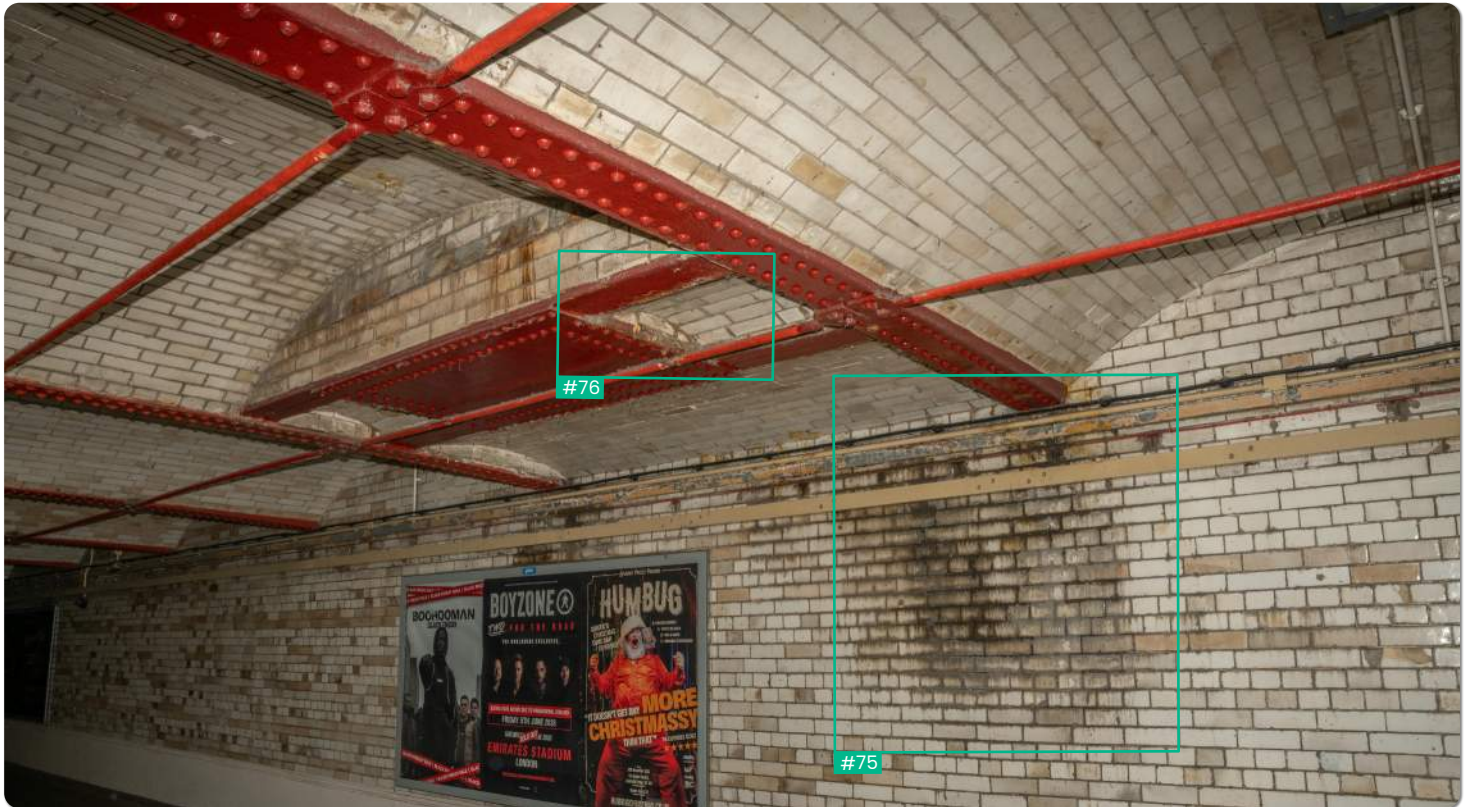
#75

Large concentrated area of dark staining to mid-height brickwork beneath cable runs. Staining is dense, uniform, and highly localised, resembling. Adjacent material shows lighter discolouration fading outward from primary patch. No evidence of tile cracking or spalling; issue is surface contamination.

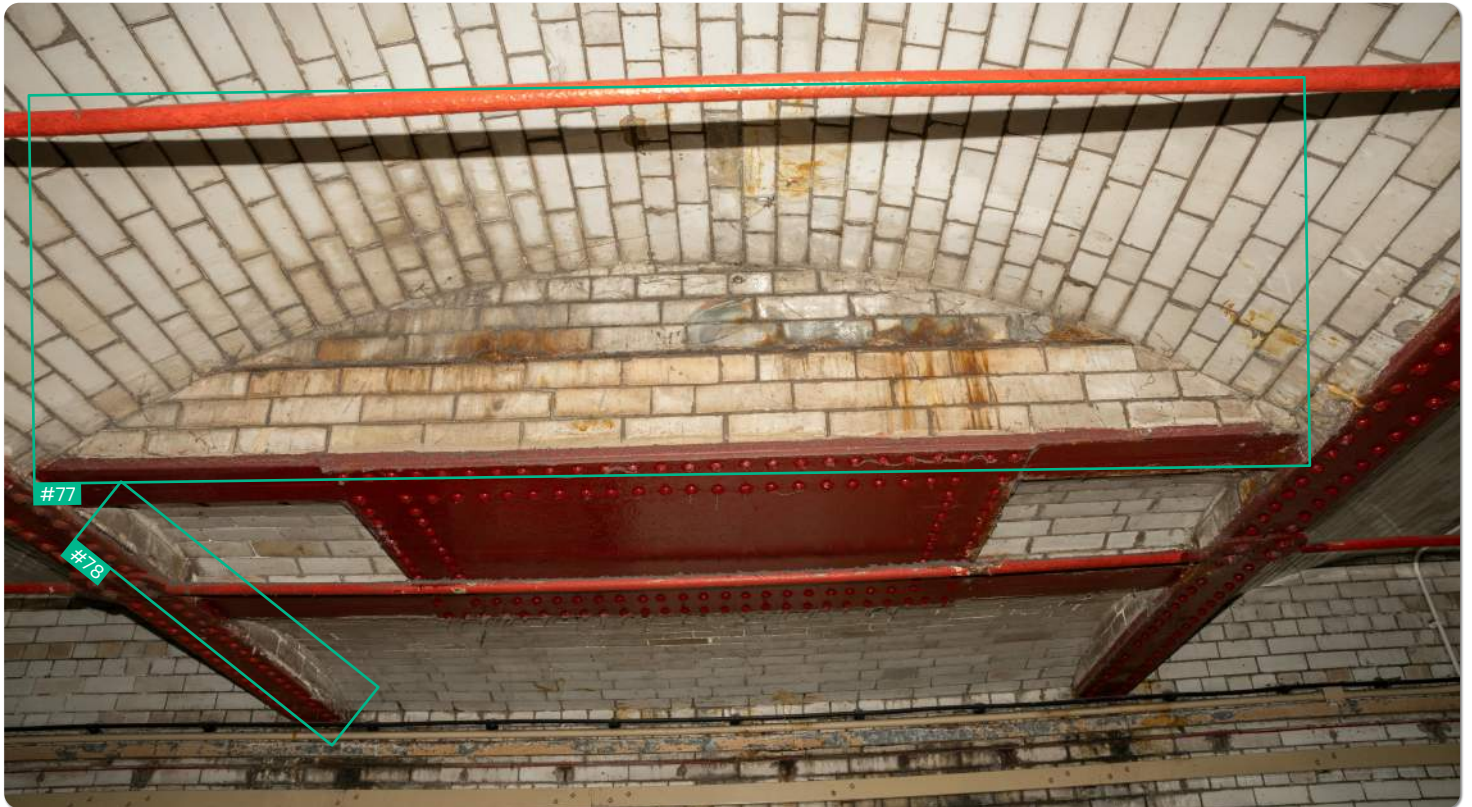
#77

Concentrated water staining present at centre of brick arch, aligned with crown. Discolouration suggests long-term seepage originating above or through joint between structural elements. No cracking observed; however, repeated damp cycles may weaken mortar or encourage mould growth. Source of ingress should be assessed and sealed

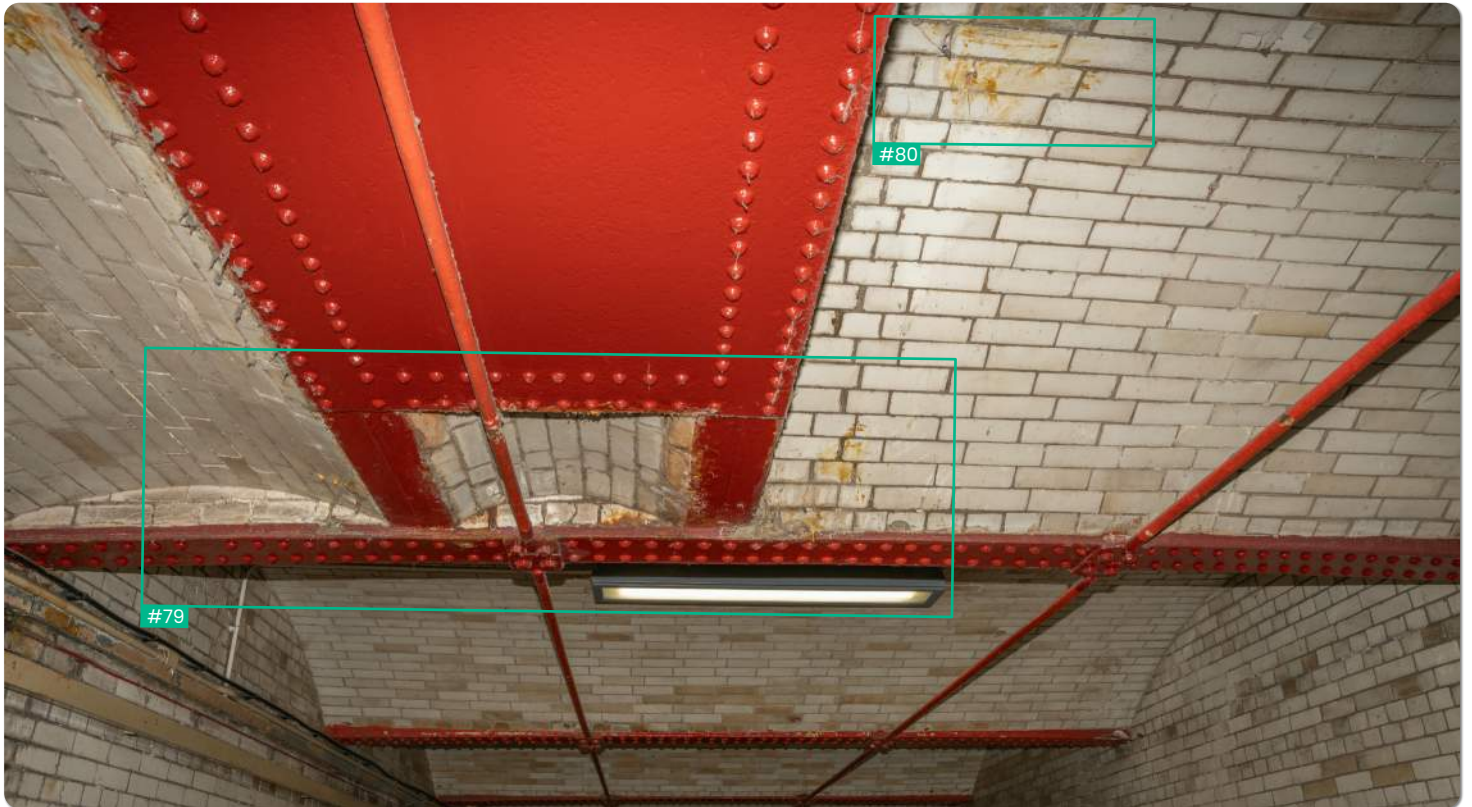
#79

The underside of beam shows distinct loss of protective coating and surface corrosion, particularly along lower flange edges. Adjacent bricks show discolouration corresponding to runoff pattern. Rust appears active and could progress beneath existing paint film. No deformation identified, but protective maintenance required to prevent further degradation.

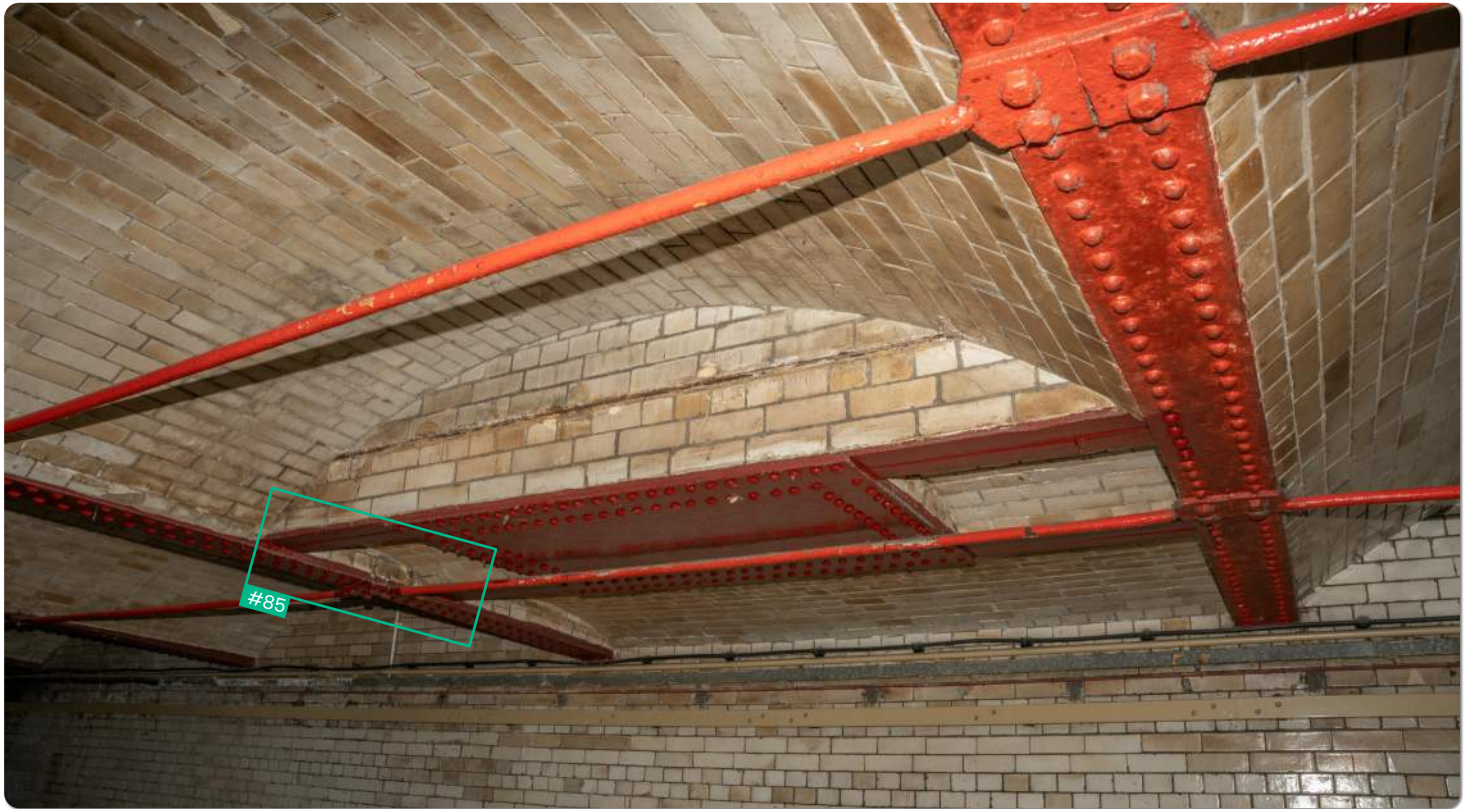
#85

A single brick unit located at the intersection between the lower arch line and vertical wall face exhibits a distinct fracture through the brick body, rather than along a mortar joint. The crack appears to bisect the brick diagonally. Surrounding mortar joints show signs of deterioration, with loosened, granular mortar and visible recession around the cracked brick,

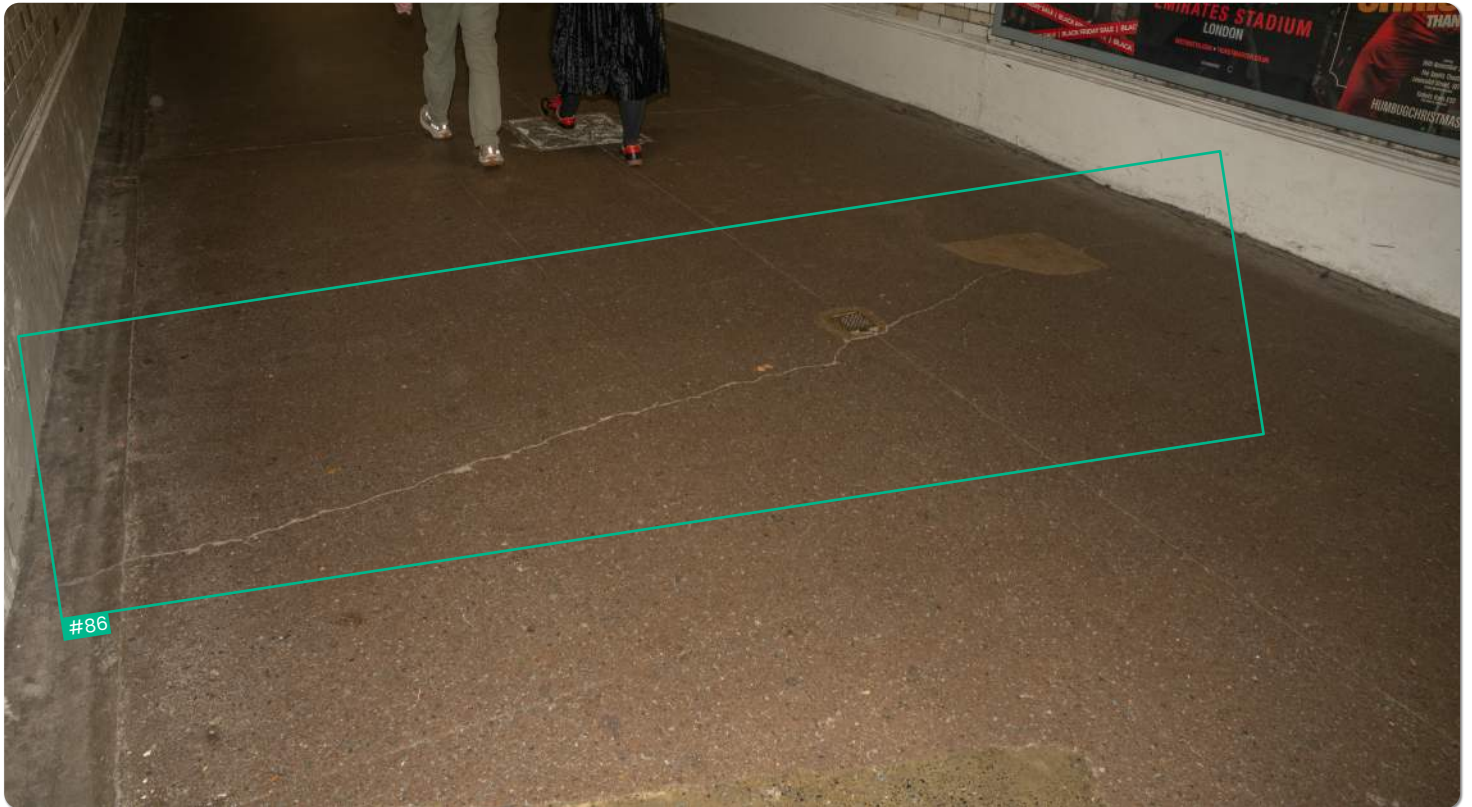
#86

A significant longitudinal crack runs diagonally across the main pedestrian walkway. The crack spans across floor and intersecting near existing access covers. The crack width appears generally fine to moderate (hairline to approx. 2–3mm in places), with certain sections showing slight material separation and edge erosion,

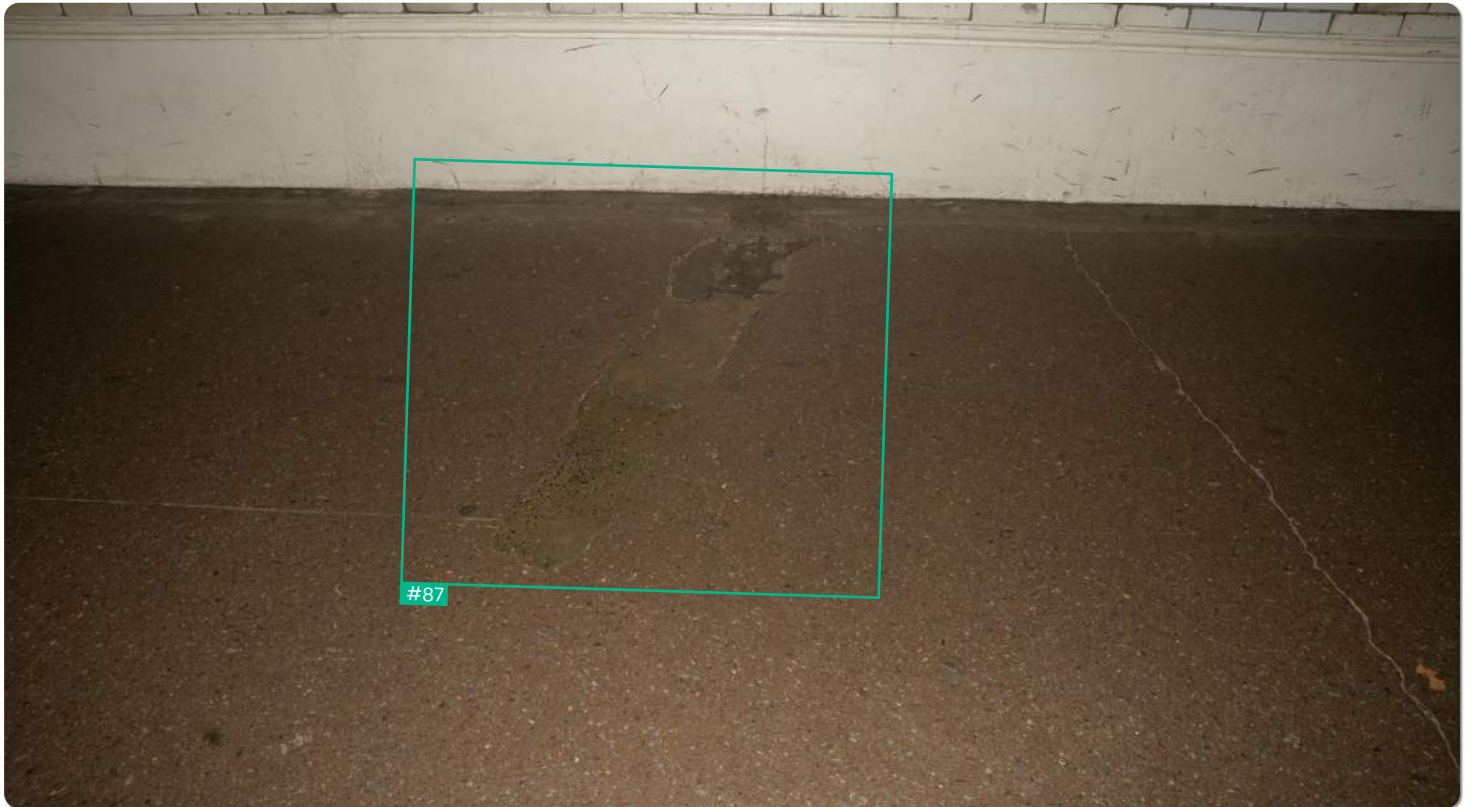
#87

A previously applied surface patch is evident within the concrete floor, positioned centrally along the pedestrian route. The repair area is elongated and irregular in profile. The patched section displays a materially distinct composition and colouration compared with the surrounding parent concrete, indicating a non-matching repair mortar or resin-based filler.
