Dilapidation Survey Report

NHM Exhibition Road Subway
15th November 2025

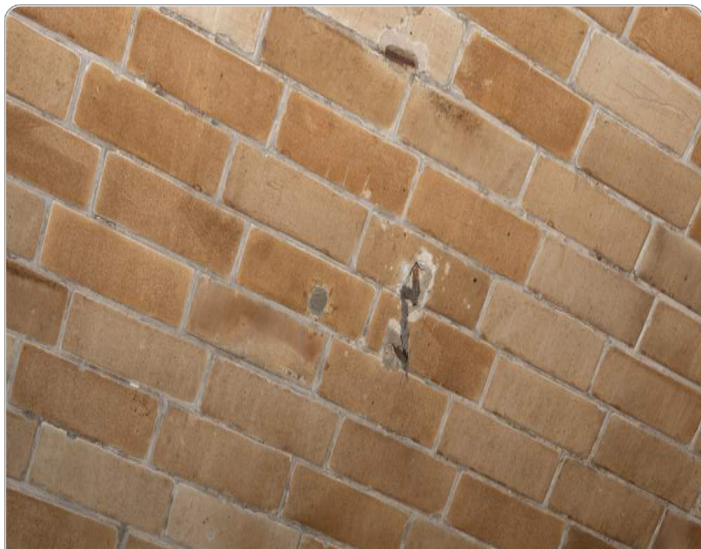
#01

Localised brick face spalling observed on soffit. Metal fixing protruding from soffit

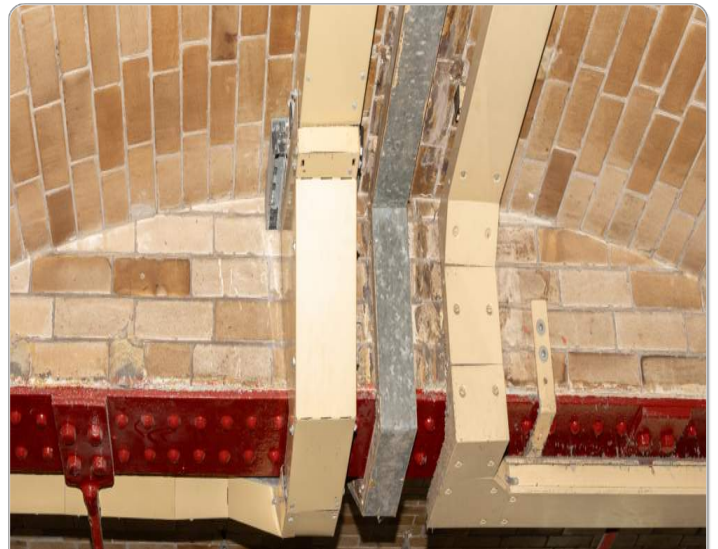
#02

Cracking and material loss surrounding steel beam interface where fixings penetrate the brick arch. Paint coating on trunking also appears aged and flaking.

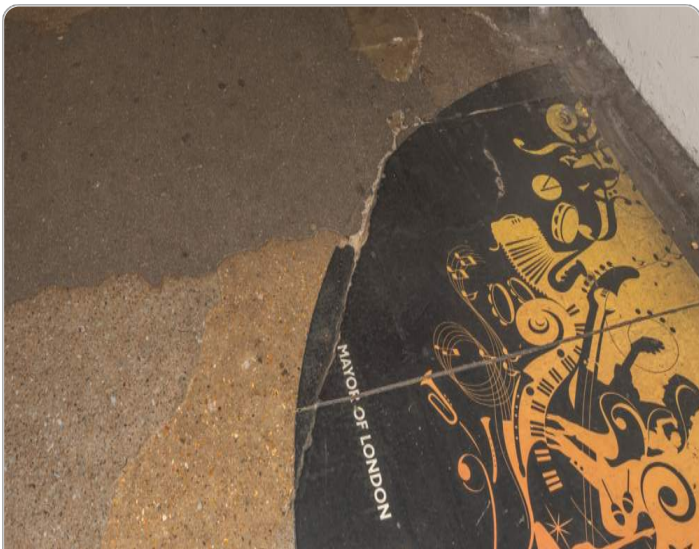
#03

Asphalt floor surface shows patch repairs with visible cracking, uneven surfacing and differentiated textures indicating multiple reinstatements over time. Edge deterioration around decorative floor graphic suggests wear from pedestrian traffic and adhesion breakdown. No visible trip hazard but aesthetic degradation noted.

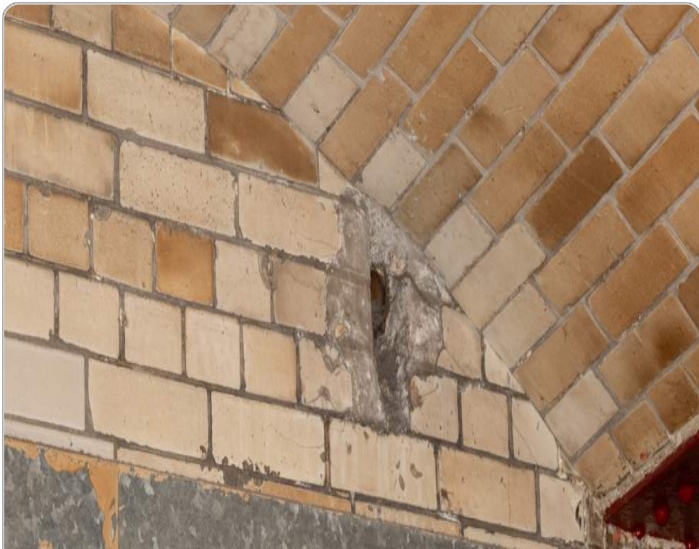
#04

Localised area of brick surface deterioration with material loss and exposed mortar bed. Tile glaze appears missing and surrounding surfaces show staining consistent with water exposure. No active water present at time of survey, but staining suggests historic leaks or condensation.

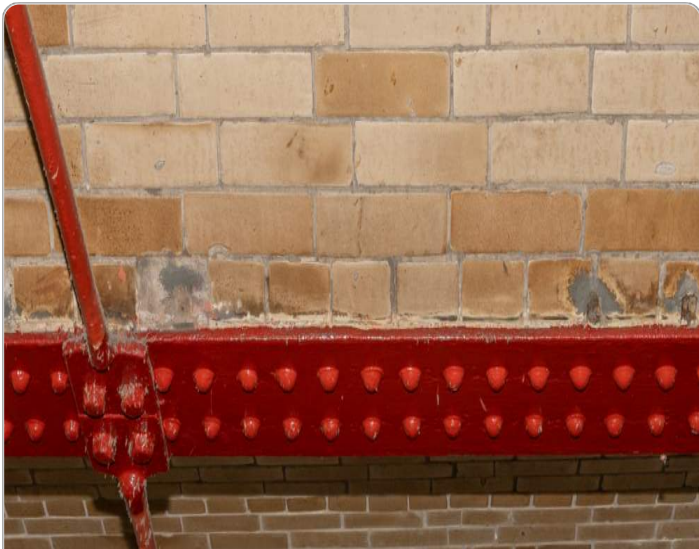
#05

Repair patches observed along the line of a primary structural steel beam fixed into soffit. Damage is linear and follows the fixing points. Surrounding brickwork shows patchy repair attempts and aged grout lines. No deformation to steel noted.

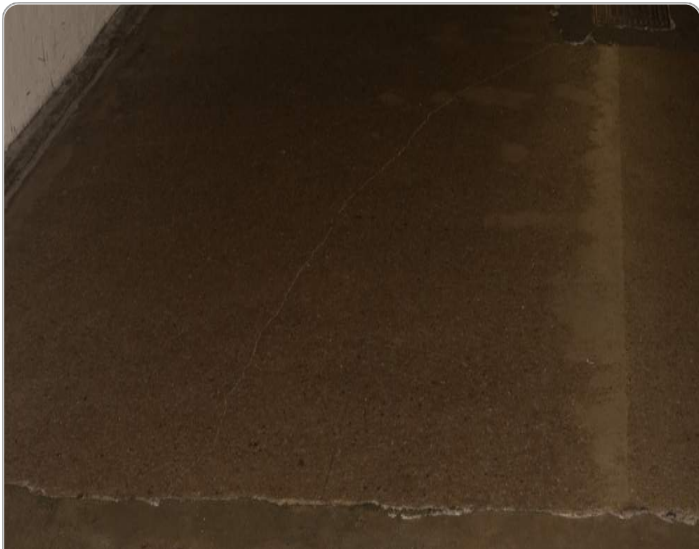
#06

Surface finish remains visually inconsistent with adjacent areas. Edges show minor cracking and settlement marks indicating possible differential wear.

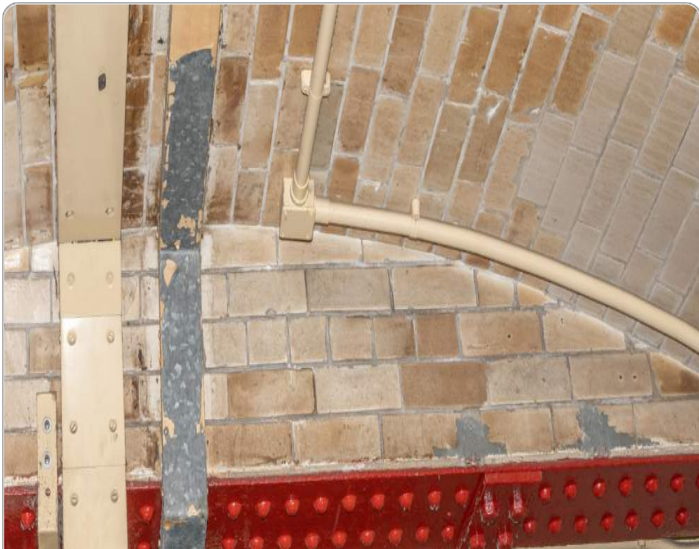
#07

Disturbed brick alignment above steel beam with visible offset between rows, cracking, and filler patches. Also trunking paint flaking/peeling off.

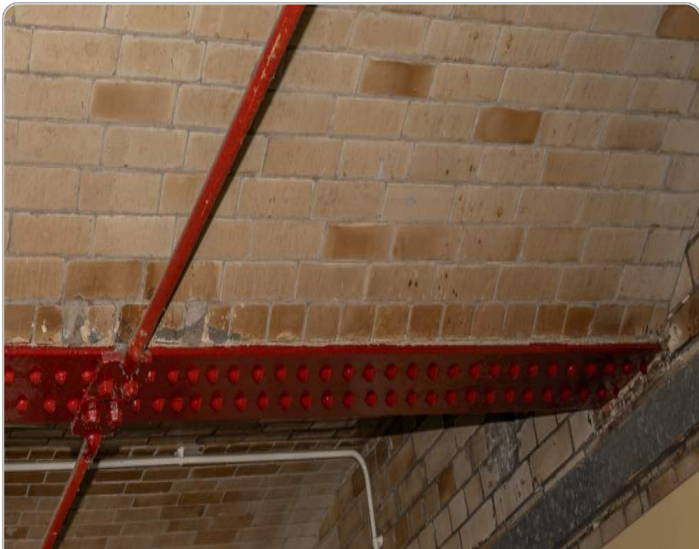
#08

Staining and discolouration across ceiling brickwork, concentrated near service brackets and lighting. . No active leak visible. There is noticeable deterioration where the glazed tile/brick face has broken away, exposing the rough substrate beneath.

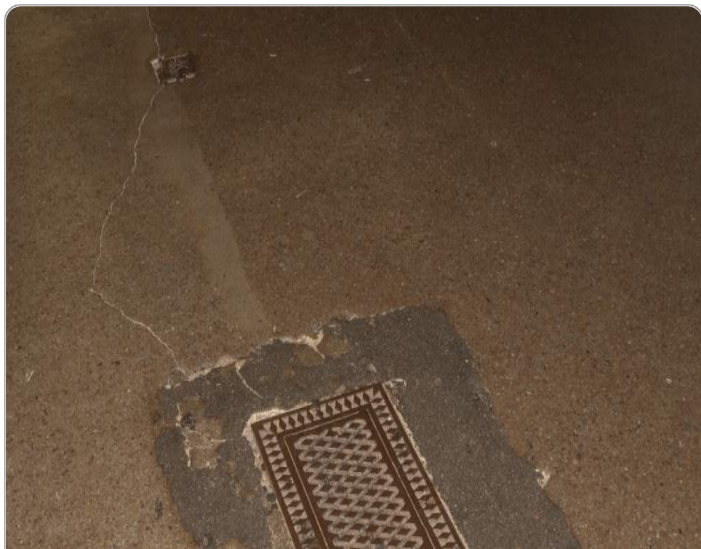
#9

Surrounding surface deterioration around cast iron service cover; asphalt patching is cracked, irregular, and separating from frame edges. Cover itself appears intact but seating substrate deteriorated

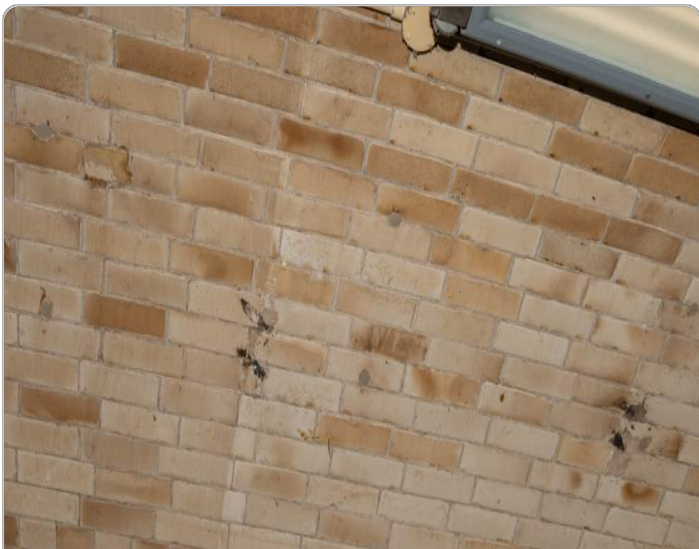
#10

Multiple penetrations and historic fixings visible on ceiling tiles with dark staining around drilled holes. Brick faces show abrasion where equipment appears to have been installed and removed. Staining could relate to moisture residue or corrosion from previous intumescent fixings.

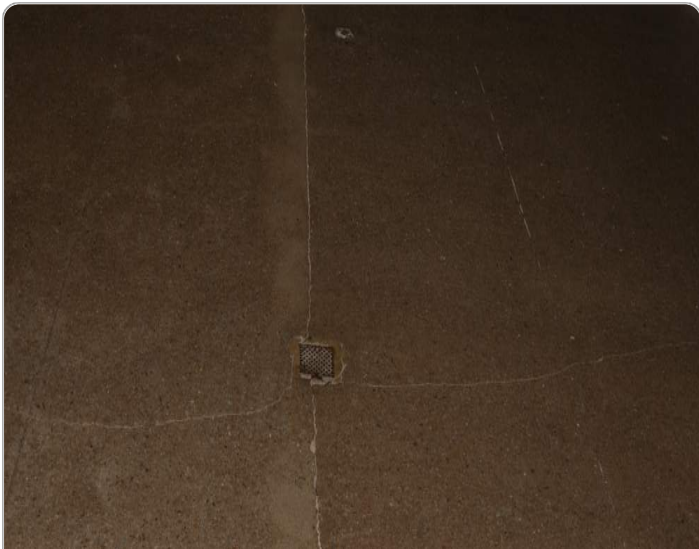
#11

Long straight construction joint visible running along corridor centreline. Minor cracking noted but slab appears generally sound. Surface finish varies either side of joint.

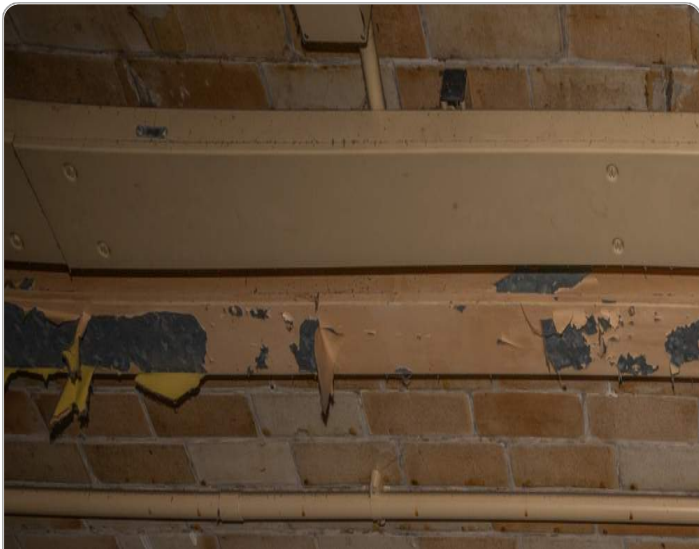
#12

Failed paint/finish around ceiling-mounted service batten; significant flaking exposing underlying substrate. Nearby brickwork shows staining and abrasion.

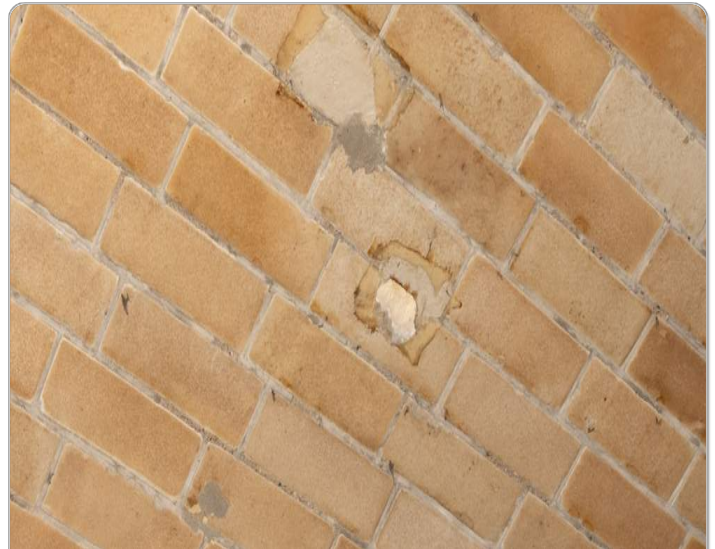
#13

Circular penetration or core hole through brick soffit where fixture was removed; brick face chipped and finish incomplete. Exposed mortar bed visible.

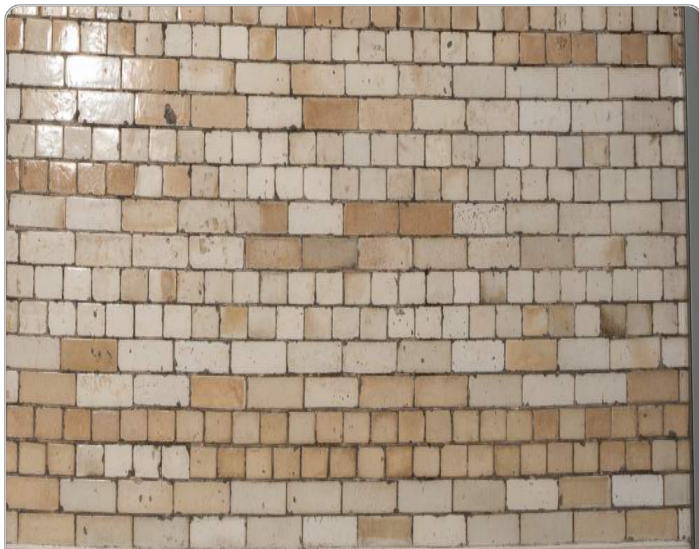
#14

Significant discolouration and variation in tile glazing across wall area; extensive patch repairs visible. No discrete structural cracking but widespread cosmetic degradation, staining, and tile mismatch.

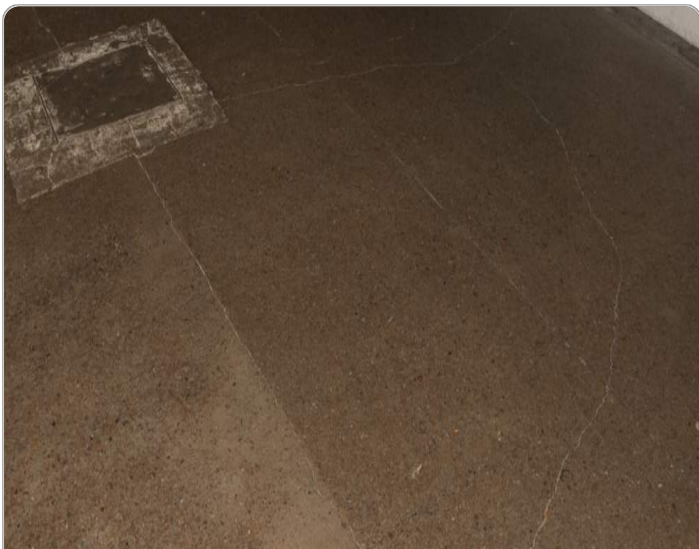
#15

Shrinkage cracks and uneven finish radiating from recessed surface cover. Cracks appear hairline but propagate across surface.

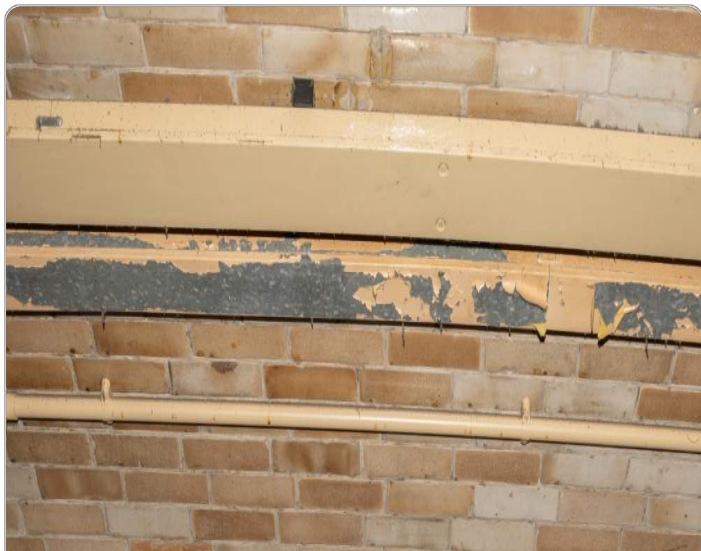
#16

Extensive flaking and deteriorated coating on trunking fixed to ceiling.

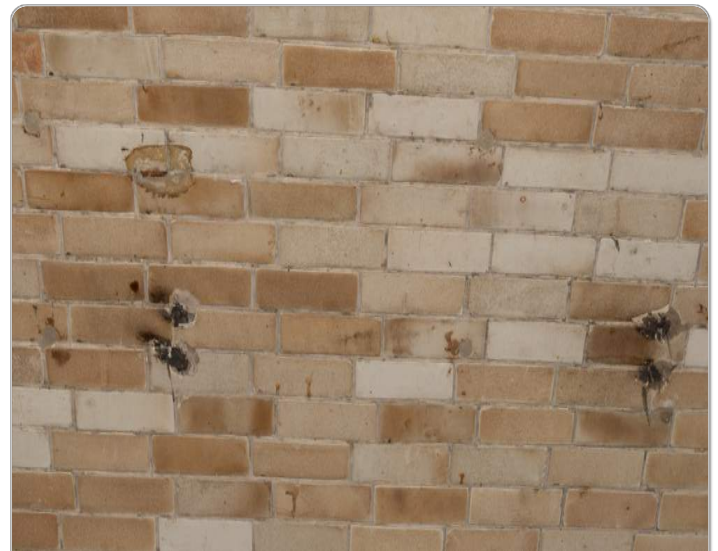
#17

Clustered historic fixing holes with dark staining and chipped brickwork. No active corrosion observed.

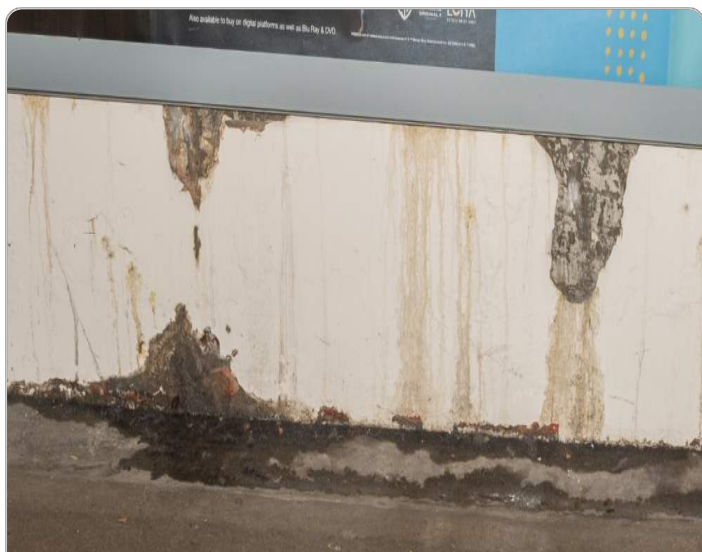
#18

Significant water staining beneath advertising panels along wall base; Lower wall surfaces show material erosion.

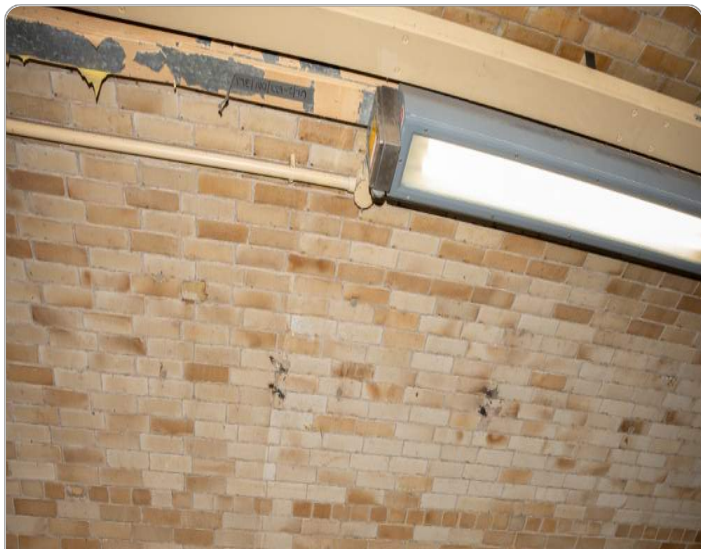
#19

Paint/coating failure along ceiling-mounted cable tray with exposed metal and flaking paint. Adjacent brickwork also exhibits surface deterioration and staining from previous fixings

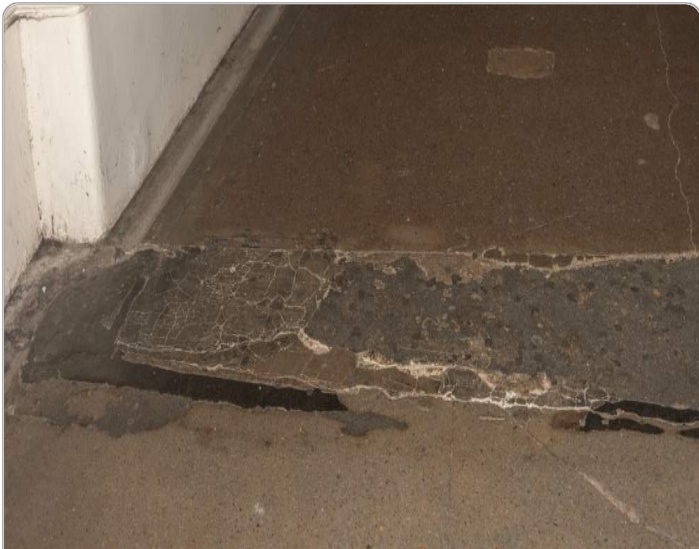
#20

Floor surface break-up along reinstated asphalt strip; significant edge deterioration, uneven height levels, and cracking possibly indicating either failed reinstatement or long-term wear.

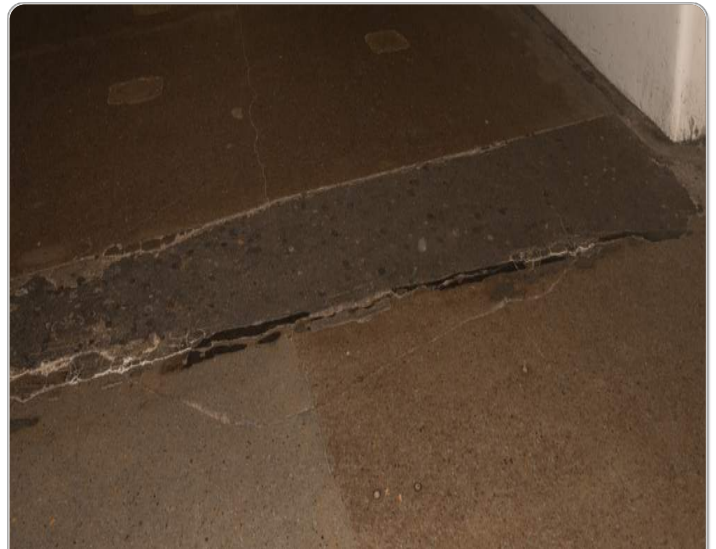
#21

Continuation of degraded reinstatement to asphalt surface adjacent to previous defect (#20). Edge breakdown, surface cracking and rough contours. Aesthetic deterioration is significant, with variable texture and patch colour mismatch.

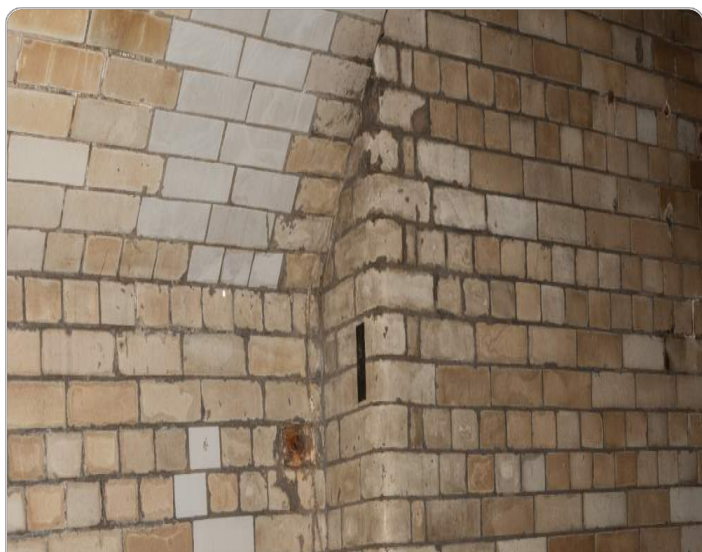
#22

Visible mortar erosion and cracking along the vertical internal corner, particularly where curved corner tiles transition into flat tiles. Two circular penetrations are visible where fixings have been removed, leaving unsealed openings in the brick face. Local surrounding tiles show chipped glaze and staining

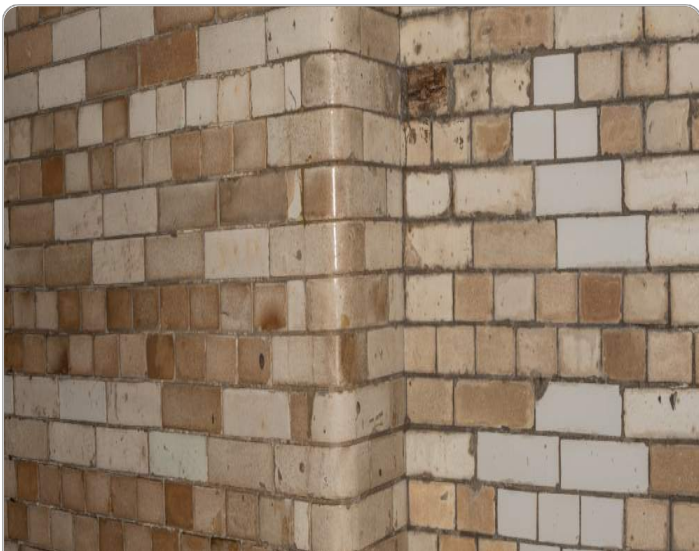
#23

Tiles along the curved corner display noticeable dullness and surface abrasion compared to surrounding wall tiles. The glazed ceramic finish has partially worn away, exposing a more porous underlying surface. Two rectangular areas show clear signs of previous surface fixings or mountings. Glaze has been chipped away and original tile faces removed, leaving unsealed cavities with rough edges

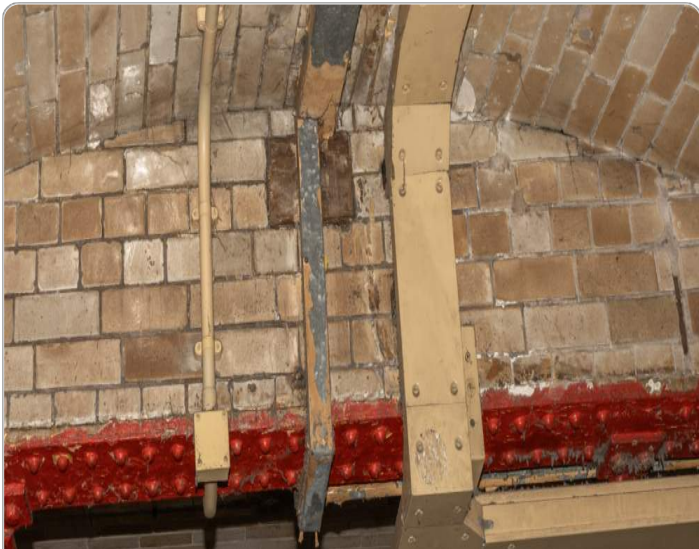
#24

Bricks adjacent to the metal service supports show spalling, chipped edges, and loss of glaze. The damaged edges appear historic and linked to repeated drilling/installation of service hangers. Repair mortar and replacement brick fragments are visible along the beam line and between tiles. These patches vary in tone and finish from original materials,

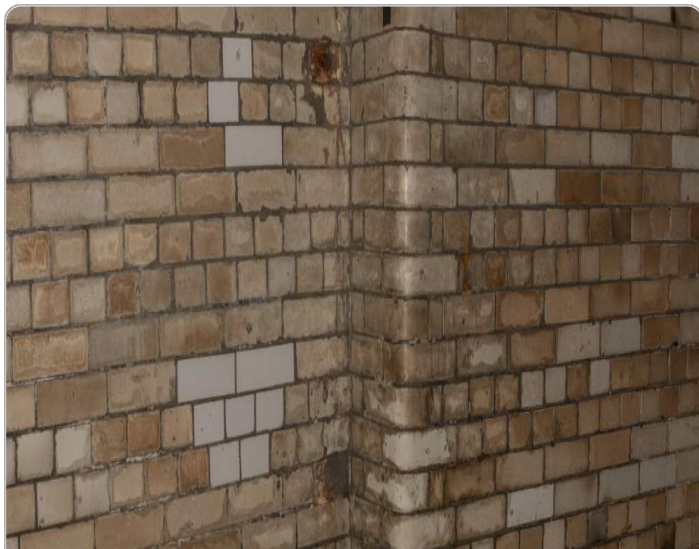
#25

Surface damage to overhead soffit where previous service fixings removed. Exposed mortar and chipped brick finish visible, along with staining. Surrounding areas show further patch repairs and unsealed penetrations.

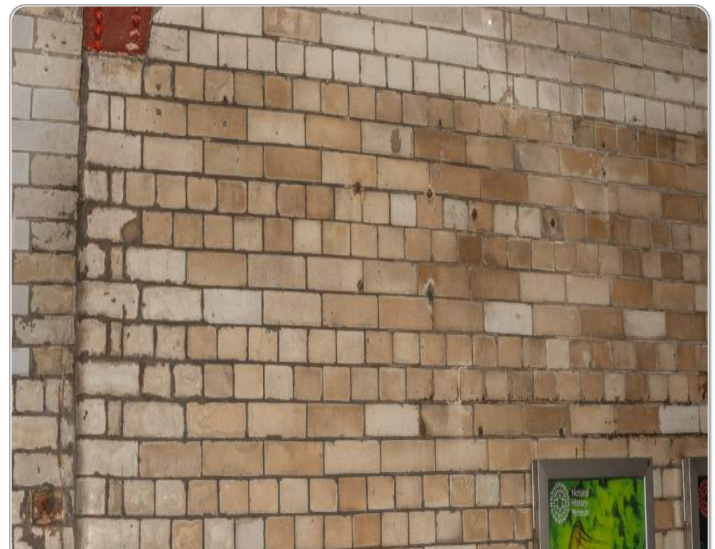
#26

Adjacent continuation of #25 defect — exposed fixings and cracked mortar where former brackets were mounted. No reinstatement work applied, leaving surface uneven and visually degraded.

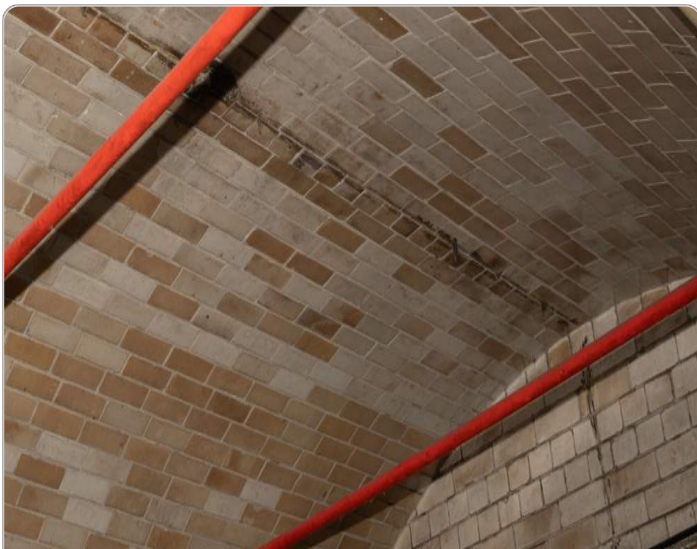
#27

Surface staining and paint failure along horizontal service band. Flaked coating exposes metallic substrate. No active water visible.

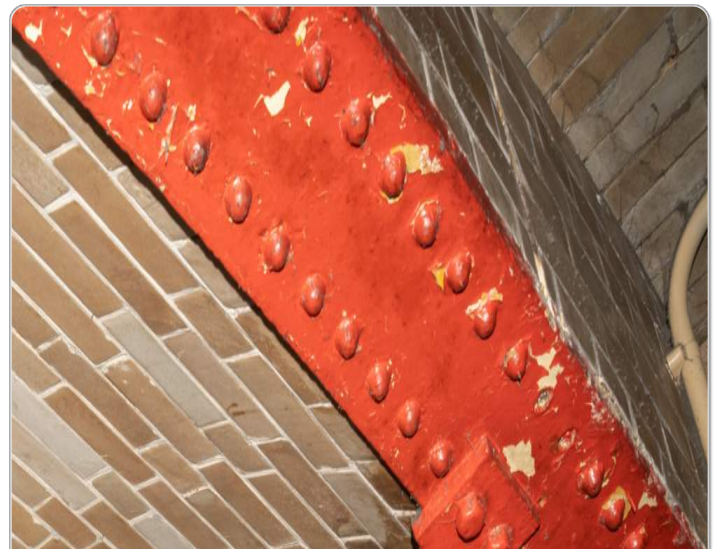
#28

Adjacent beam shows flaking paint and coating breakdown around fasteners, with minor corrosion evident. Defects are predominantly cosmetic but indicate ageing fabric requiring periodic maintenance

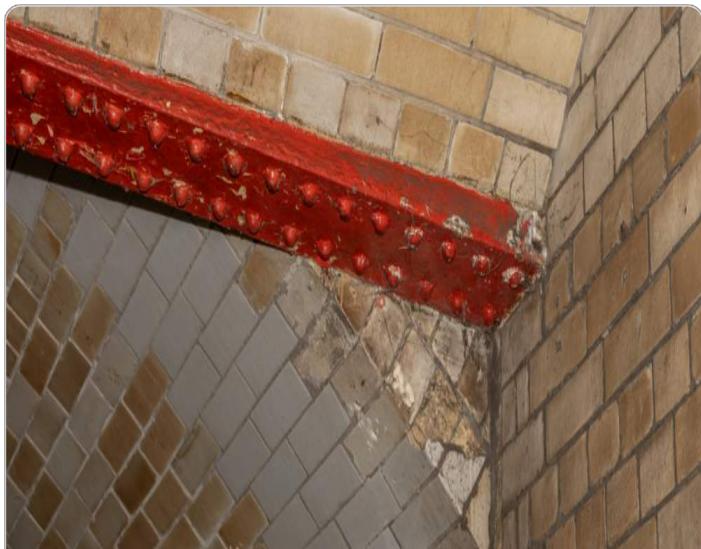
#29

Brickwork deterioration at the interface between soffit and supporting steel beam, including cracking along the springline, surface spalling, and historic patch repairs. The paint on the beam above appears chipped, with partial loss of coating exposing the metal substrate. No severe corrosion is visible.

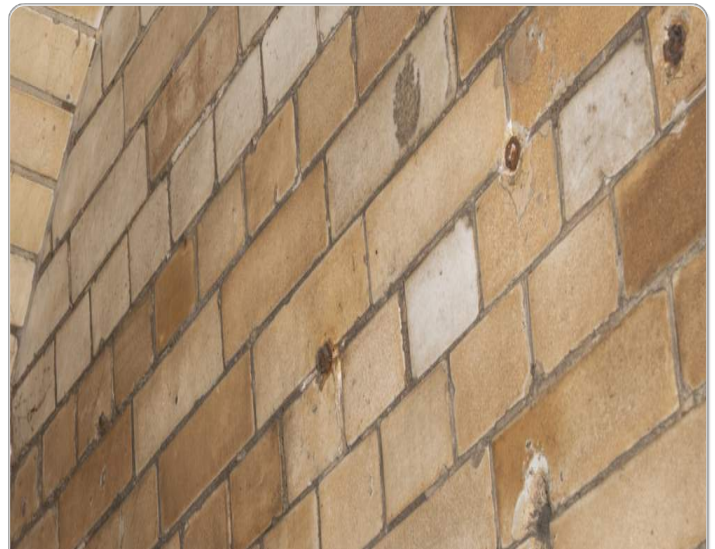
#30

Exposed substrate and accumulated staining indicate long-term wear associated with previous connection points.

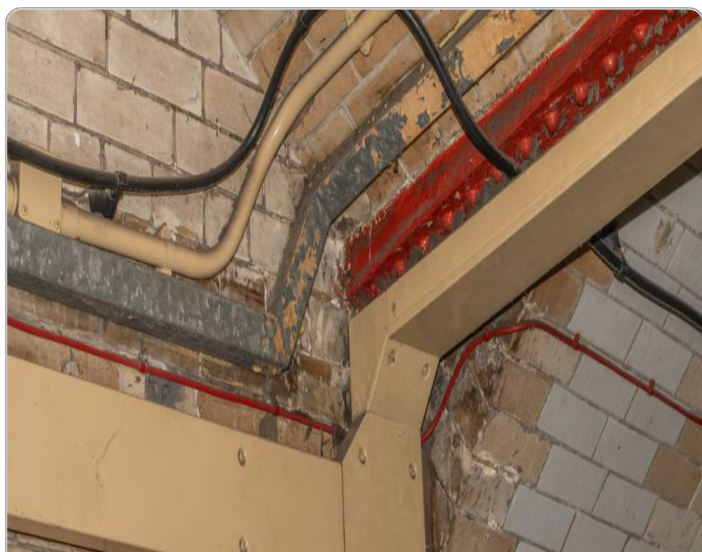
#31

Ceiling fixings and brackets show coating breakdown and corrosion staining. Brick soffit shows damaged glaze. Localised material loss and spalling observed at the arch springline where soffit meets the steel beam. Brick tile faces have detached, exposing underlying mortar, with cracking visible along mortar joints.

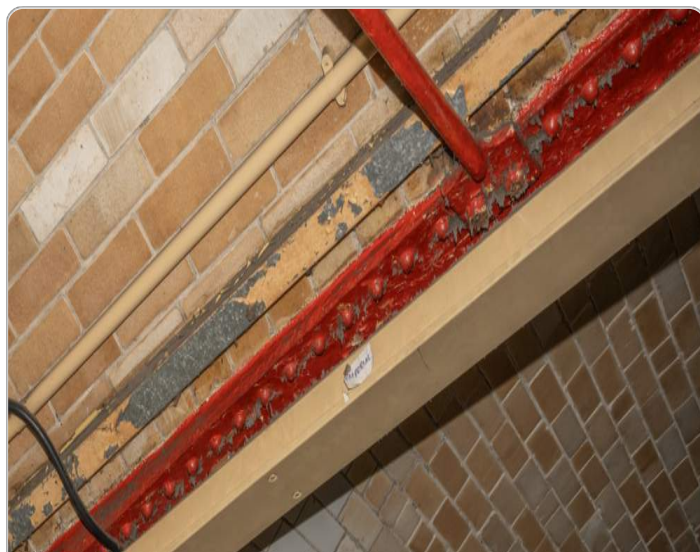
#32

The adjacent steel beam displays chipped coating at fixings with exposed metal.

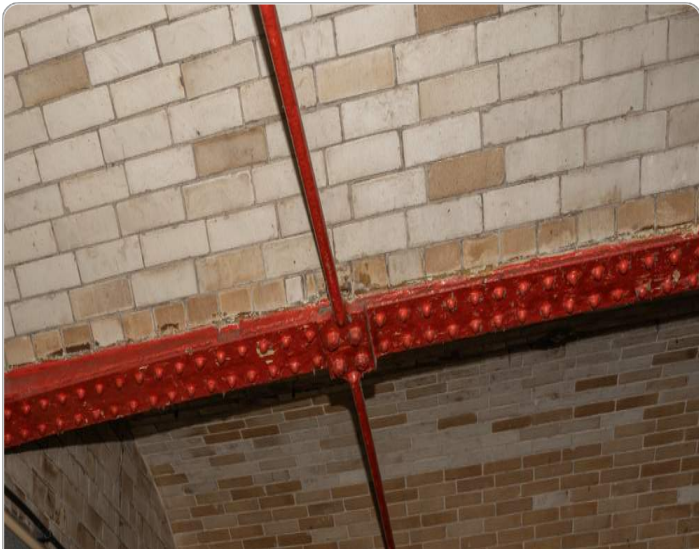
#33

The red beam exhibit visible flaking paint, rust patches, and surface corrosion, particularly around rivets and edges. Protective coating appears to be coming off in several locations, exposing metal to oxidation

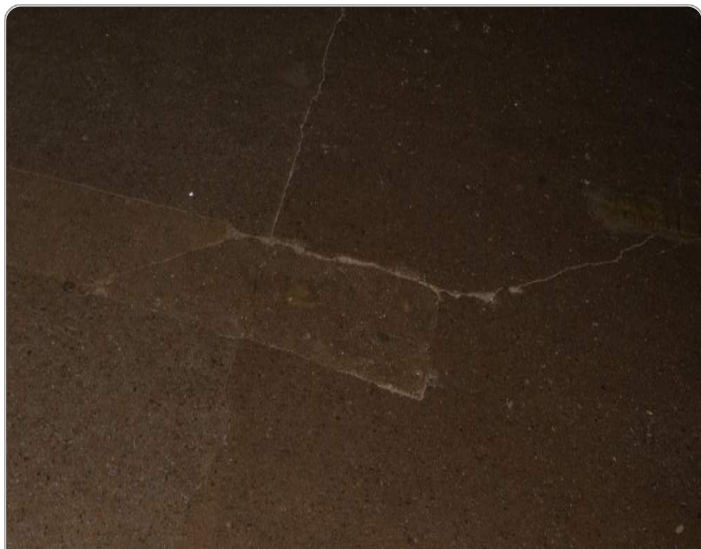
#37

A large, irregular-shaped repaired floor section is present within the main walkway. The repaired patch is visibly different in colour, aggregate composition, and surface finish compared to the surrounding original flooring. The perimeter of the patch shows fine cracking and differential surface levels, indicating a poorly matched repair or settlement following installation.

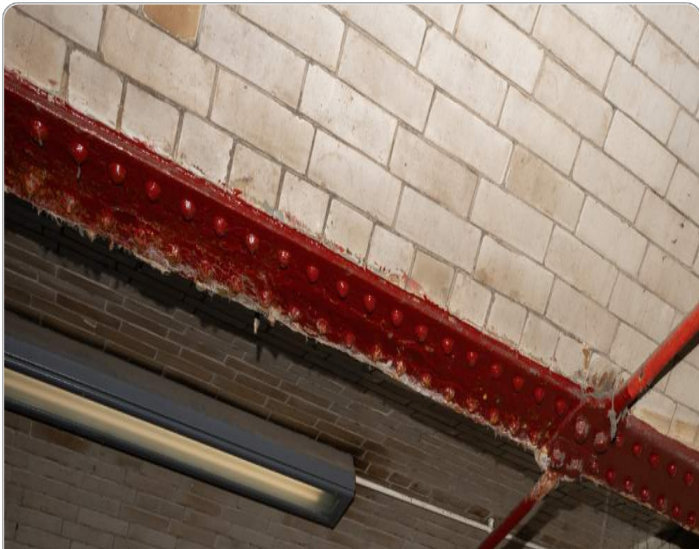
#40

The highlighted section of the red-painted riveted beam shows advanced surface degradation, with extensive paint failure and visible corrosion. There is significant flaking, rusting, and rough surface texture, particularly along the underside and edges of the beam where water or condensation may accumulate. The deterioration is more severe around rivets and beam joints, indicating prolonged exposure and limited protective maintenance.

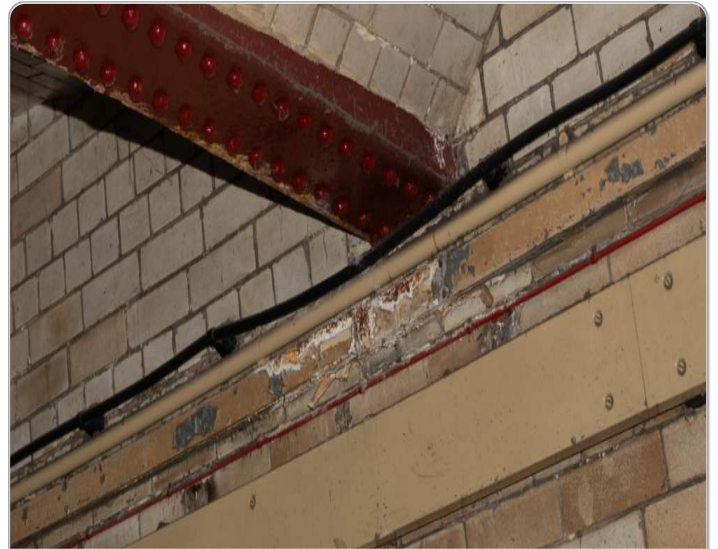
#41

The steel support beam shows extensive paint failure and advanced corrosion along the lower flange and rivet line. The deterioration appears continuous across the span rather than isolated, with the coating having peeled away in strips,

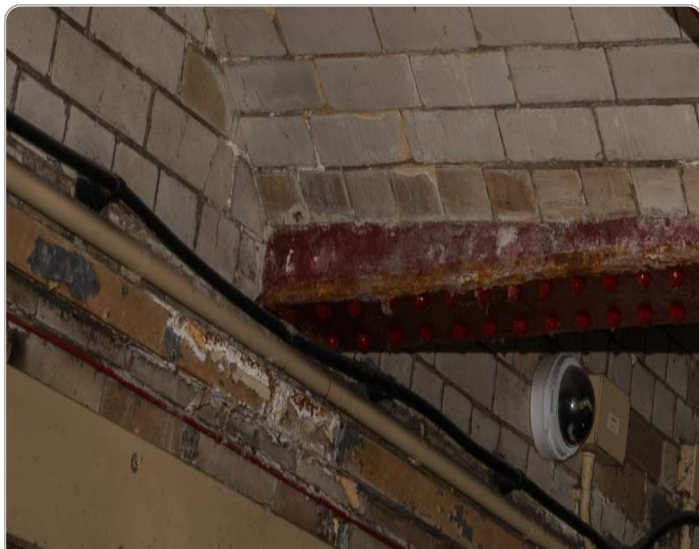
#42

The trunking appears aged, poorly maintained, and exhibits surface deterioration, including peeling paint, corrosion to trunking components, uneven patching, and deterioration to surrounding wall finish

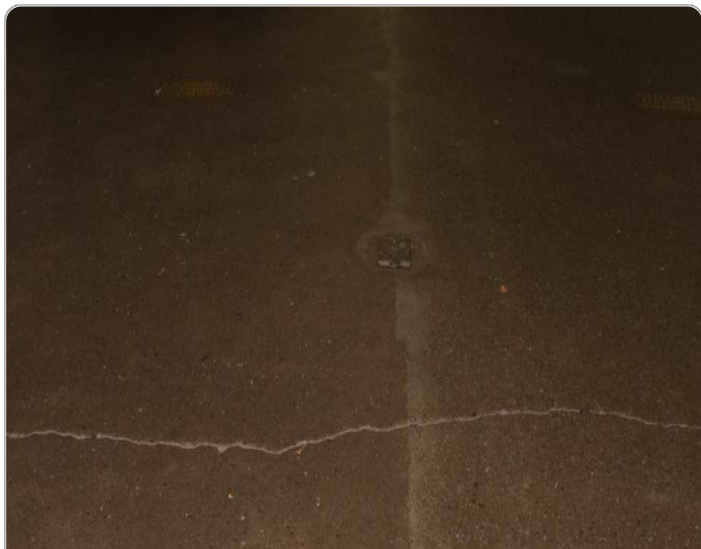
#59

A pronounced continuous linear crack extends along the floor alignment. The crack width appears fine but consistent throughout, with no immediate signs of vertical displacement or material loss. The crack intersects at least one service access plate

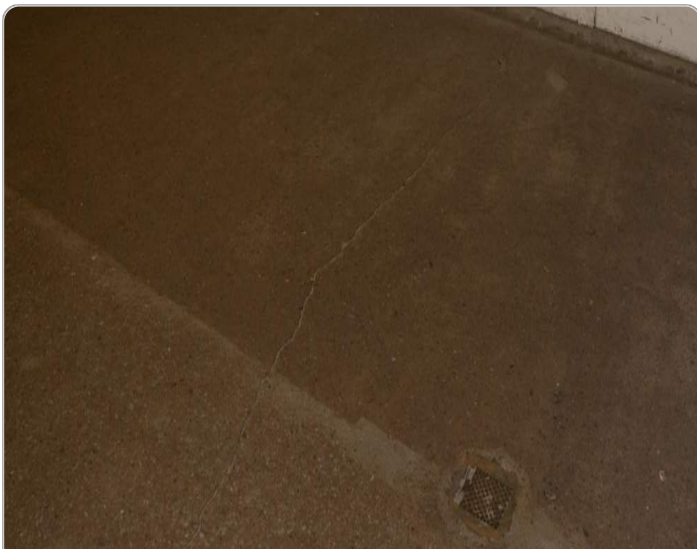
#60

A shorter ancillary crack branches from a joint line towards the drainage feature. The crack shows fine-width fissuring, with gradual feathered wear along its perimeter caused by repeated surface abrasion.

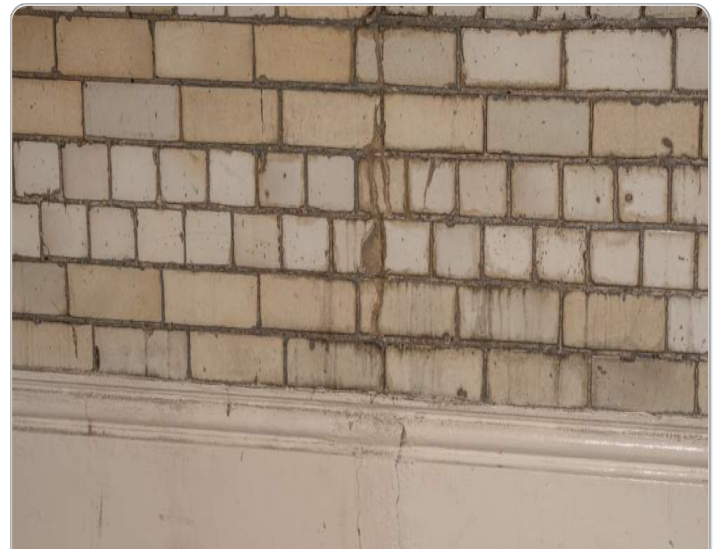
#61

A distinct continuous vertical moisture stain begins at the underside of the window sill where deterioration to paint and minor cracking around the framed junction is visible. The stain continues down the wall, darkening bricks and appearing to carry dissolved contaminants. Mortar joints along the path show softened, darkened and in places eroded bedding, indicating loss of binder. The feature terminates at the floor line, where paint to the lower skirting is visibly bubbled, marked, and lifting.

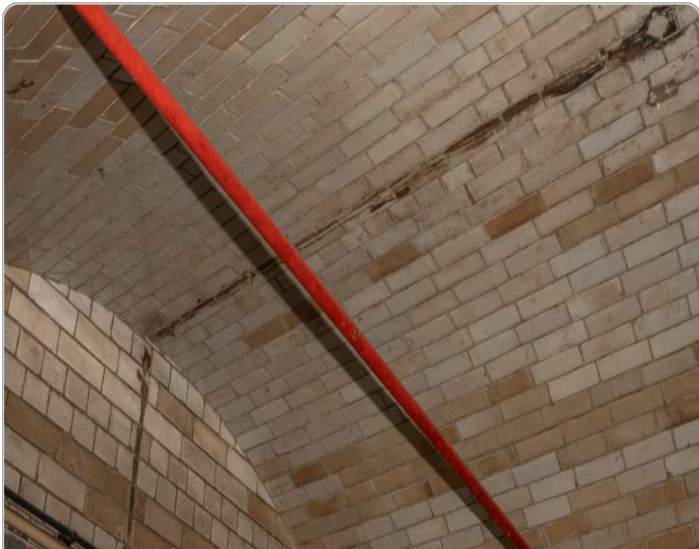
#62

The affected area displays a broad, irregular zone of darkened surface staining, with discolouration extending across multiple brick faces rather than confined to mortar joints. The staining follows a gentle linear path along the curvature of the arch,

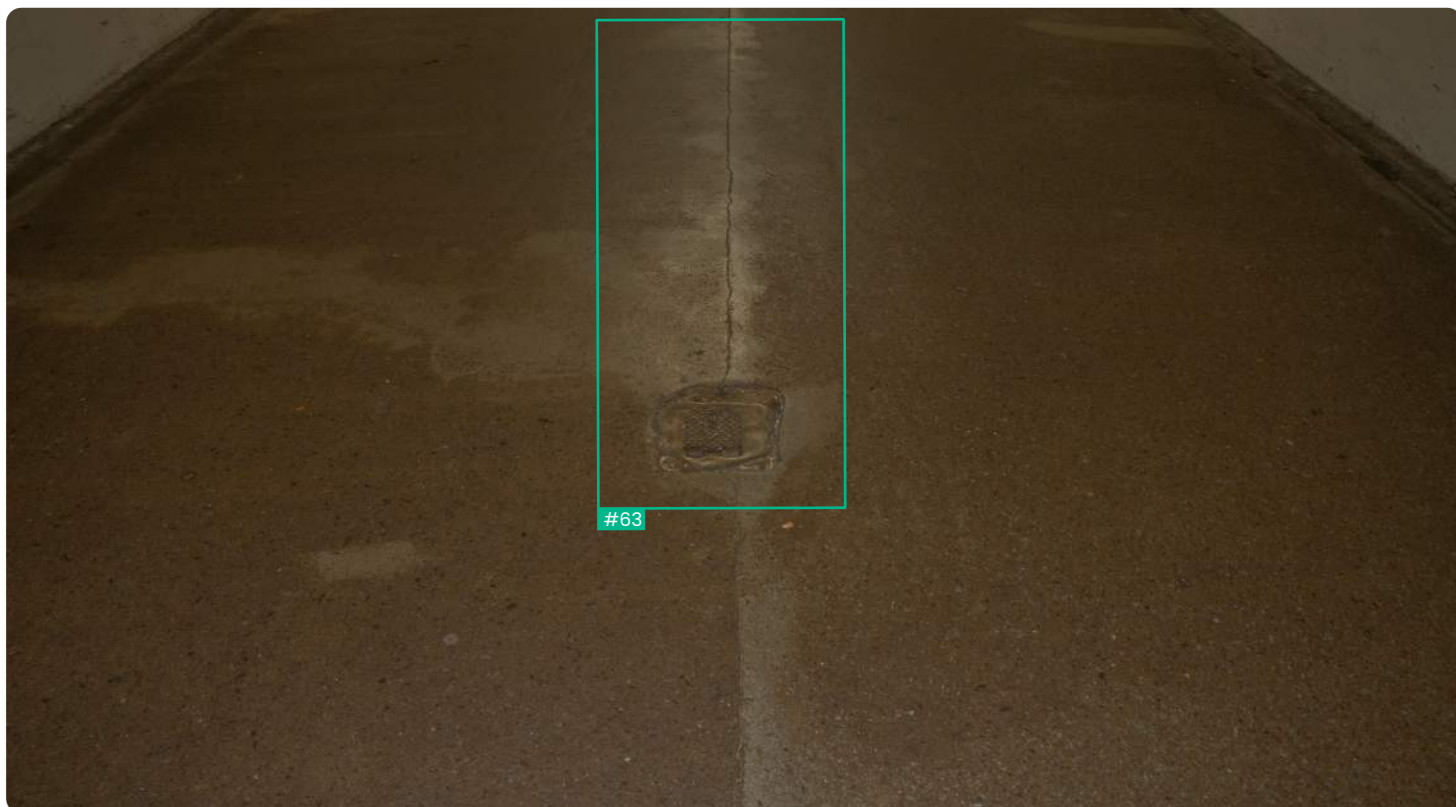
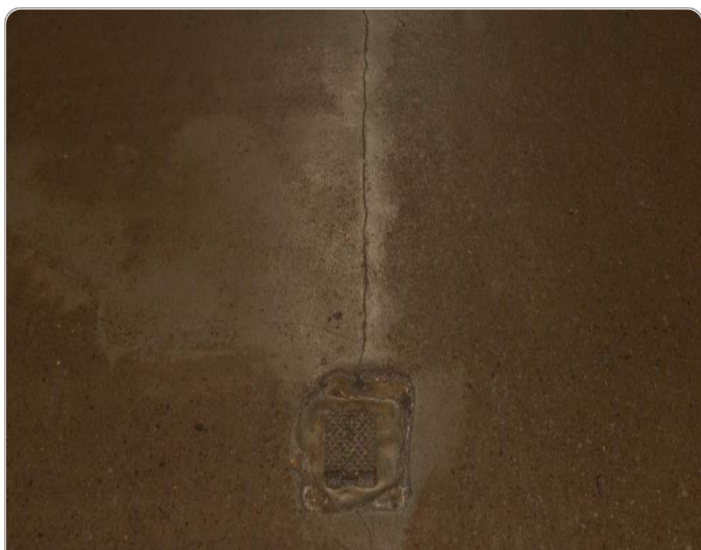
#63

The affected area displays localised surface deterioration centred around the perimeter of a recessed access cover. The finish surrounding the frame exhibits noticeable abrasion, thinning of surface coating, and erosion of fine aggregate, producing a slightly roughened texture compared to the adjacent original finish. A short hairline linear fissure extends radially from the corner of the access frame, progressing outward into the slab surface.

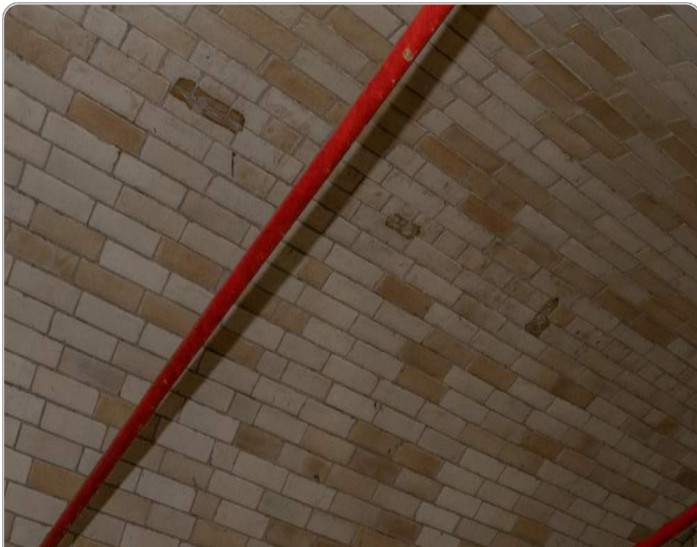
#64

A section of the vaulted ceiling tiles shows noticeable discolouration and darkened staining, concentrated along mortar joints and individual tiles. The affected area spans multiple tiles and appears darker than surrounding surfaces,

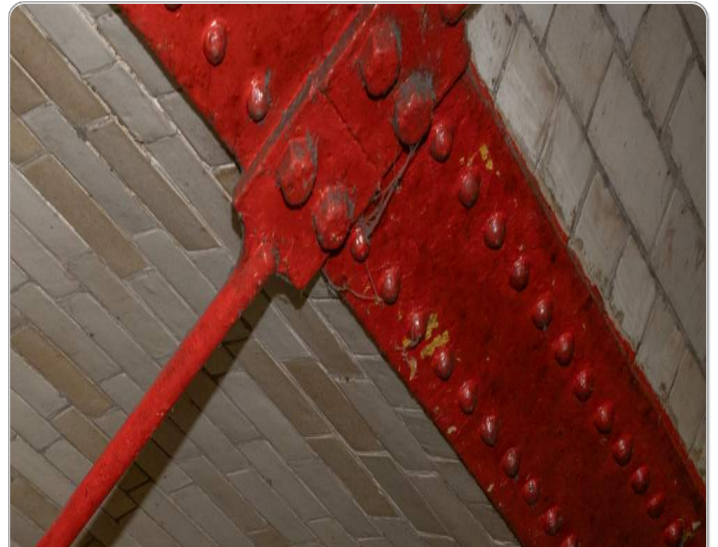
#65

Corrosion is visible at the junction between the red-painted steel beam and supporting tie-rod connection, where protective paint has deteriorated and surface rust is exposed. The corrosion appears concentrated around bolt heads and along the seam where steel members meet,

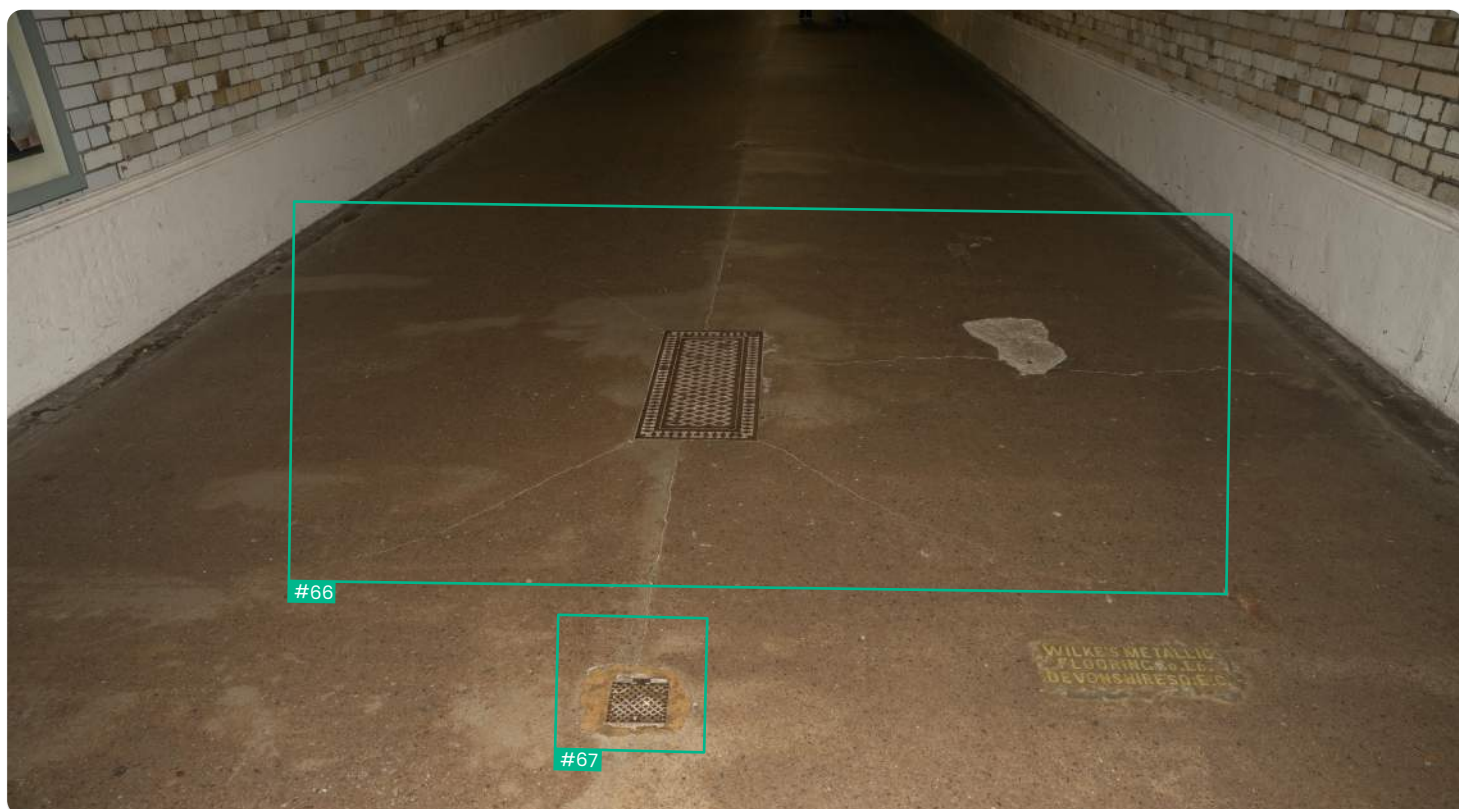
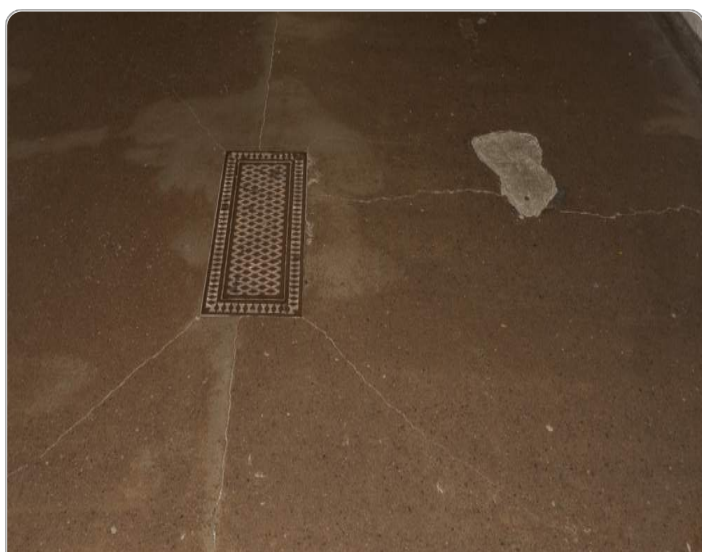
#66

A large rectangular floor cover sits within a broader area of cracking, where several cracks radiate outward from the hatch in multiple directions. The cracks vary in length and follow a linear pattern consistent with movement between service cover edges and adjacent concrete slab.
