Dilapidation Survey Report

NHM Exhibition Road Subway
15th November 2025

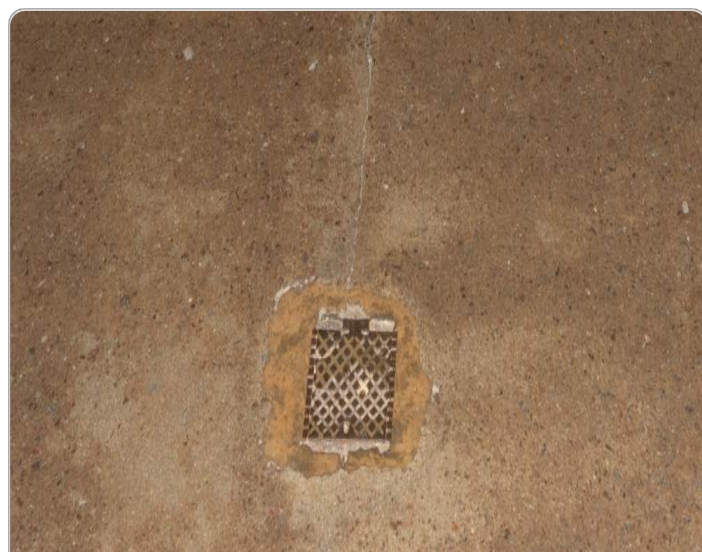
#67

A small metal access cover is set within a locally patched concrete area that is visibly rougher and lighter in colour than surrounding flooring. The reinstatement material shows poor bonding, with crumbling edges and joint separation, particularly around the perimeter where the concrete appears to have eroded back from the cover edge.

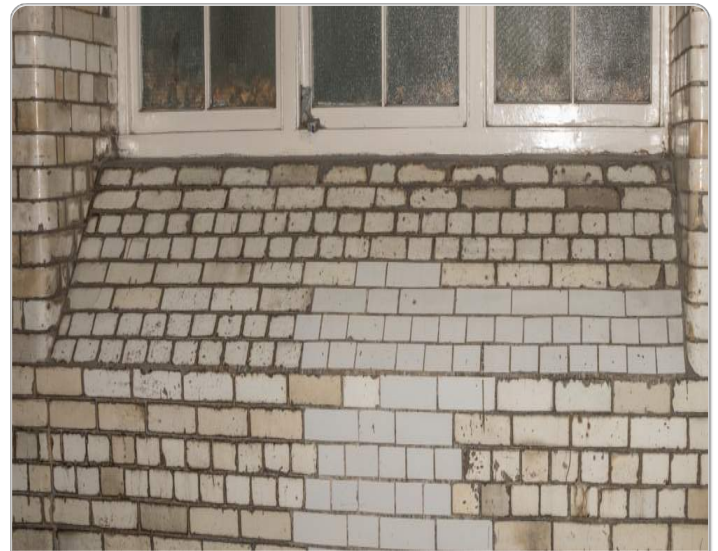
#68

Localised impact damage observed to the lower plastered wall plinth directly beneath window recess. The surface exhibits a concave depression with surrounding abrasion marks and dark smudging consistent with repeated physical contact, likely from trolleys, equipment, or pedestrian interaction. The paint finish is worn through to the substrate,

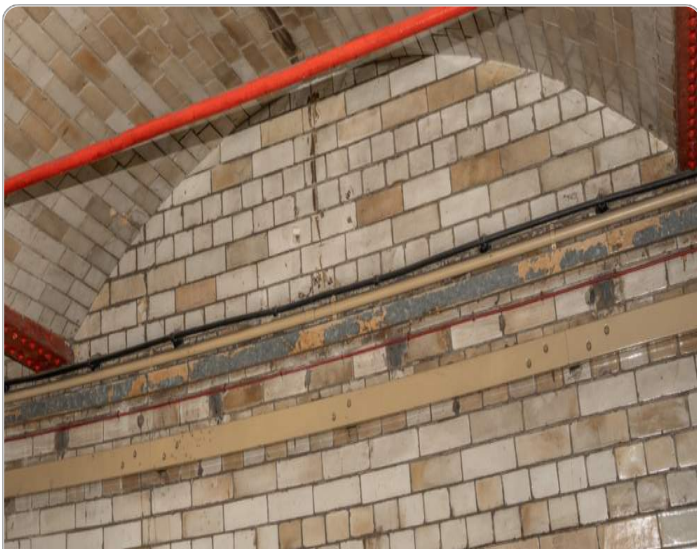
#69

Widespread discolouration and patchwork tile replacement evident across the sloped wall section below windows. Original glazed tiles exhibit varying degrees of surface staining, dirt accumulation, and fading, resulting in a visually inconsistent façade. Several tiles appear to have been replaced previously using mismatched tones and finishes, leading to a non-uniform appearance. Evidence of moisture staining suggests prolonged damp exposure or historic leaks from the window assembly above.

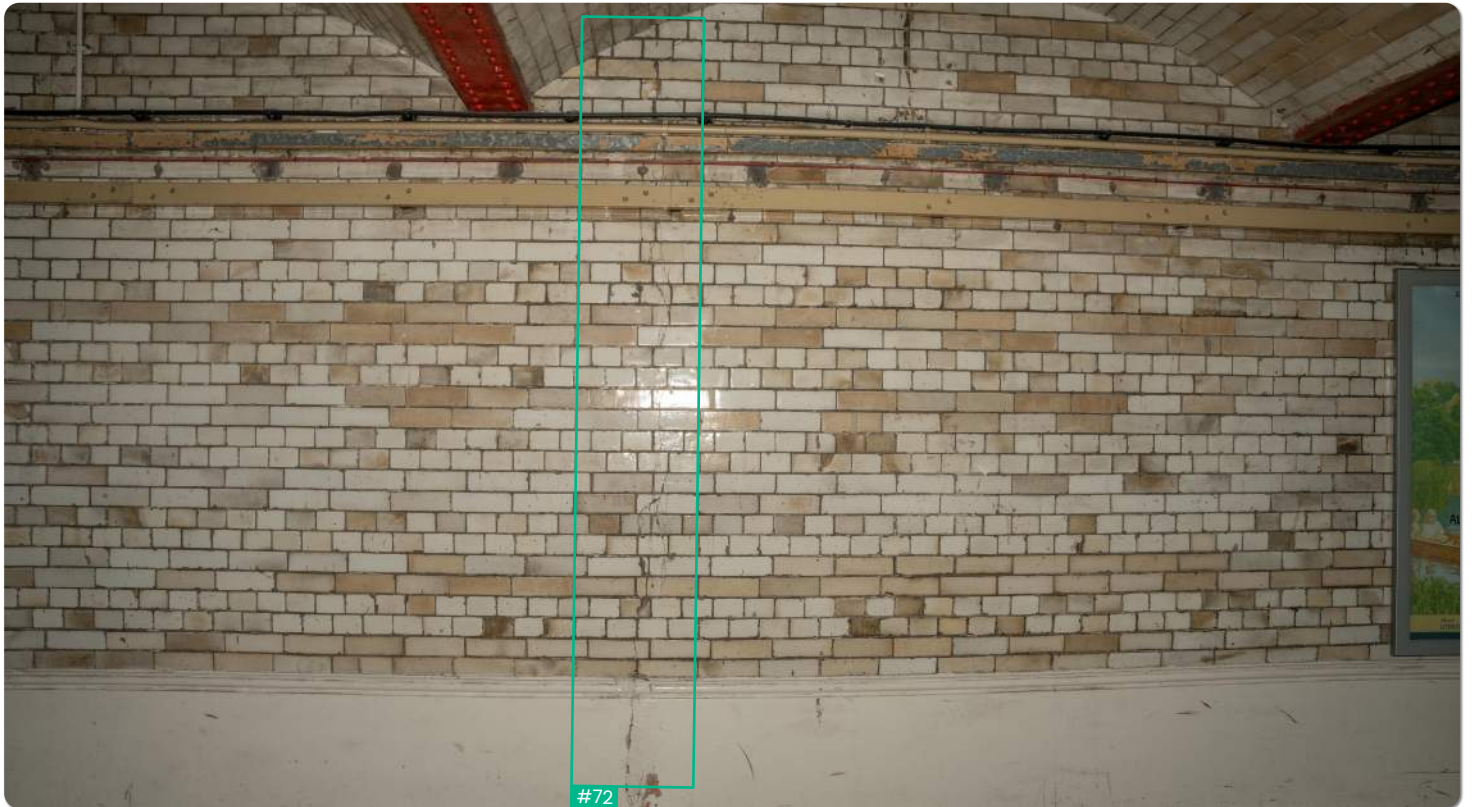
#71

A distinct vertical line of darkened brickwork and mortar joints running from the arch crown downward to the wall support level.

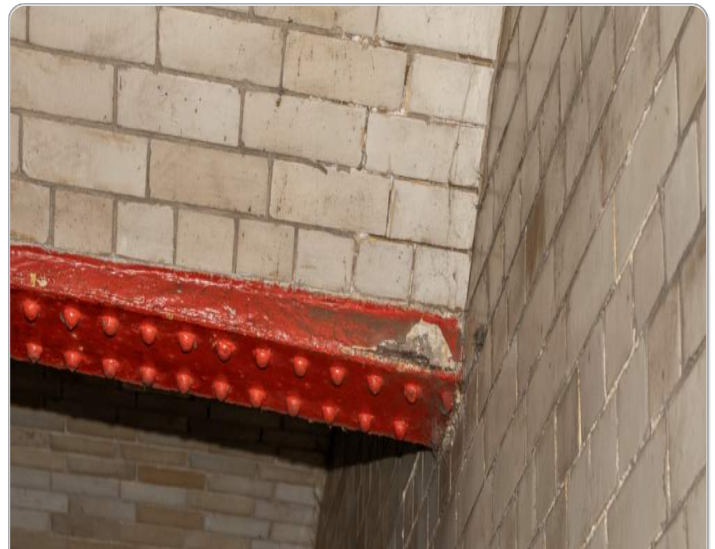
#73

Localised patch of exposed steel showing significant paint breakdown with visible oxidation at the connection between horizontal beam and adjacent steel strut. Rust formation concentrated around rivet heads and weld junctions.

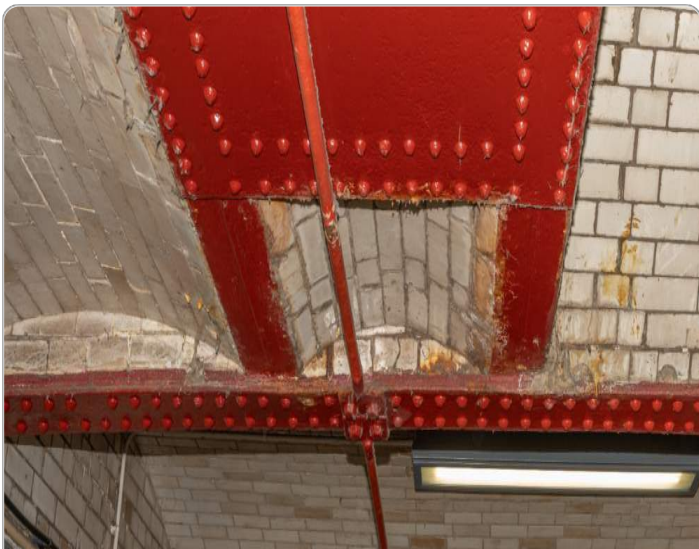
#78

Rust streaking concentrated at joint where secondary beam meets primary rib structure. Rust residue is washed down onto surrounding tiles, forming defined vertical trails. Metal surface exhibits uneven paint adhesion and some exposure of bare steel.

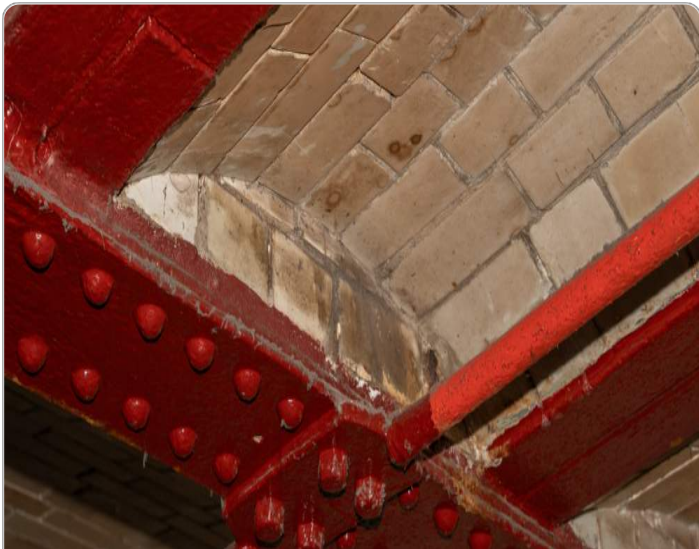
#84

The defect consists of several visible cracks running across individual surface tiles located along the curved section of the vaulted wall/soffit beneath a steel beam connection. The cracks appear to propagate along the tile face rather than solely following mortar joints,

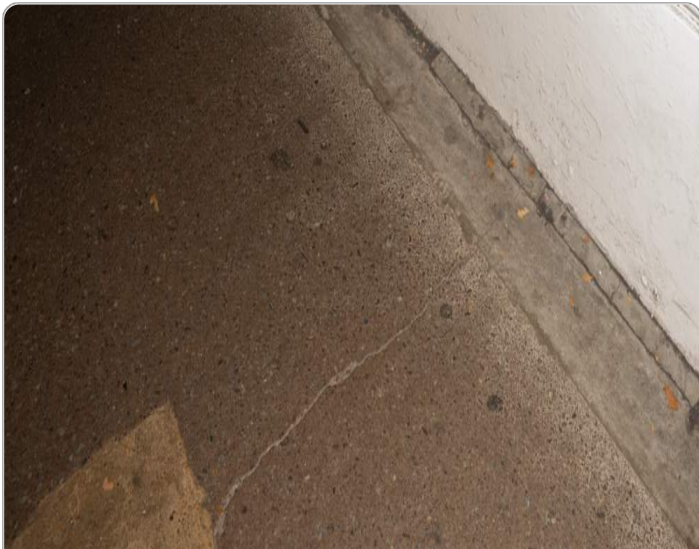
#88

A longitudinal crack is present along the floor surface running parallel to the wall line. The crack follows the construction joint zone where the concrete slab meets the skirting. The crack, extends, with varying width along its length, though predominantly hairline to fine ($<2\text{mm}$). No significant vertical displacement is visible; however, subtle surface erosion along the crack edges is visible.

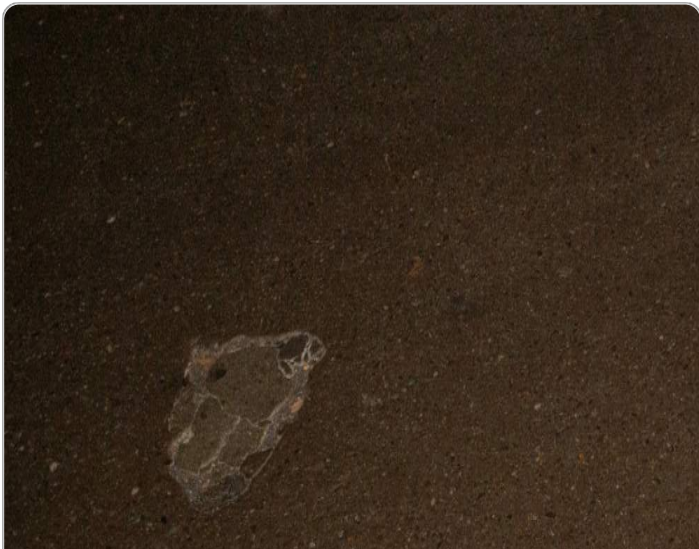
#89

A small, isolated area of surface spalling is present within the walkway floor. The defect is circular and shallow but exposes rougher aggregate beneath the original finish. Edges are sharp with no feathering, consistent with sudden detachment rather than slow erosion.

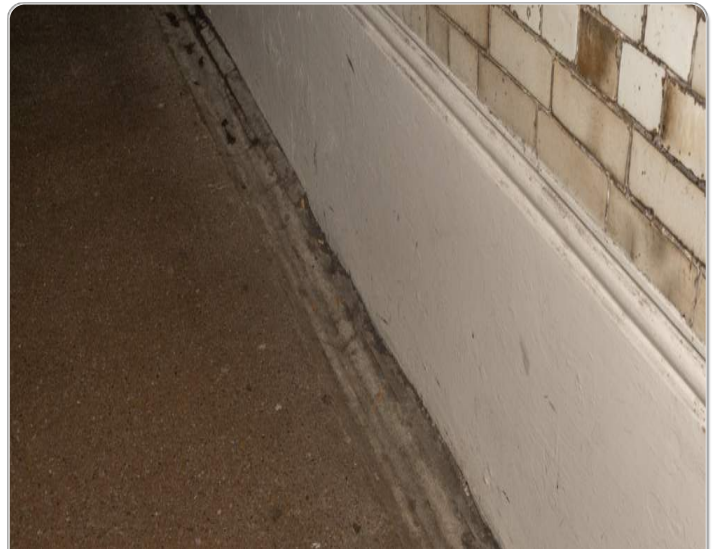
#90

Along the base of the wall is a continuous joint or historic infill strip where the floor meets the wall, likely formed from a different cementitious material. The finish is rough and uneven, with visible discoloration, worn edges, and exposed aggregate.

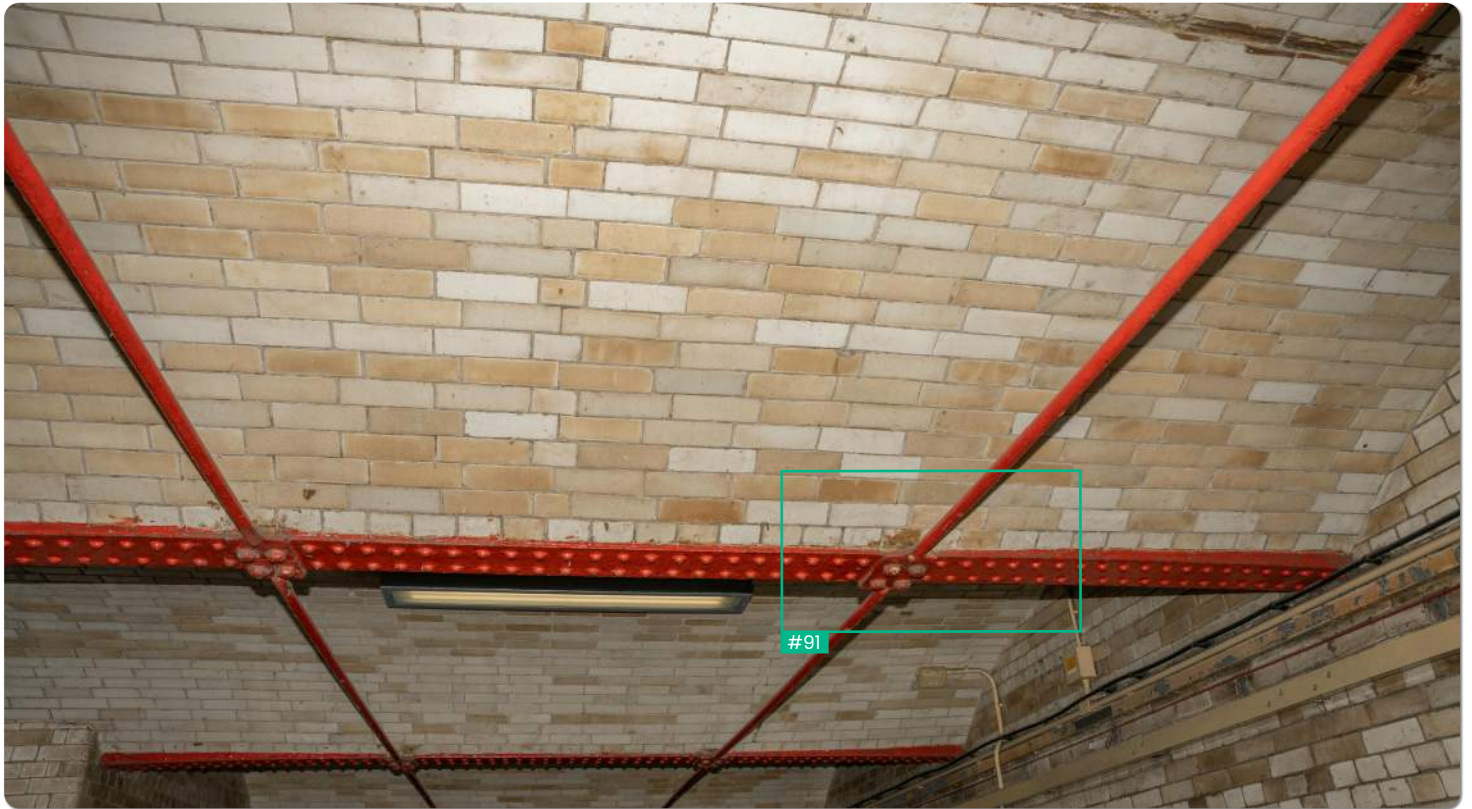
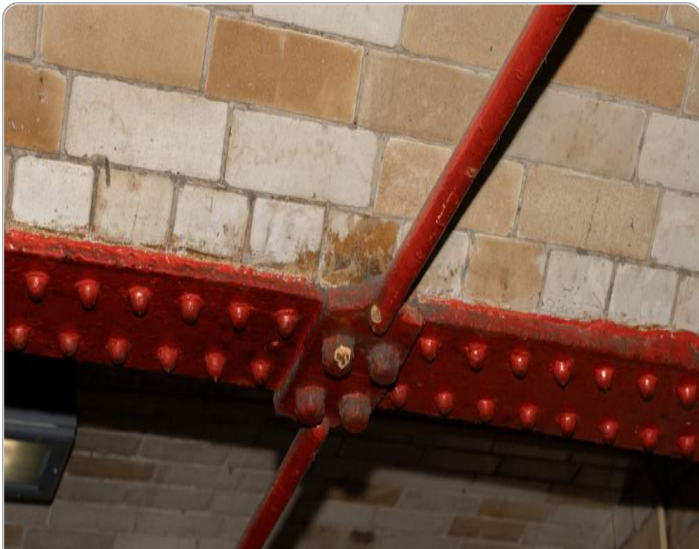
#91

Brown/orange rust staining is present below steel beam flanges positioned overhead, tracking downward across the glazed brick tiles. Tiles themselves remain intact, with no cracking observed.

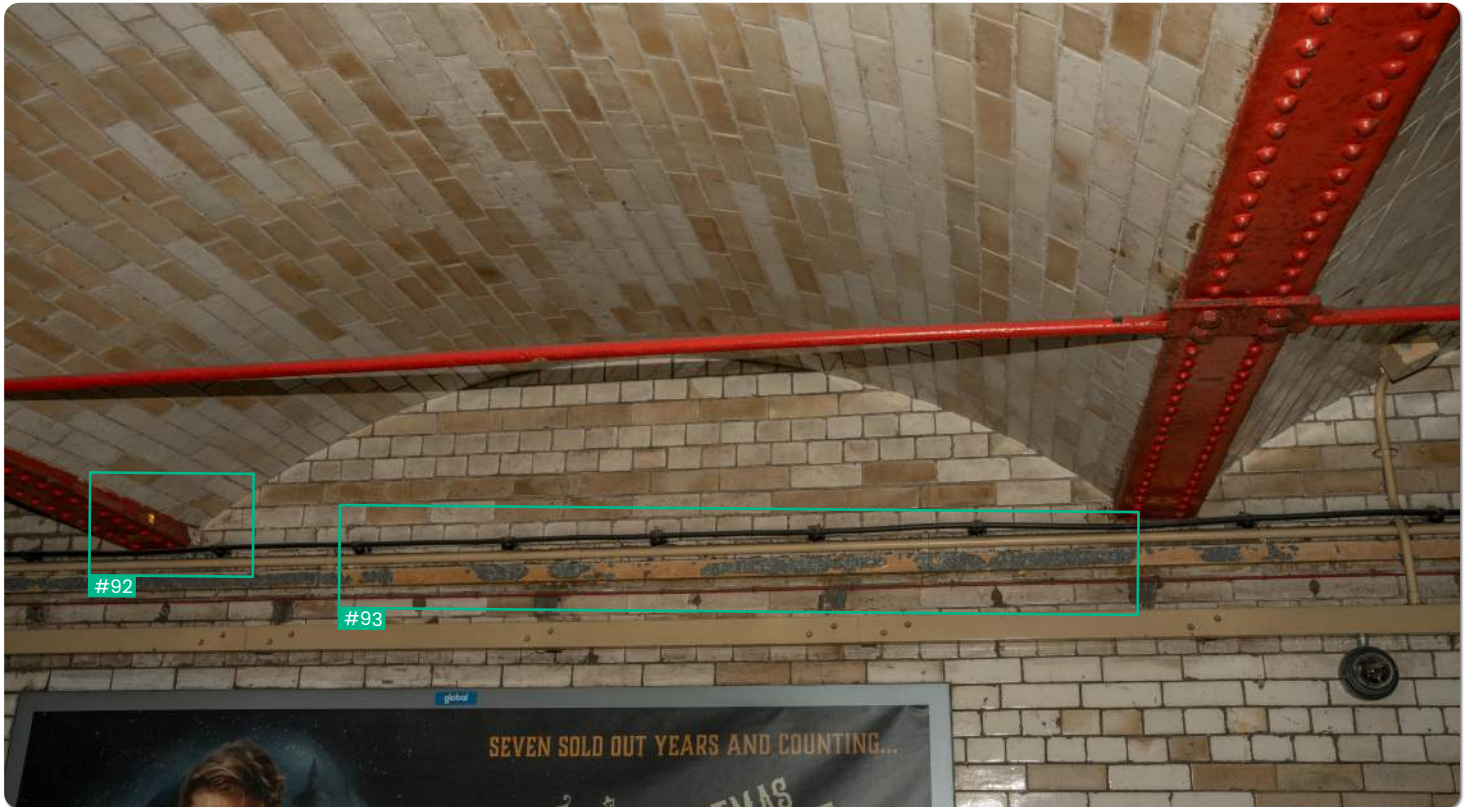
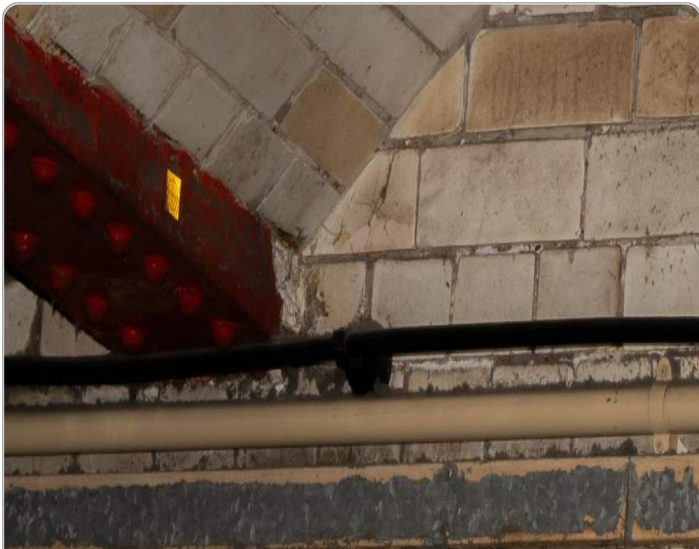
#92

The steel beam end (painted red) located at high level shows visible damage and deterioration to its protective coating. The red paint finish has broken away, exposing underlying steel surfaces and rivet heads, particularly around the lower edge and corner of the beam termination. The exposed metal surface appears discoloured and blemished.

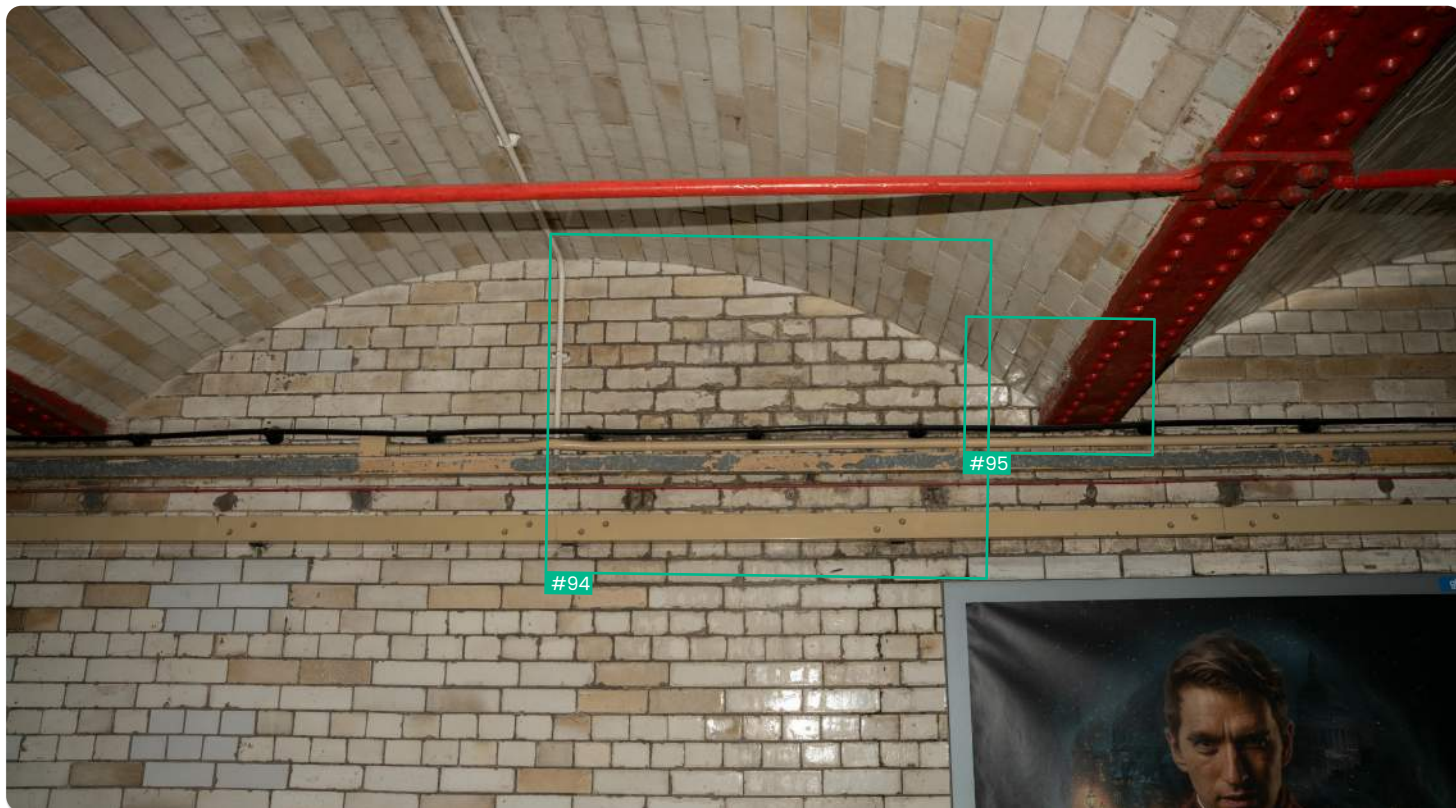
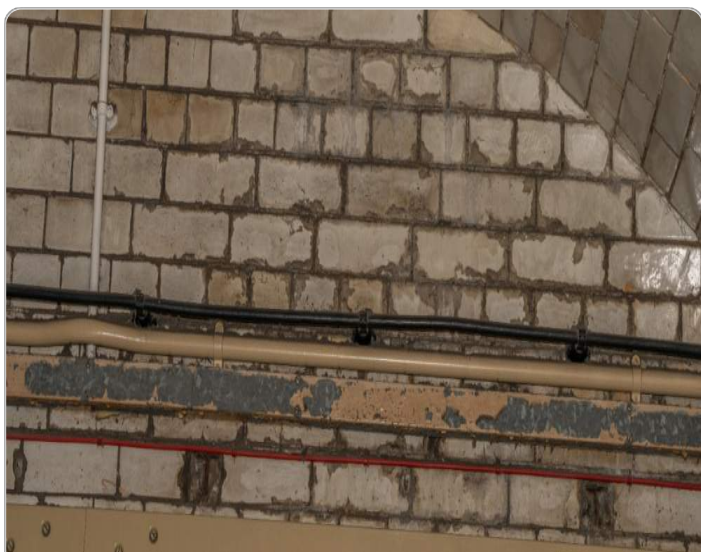
#94

Tiles along the mid-height wall course show visible degradation of mortar joints, where joint material has eroded, leaving recessed profiles. Several tiles display chipped glaze and surface wear, particularly near cable fixings. Staining and discoloration indicate prolonged dirt accumulation and moisture pathways. No dislodged tiles are observed;

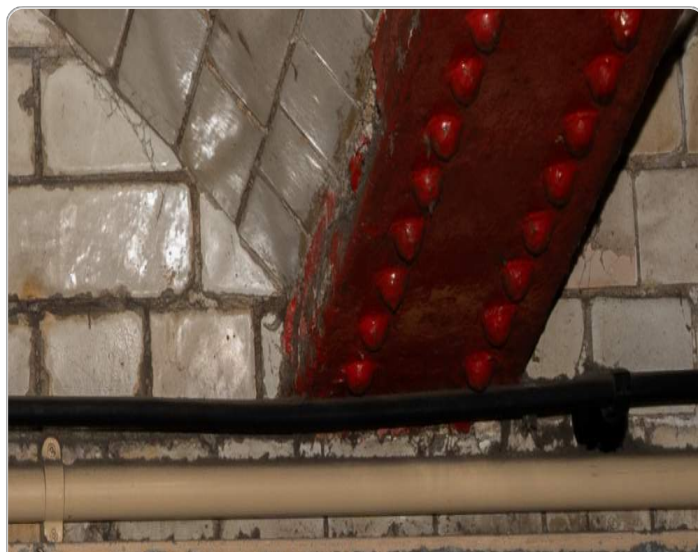
#95

At the interface between the structural beam and glazed brick arch, rust staining is evident along the beam edge and adjacent tile courses. The corrosion appears to originate from steel sections above, with staining streaking downward and seeping into mortar joints. Some mortar cracking is present where tiles meet the steel support network.

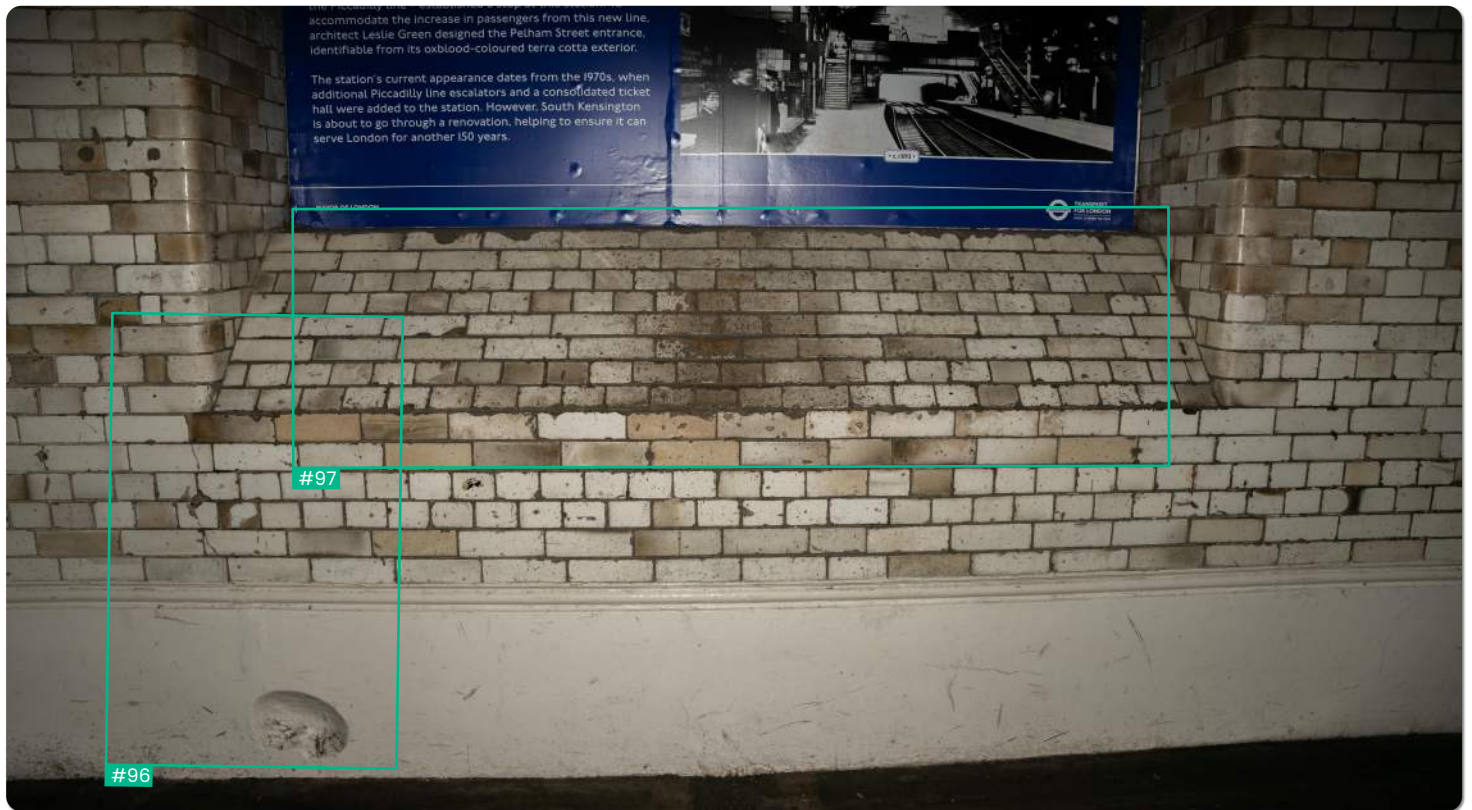
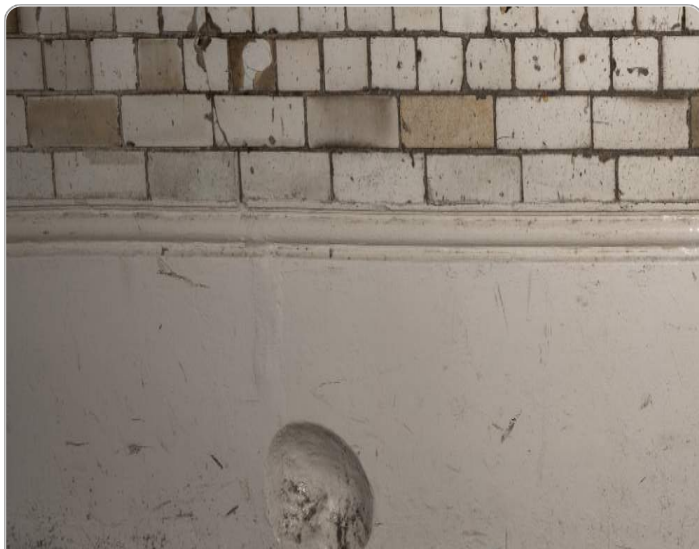
#96

A protruding impact mark is visible on the painted skirting panel. Material has been indented inward, creating a concave cavity with rough exposed plaster material. The finish coating has fractured, exposing porous substrate that could further degrade.

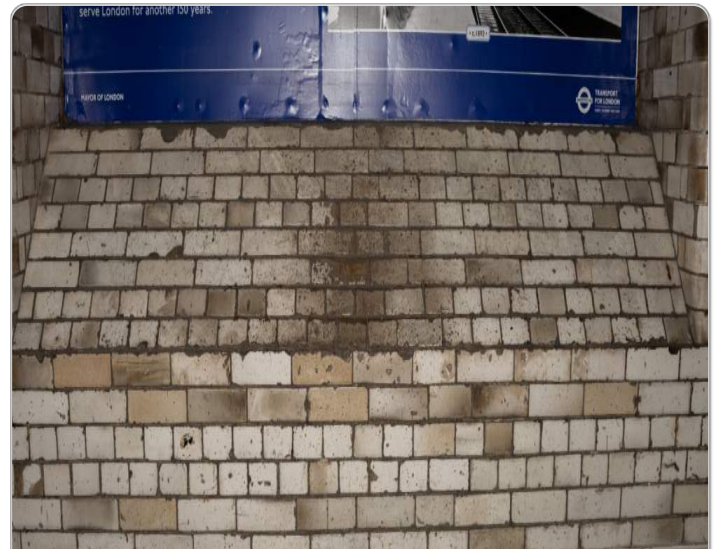
#97

A large rectangular area of tilework displays heavy blackened staining consistent with soot, residue, or historic water runoff. The area appears darker centrally, with fading toward the edges, indicating prolonged environmental exposure rather than a singular event. Tiles show patchy glaze loss and minor mortar joint erosion.

There is no apparent cracking, but there is clear visible surface degradation

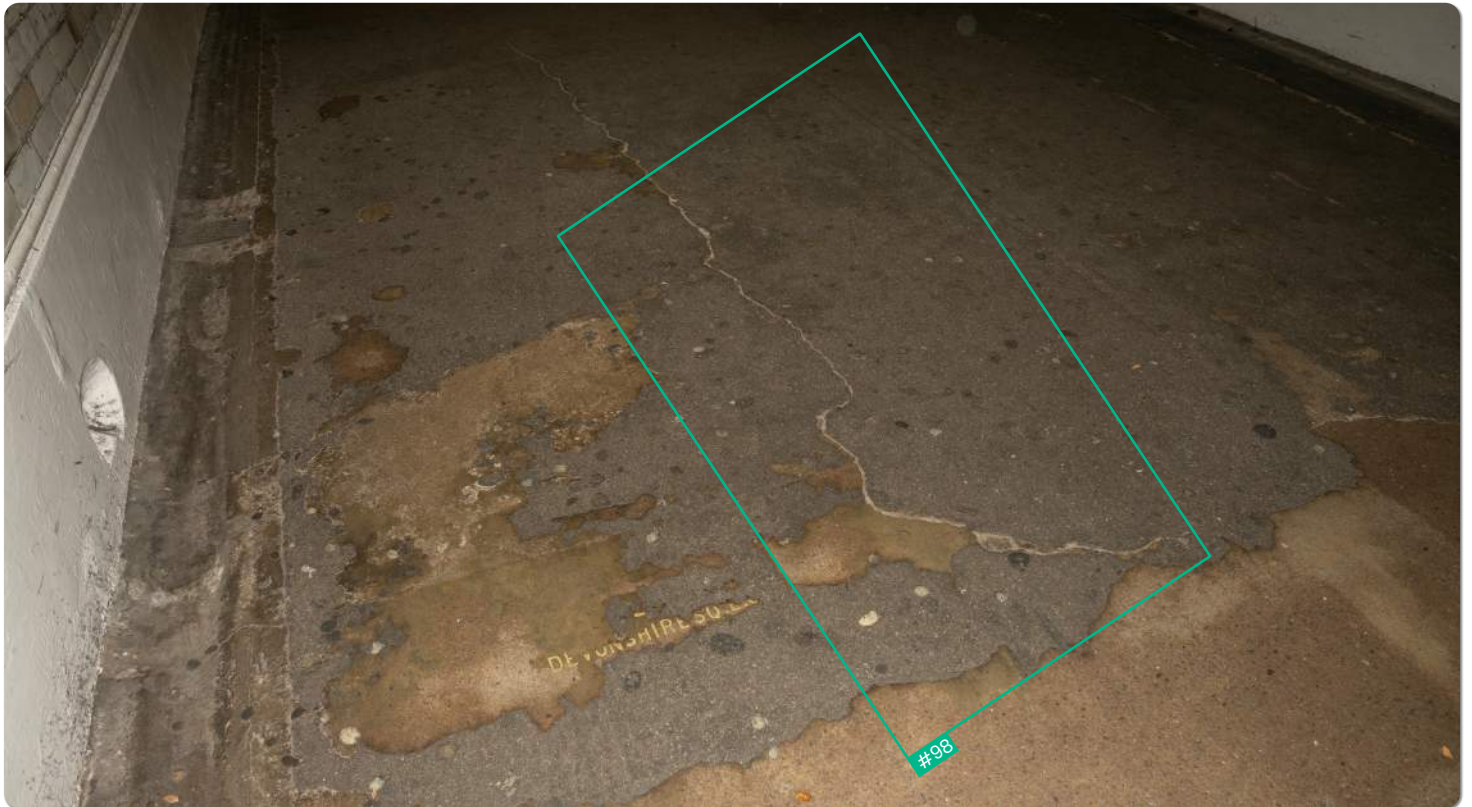
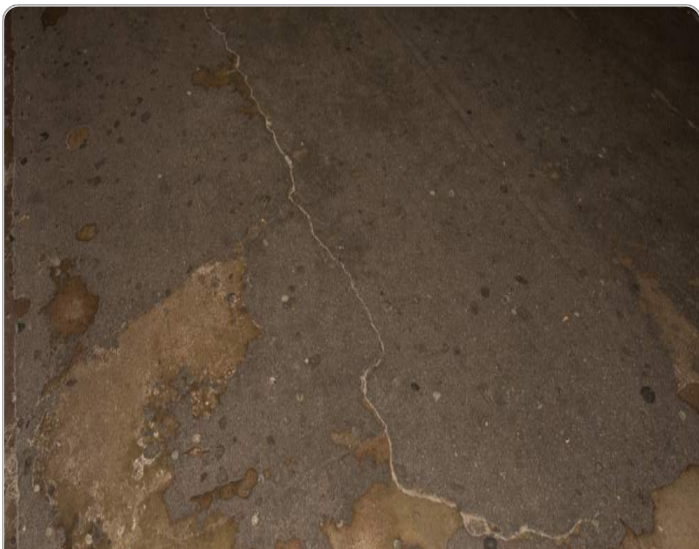
#98

The asphalt floor finish is heavily deteriorated, with large patches of material missing, exposing rough sub-layers beneath. Multiple overlapping repair attempts are visible. A pronounced crack runs through the deteriorated zone, widening where it intersects weaker degraded material.

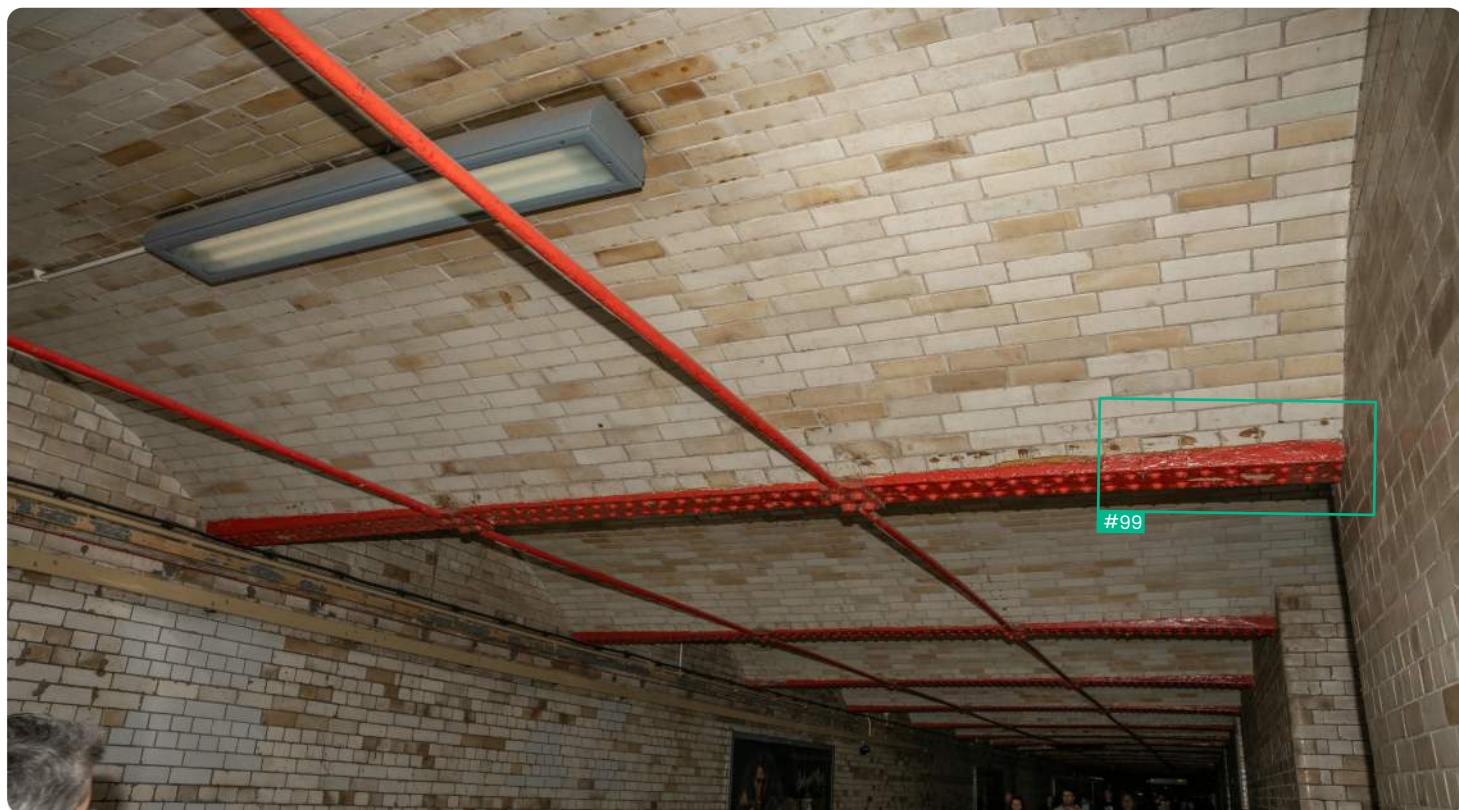
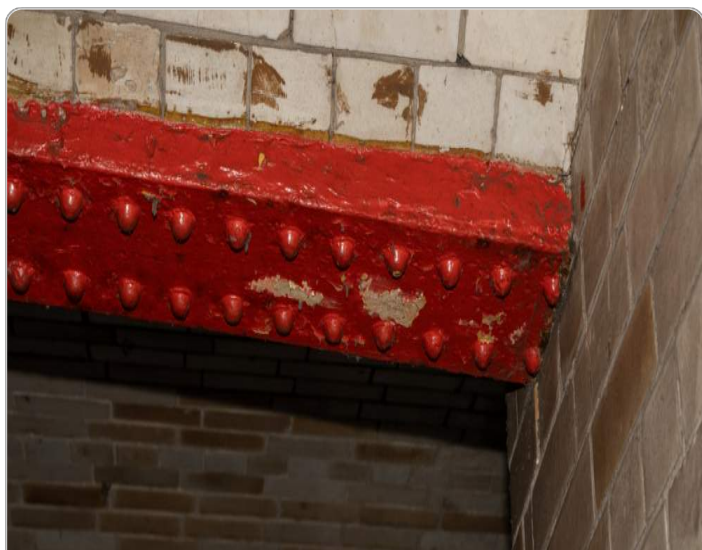
#99

The overhead structural beam shows extensive coating breakdown, with large areas of red protective paint peeling and flaking away, exposing underlying steel. Corrosion spots are visible where the coating has failed, with rust deposits forming at rivets and edges. Staining is also visible on adjacent wall tiles.

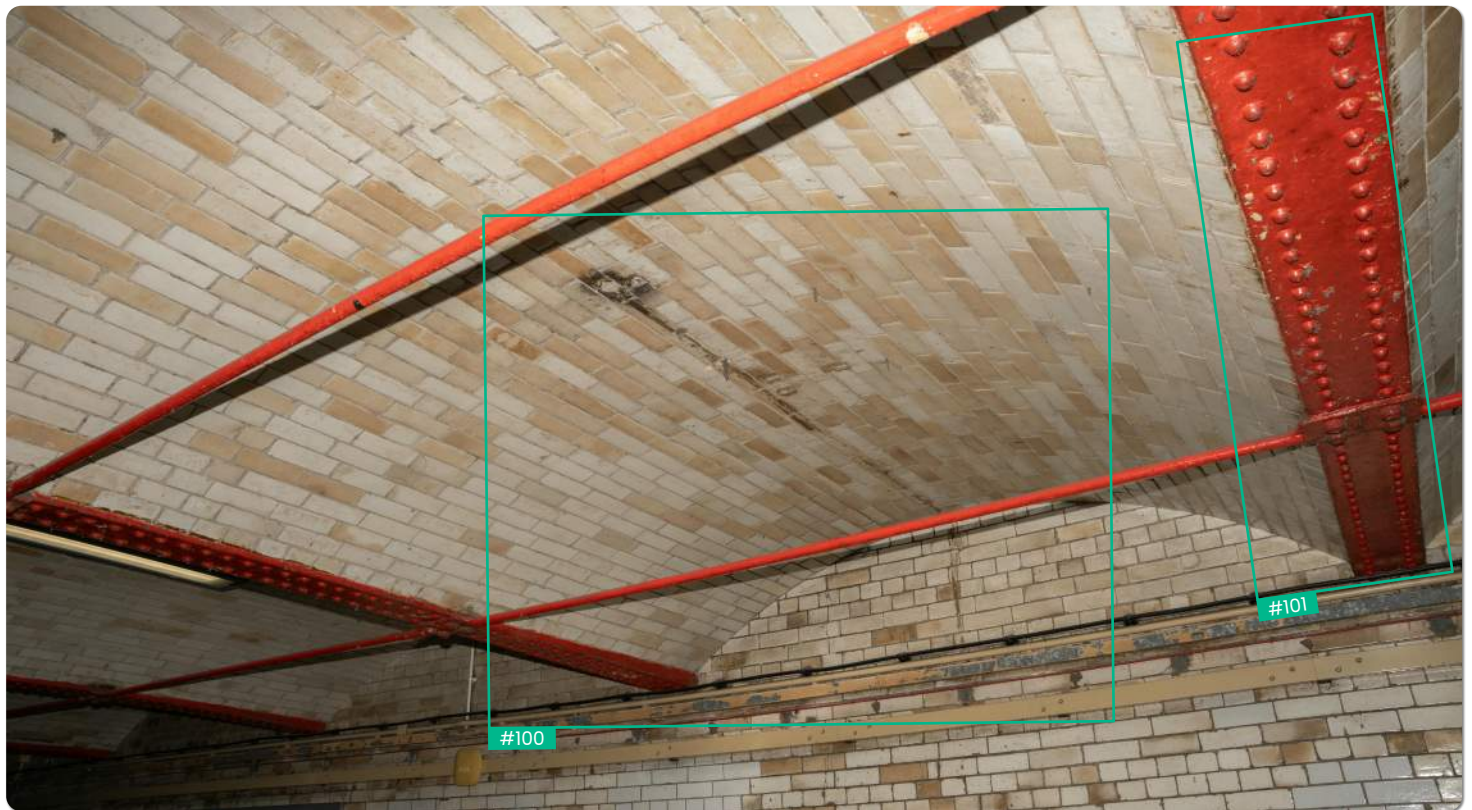
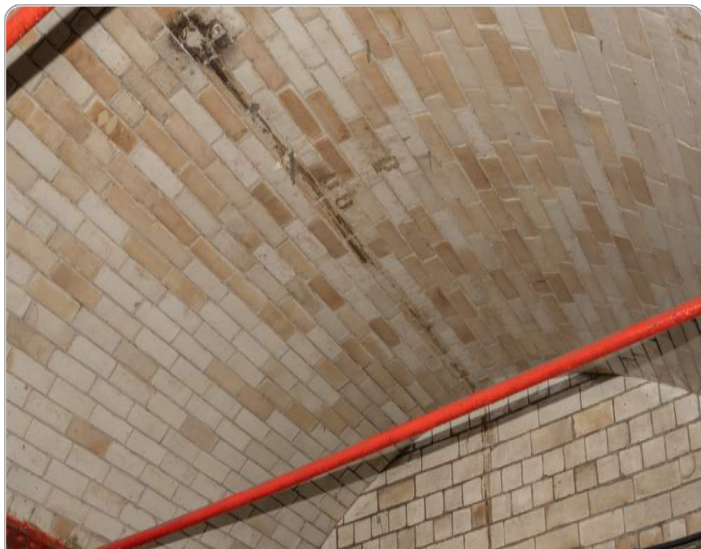
#100

The ceiling tiles within the vaulted section display extensive darkened streaks and mottled discolouration across multiple courses, concentrated along grout joints and spreading irregularly across the tile faces. The staining pattern follows a directional path across the soffit. The glaze layer on several tiles appears dulled and uneven, with sections showing matte areas where surface finish has worn away. No visible fragmentation or tile displacement observed

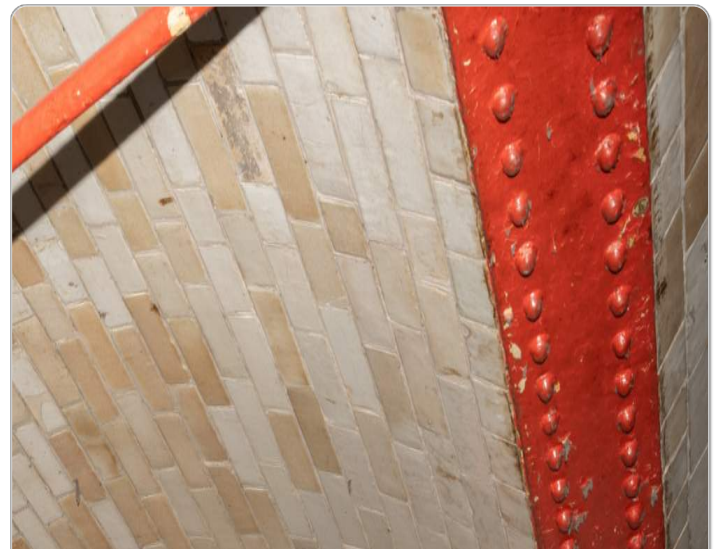
#101

The red-painted steel beam running transversely across the ceiling shows widespread deterioration of its protective coating. The paint layer is flaking in thin sheets, exposing underlying metal along the edges of the flanges and around rivet heads. Multiple areas exhibit raised blistering of paint.

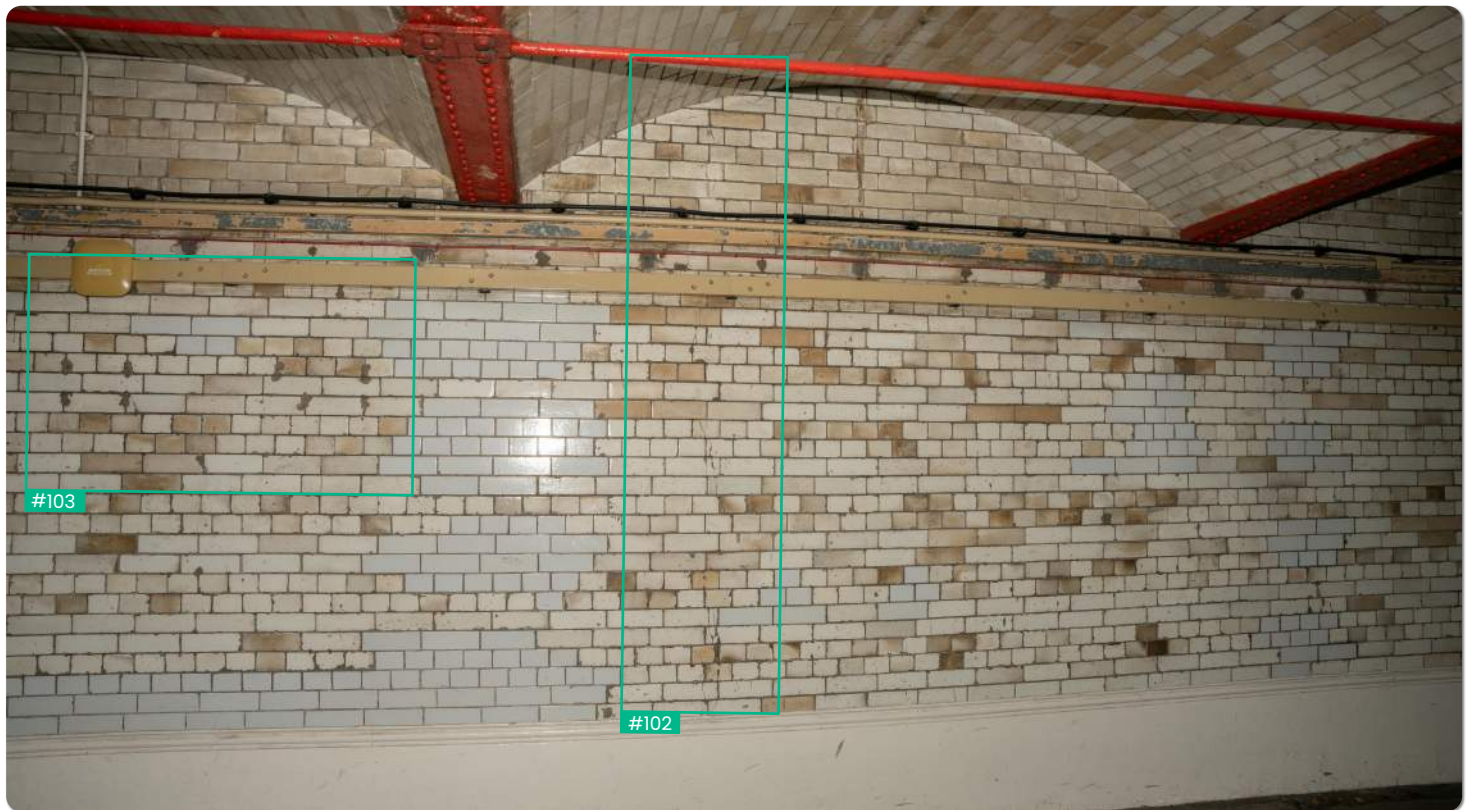
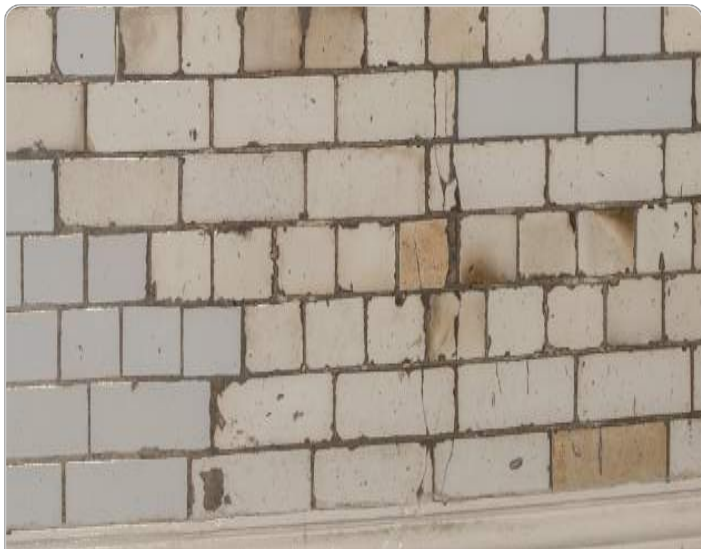
#102

A continuous vertical crack is present running from the lower skirting line through multiple tile courses extending upward toward the arch. The crack traverses tile faces rather than following grout lines. The crack width varies slightly along its length, with minor chipping to tile edges adjacent to the fracture line. Tiles at the lower section show slight separation at joints and visible hairline fissures branching laterally.

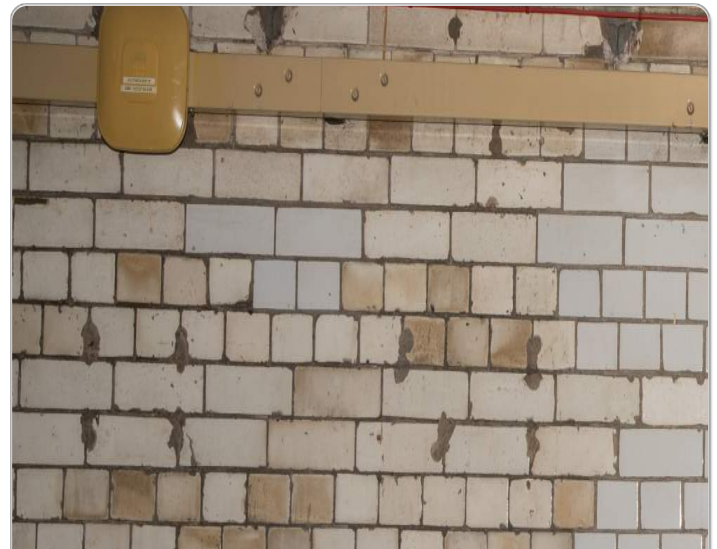
#103

Tiles within this section display a mixture of surface degradation, including scarring, glaze erosion, and areas where patch material has been applied over previous fixings. Several tiles exhibit shallow recesses or worn indentations where fixtures may have been installed and later removed. Colouration is irregular, with multiple tones where tiles have been replaced or refinished. The overall finish appears aged and inconsistent, with worn grout and darkened residue trapped within recessed joints.

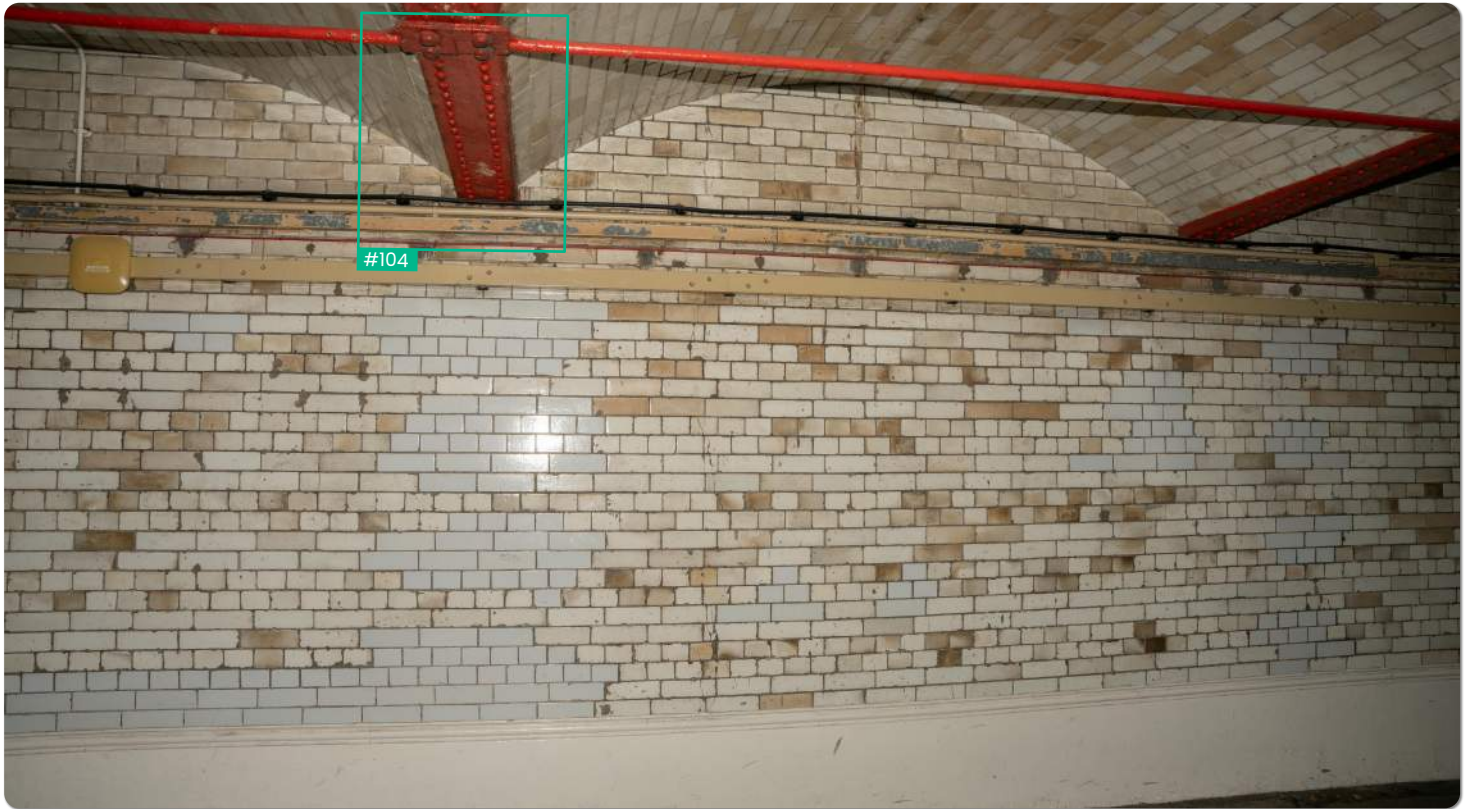
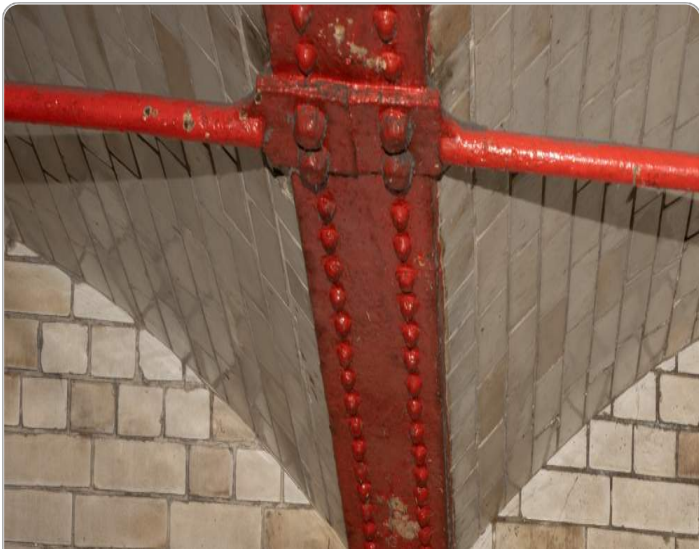
#104

Paint deterioration is concentrated where the steel beam meets the tiled arch. The coating is visibly thinned, with flaking particularly prominent around rivet heads and along the welded connection. The surrounding surface appears roughened with partial loss of protective paint, leaving uneven exposed areas.
