Dilapidation Survey Report

NHM Exhibition Road Subway
15th November 2025

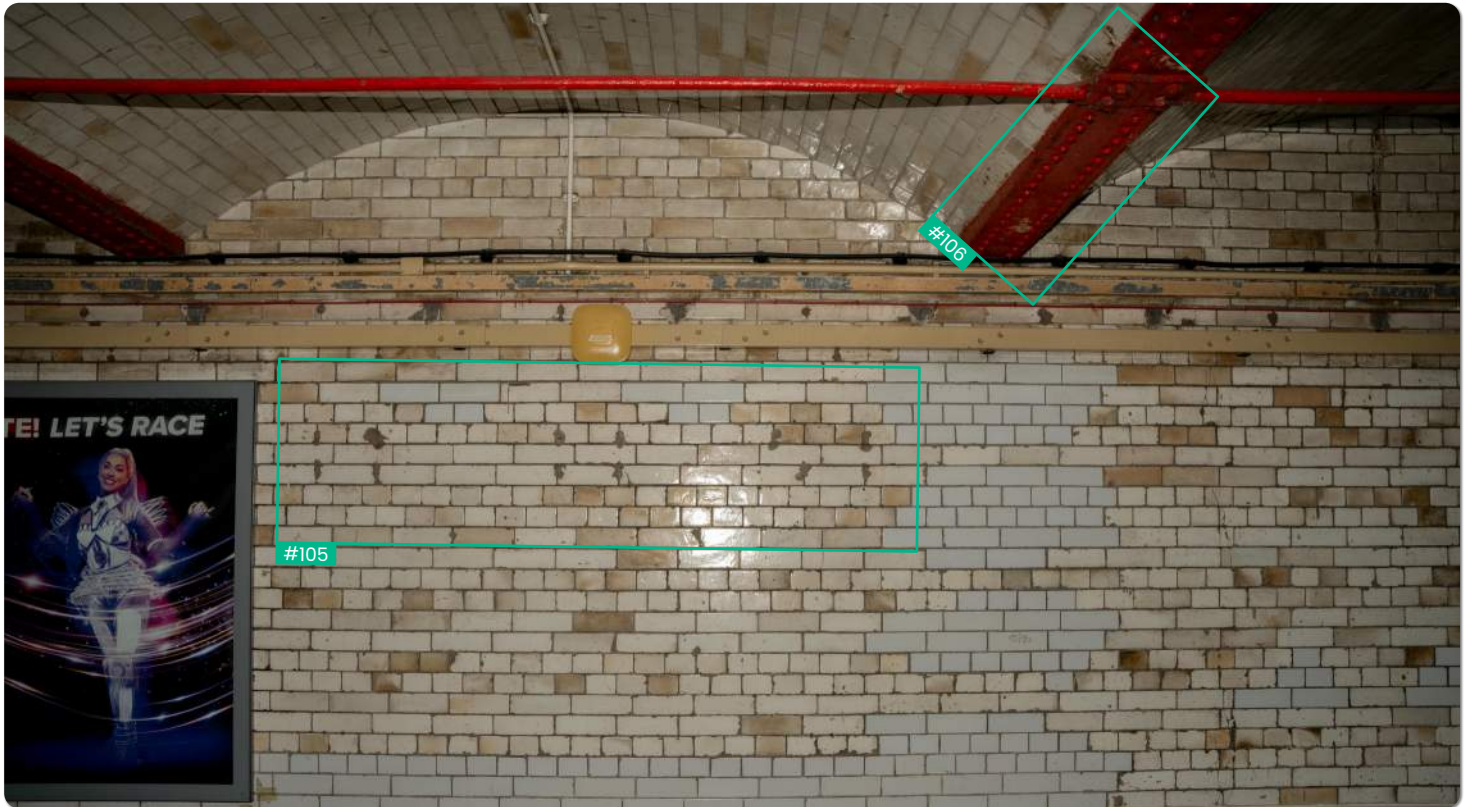
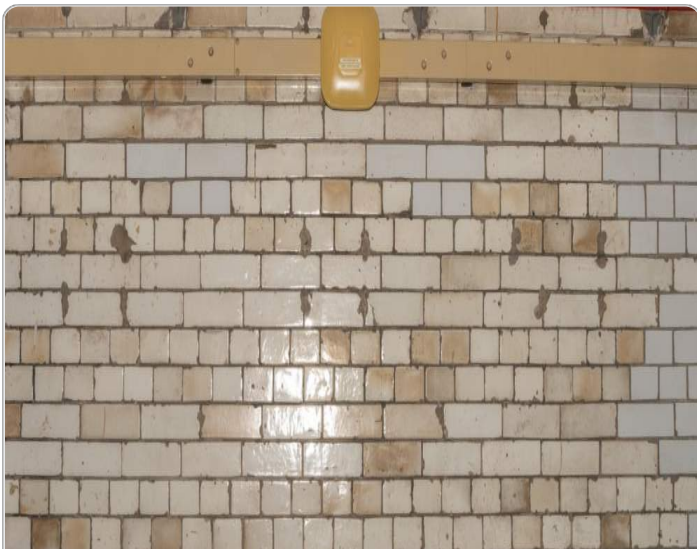
#105

Tiles across this wall span show widespread degradation of original finishes. The glaze is worn in multiple areas, and several tiles exhibit a matte, porous appearance, indicating historic weathering. Tile colouration varies significantly, with replacement units clearly distinguishable in tone and dimensional variation. Existing grout lines appear uneven, with infill materials of differing composition and age visible between original and replacement tiles.

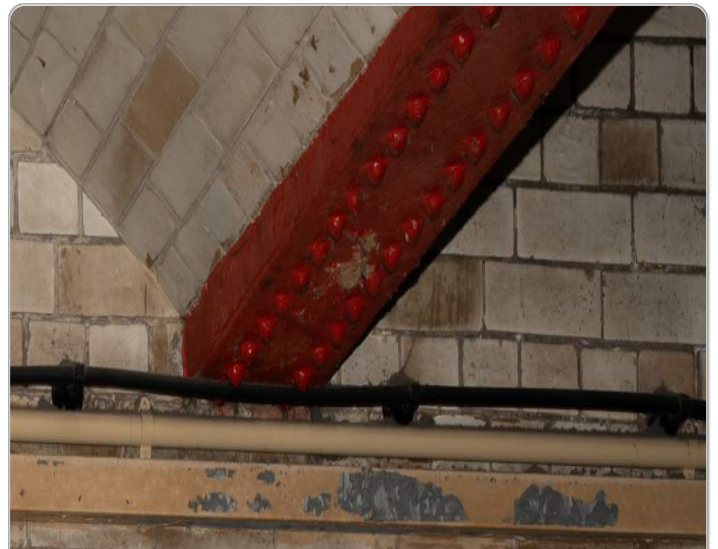
#106

The steel beam running laterally across the vaulted ceiling shows notable deterioration of its protective red coating, particularly concentrated along the lower flange and connection points where the beam intersects the tiled arch.

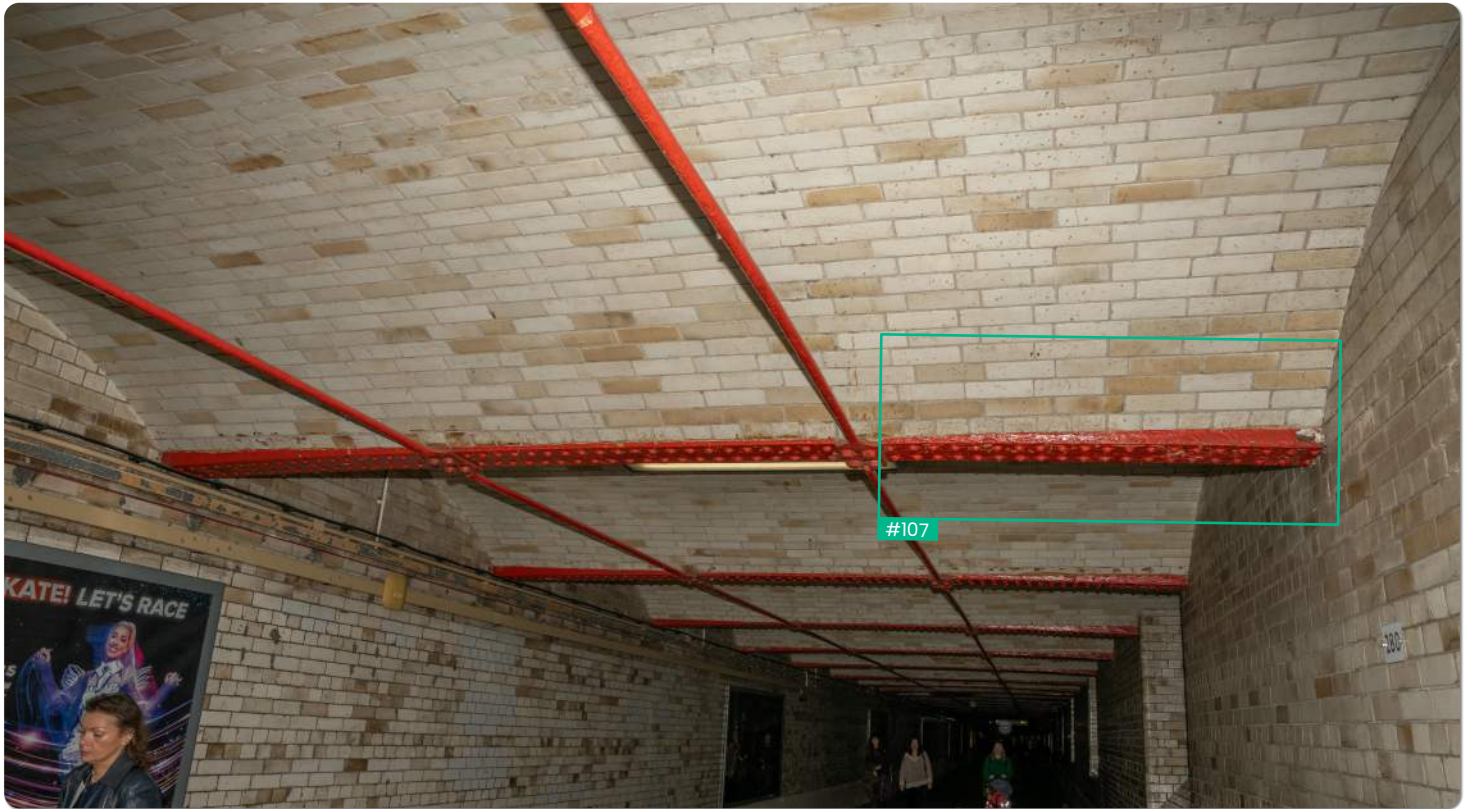
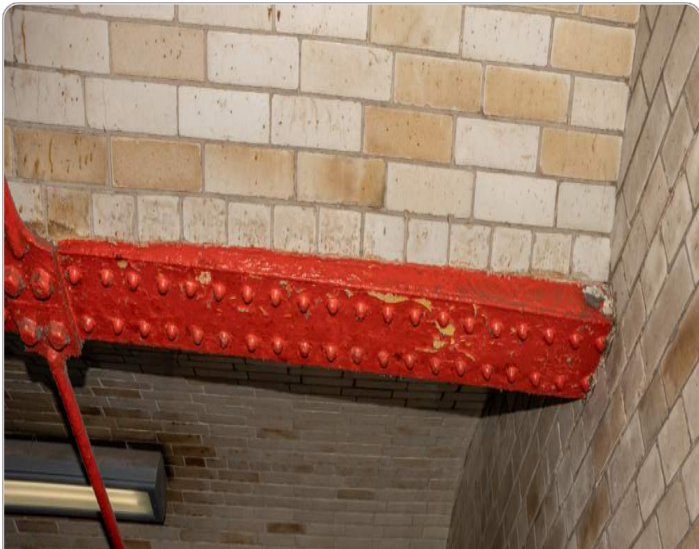
#107

The beam displays extensive longitudinal coating degradation with large sections of paint missing from the underside and edges. The remaining paint appears thin and brittle, with pronounced flaking around rivet patterns. The finish lacks uniform texture, with rough and uneven exposed surfaces contrasting with isolated patches of intact coating. Minor surface pitting is visible where exposure has persisted for extended periods.

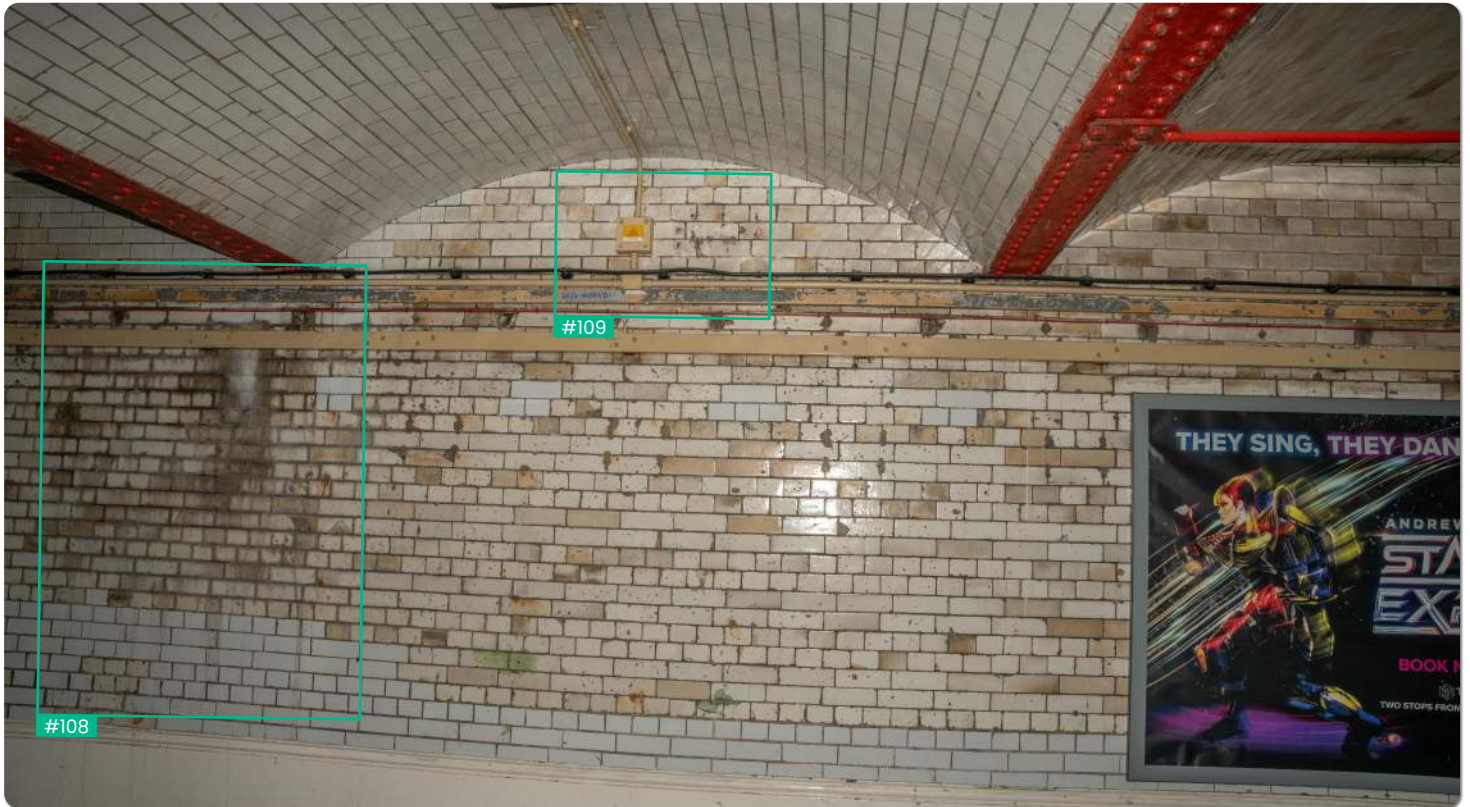
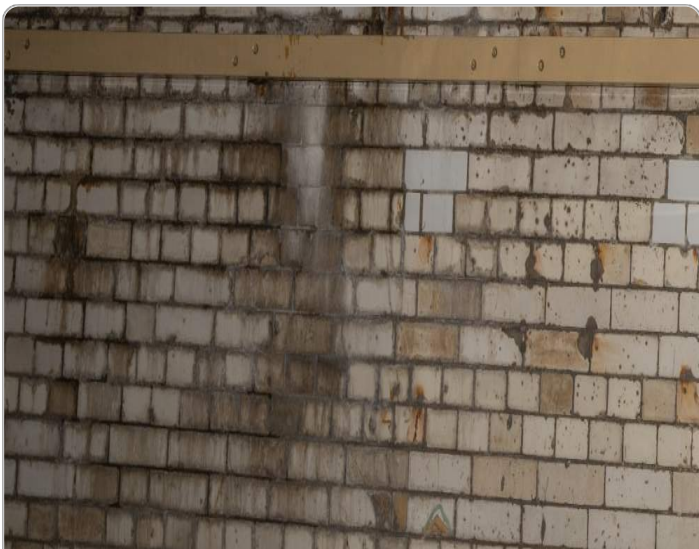
#108

The wall section shows a large patch of dark staining concentrated vertically from the upper tile courses down toward the mid-wall level. The staining has a distinct downward "run-off" pattern with irregular streaking and darker concentrations at the upper points before tapering as it descends. The affected tiles appear darker than surrounding areas and show variations in tone consistent with prolonged exposure to moisture or repeated wetting. Some tiles also display surface dulling and residue accumulation compared to adjacent cleaner tiles.

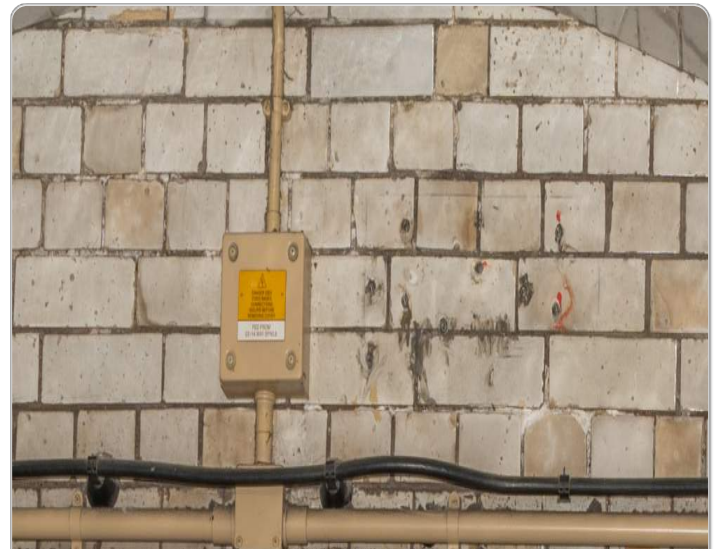
#109

Tiles surrounding the mounted electrical enclosure display multiple surface abrasions, shallow impact marks, and remnants of previous adhesive or sealant deposits. Circular and linear indentations suggest historic drilling or mechanical attachment. Surface finish is uneven with small losses of glaze and chipped corners around drilled penetrations. Grout lines show uneven thickness where tiles appear to have been altered or repositioned.

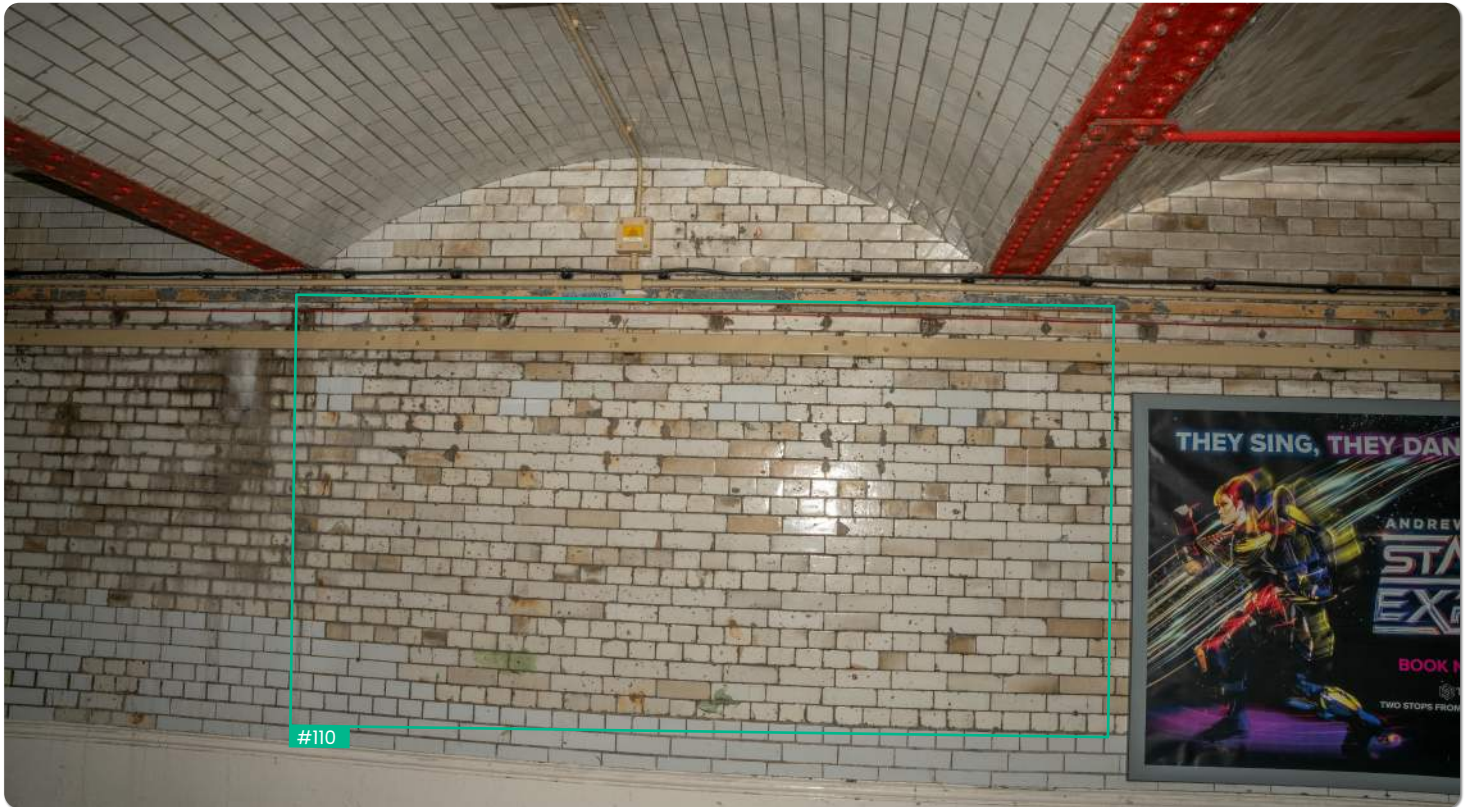
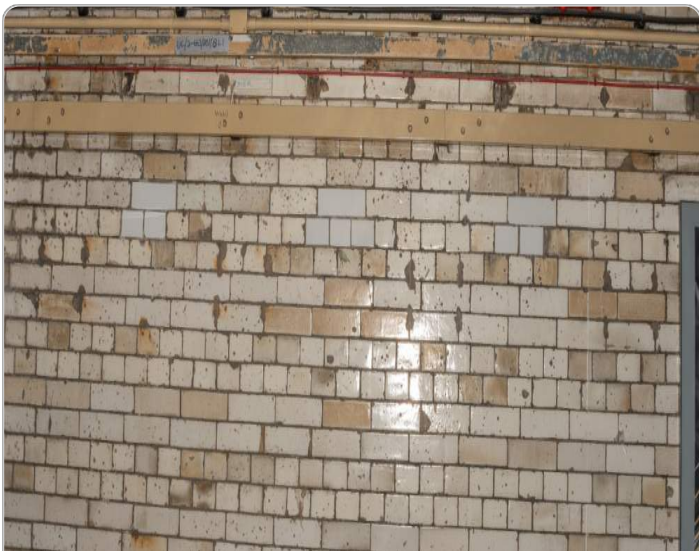
#110

This wall segment contains a large area of tiles exhibiting inconsistent ageing patterns, including widespread dulling, patchy tone variation, and differential surface textures. Multiple tiles are noticeably newer, smoother, and cleaner, contrasting heavily with surrounding original units. Irregular spacing and mismatched grout indicate repeated repairs across the area. No distinct crack lines noted but overall surface condition appears degraded.

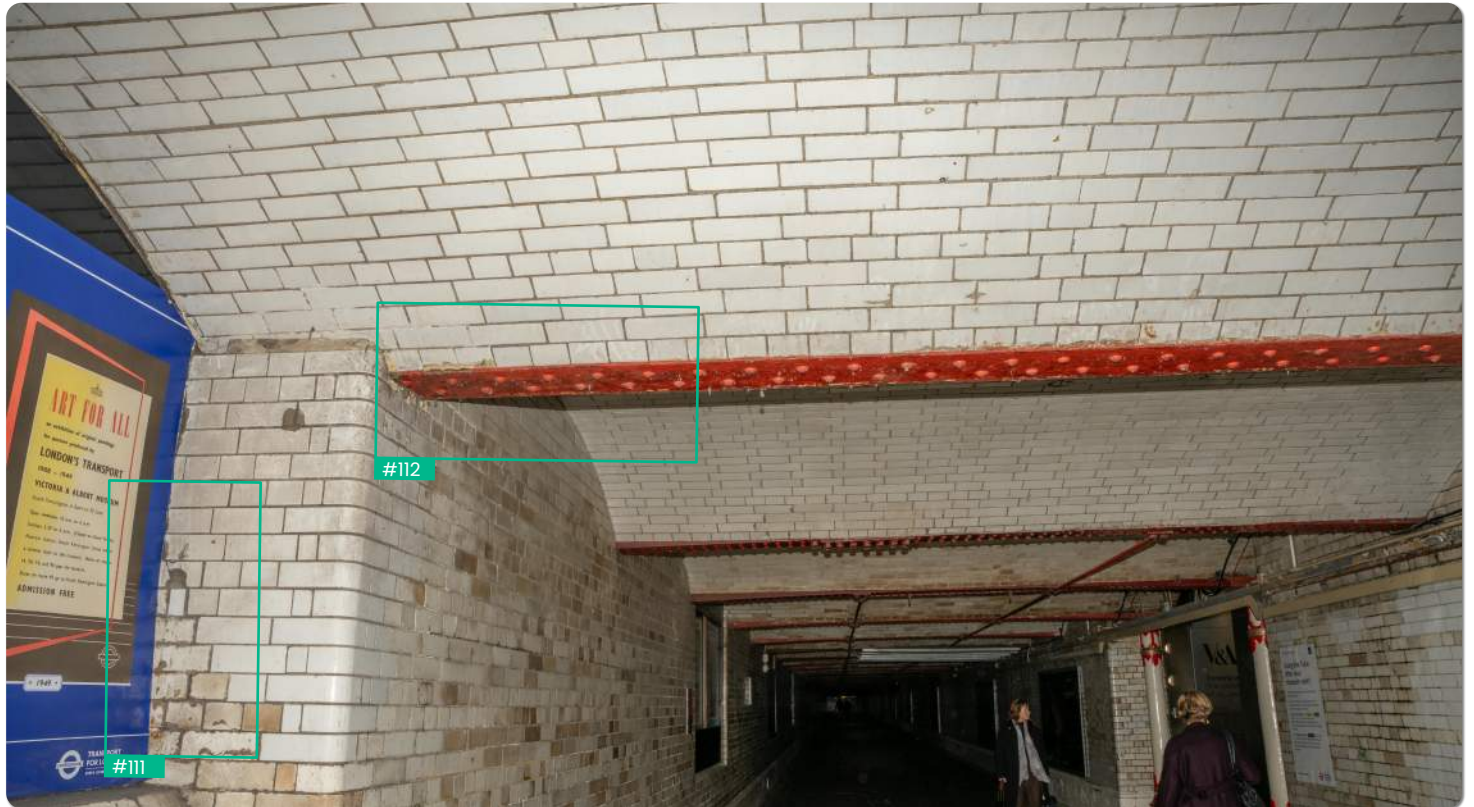
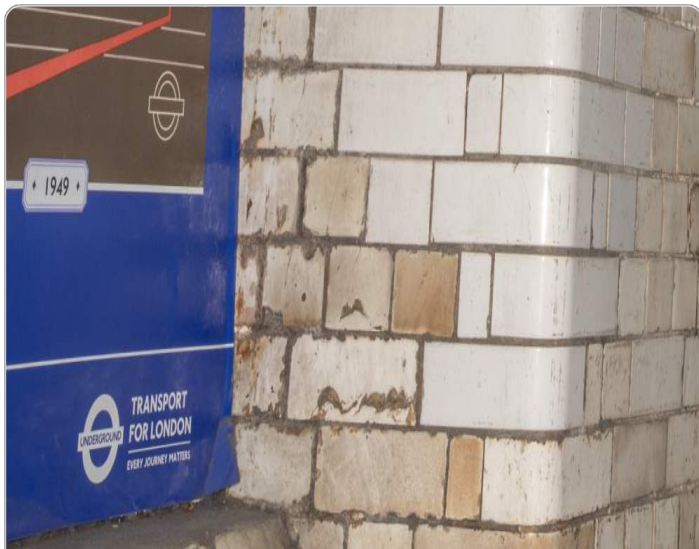
#111

The wall section shows localised deterioration of the tile joints, particularly along the corner return and lower tile courses. Jointing material appears worn, eroded, or missing in several areas, leading to uneven gaps between tiles where mortar should typically provide a uniform seal. The exposed joints exhibit a rough and degraded surface profile, with visible recesses where mortar has broken away over time.

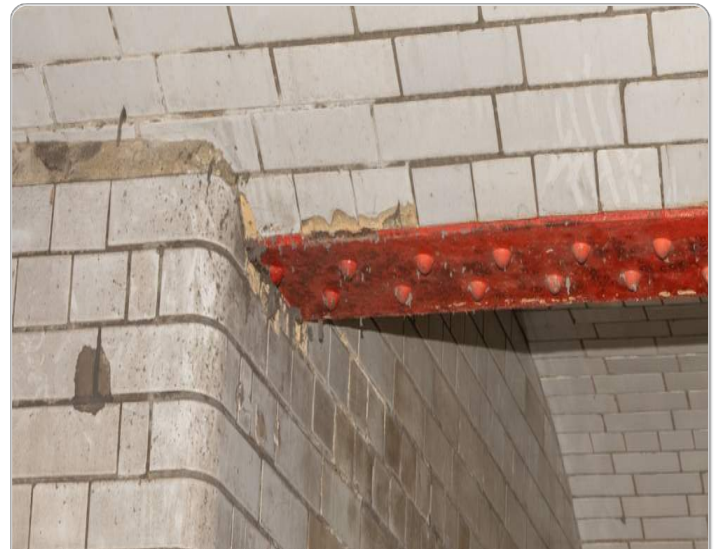
#112

Tiles directly beneath the edge of the beam show missing segments along tile tops, exposing rough substrate material. The breakage runs intermittently along the corner where tiles meet the structural steel. Mortar has deteriorated in voids, leaving irregular joint gaps. The steel beam positioned directly above the tiled wall section shows visible deterioration along its lower flange and web surfaces. The red protective coating has worn away in multiple irregular patches, exposing bare metal beneath, particularly concentrated along the underside where the beam projects outward from the supporting wall line.

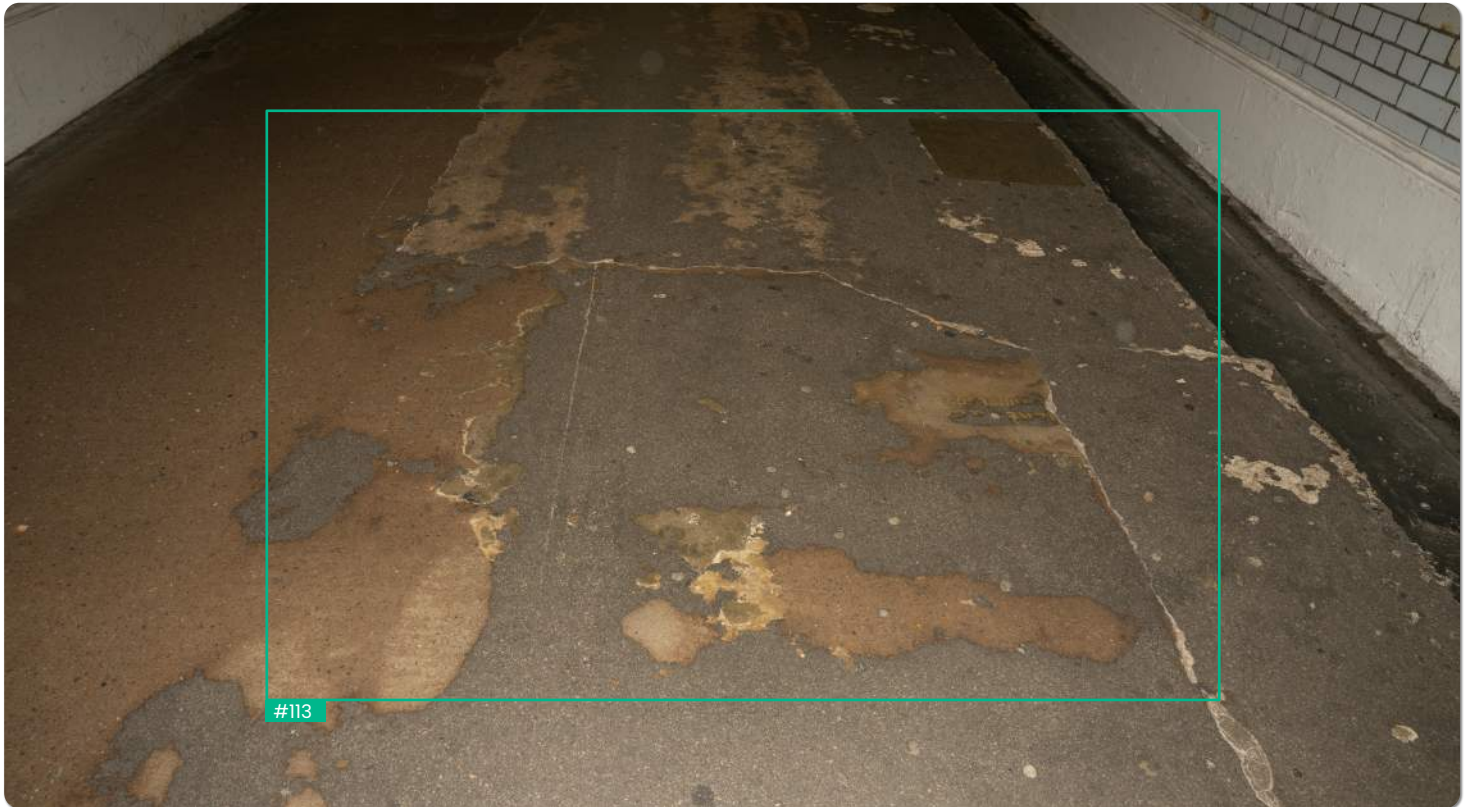
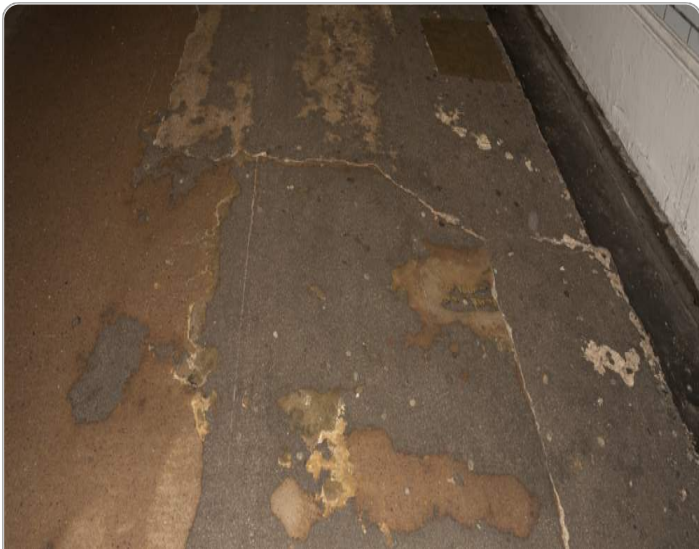
#113

A large worn section of floor surfacing shows broad delamination exposing coarse aggregate beneath. The remaining coating is uneven with feathered edges and multiple overlapping patch layers. Long cracks run diagonally across the exposed substrate, with smaller hairlines branching outward. Texture varies significantly, with smooth worn patches adjacent to rough aggregate areas.

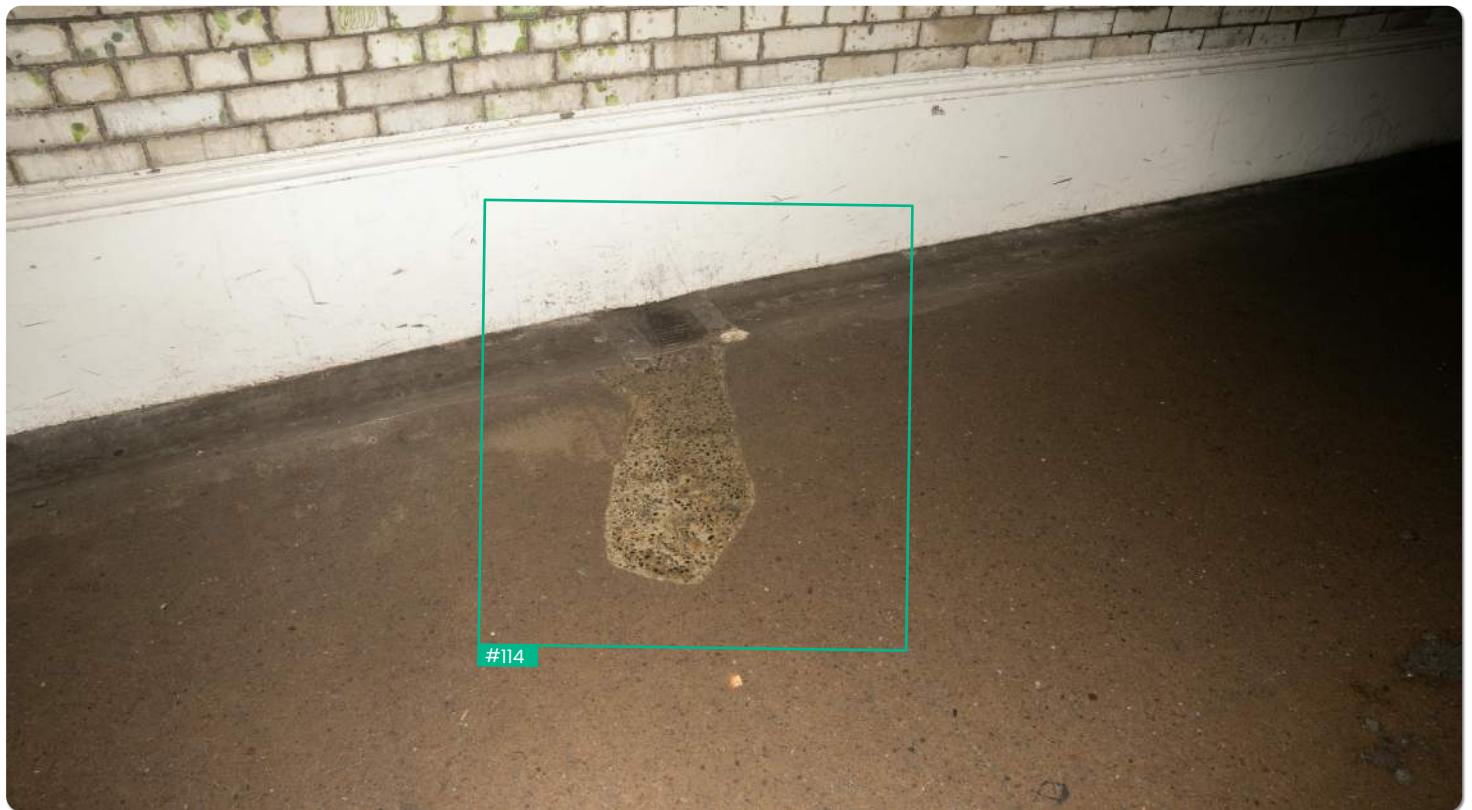
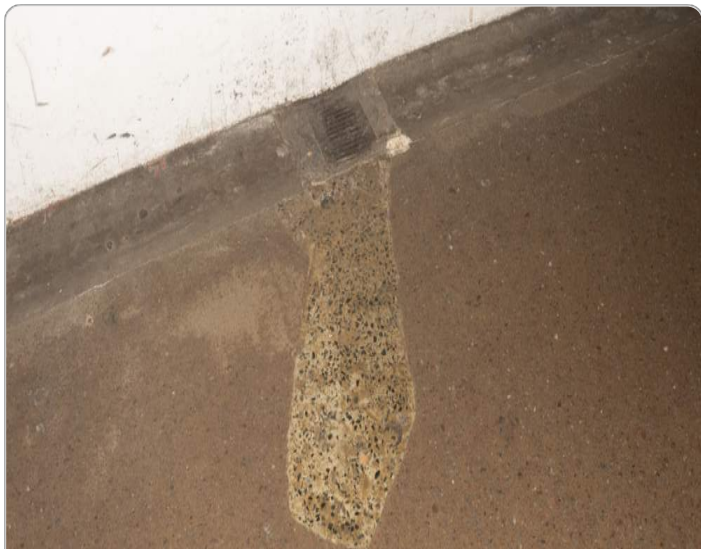
#114

A large repaired area of floor surface is visibly worn away, leaving exposed coarse aggregate protruding above the surrounding substrate. The perimeter of the patch has irregular, frayed edges where the overlay material has thinned and peeled away.

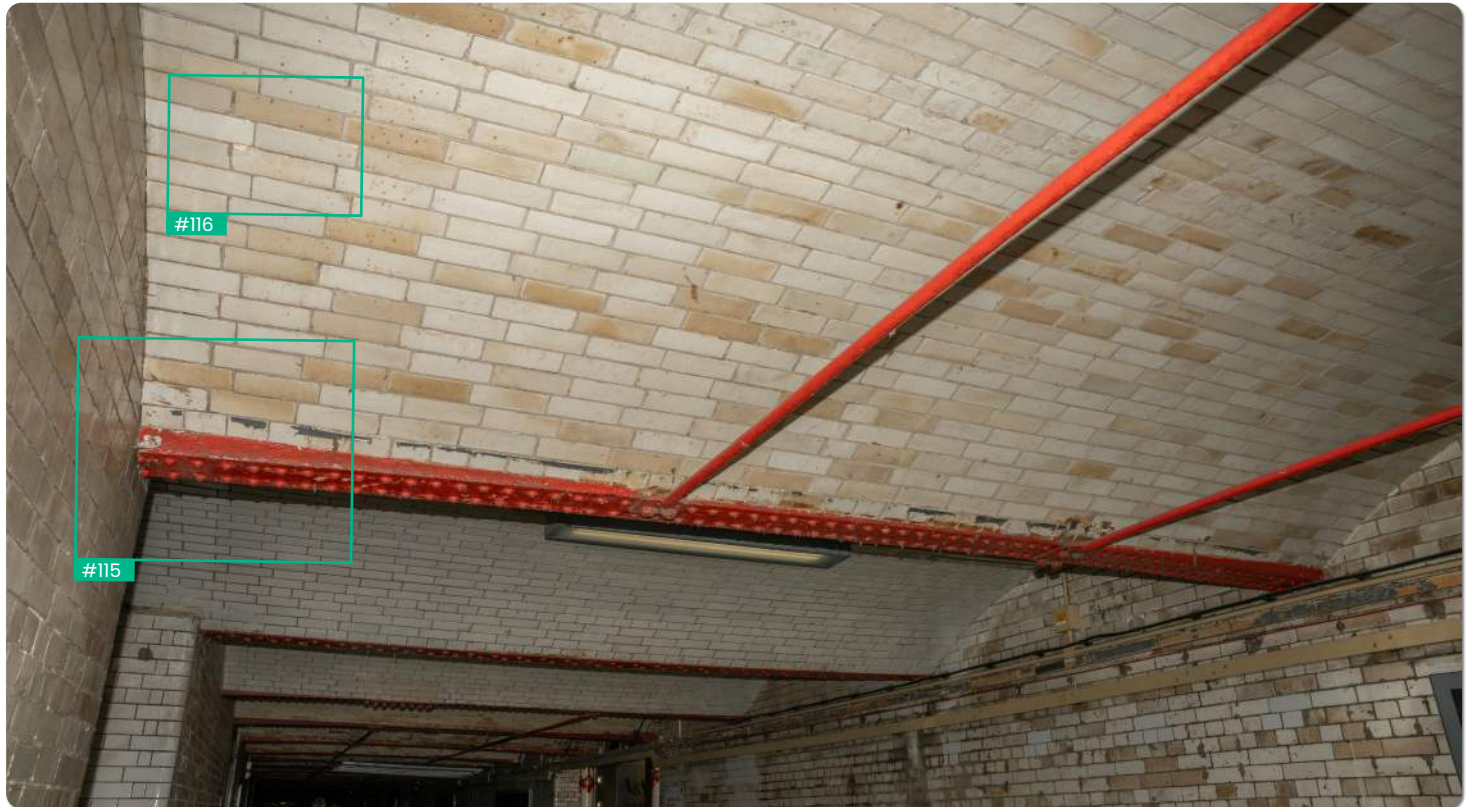
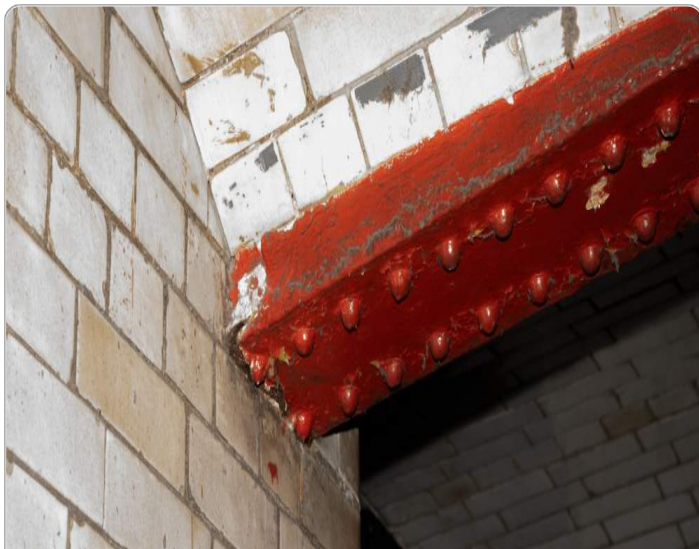
#115

The steel beam running horizontally across the wall shows notable paint breakdown and exposure of underlying metal. The red protective coating has peeled back in irregular, uneven patches, particularly along the lower flange and bolt locations. The surrounding tiles beneath the beam show streaking and dark staining consistent with runoff from the metal surface over time.

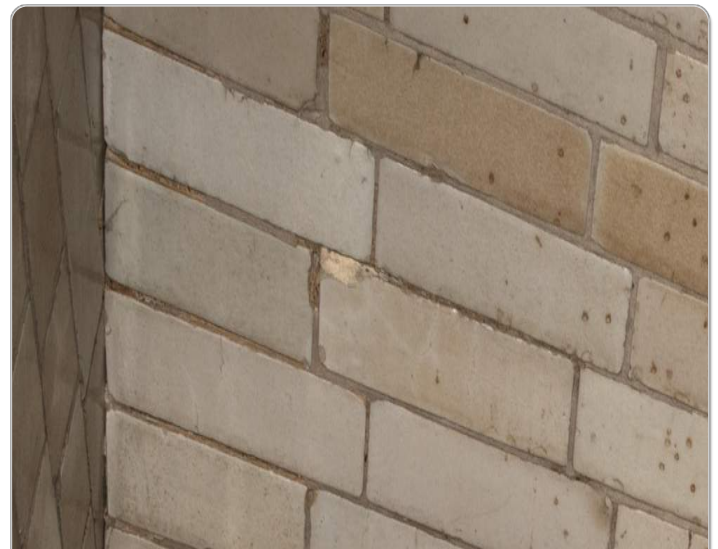
#116

Localised deterioration of wall tiles is visible around individual tile faces rather than across a continuous region. Several tiles display surface chipping and loss of glaze, revealing a rough, porous substrate. The mortar joints around these tiles appear unevenly filled, and some joints have recessed noticeably, creating narrow shadowed gaps.

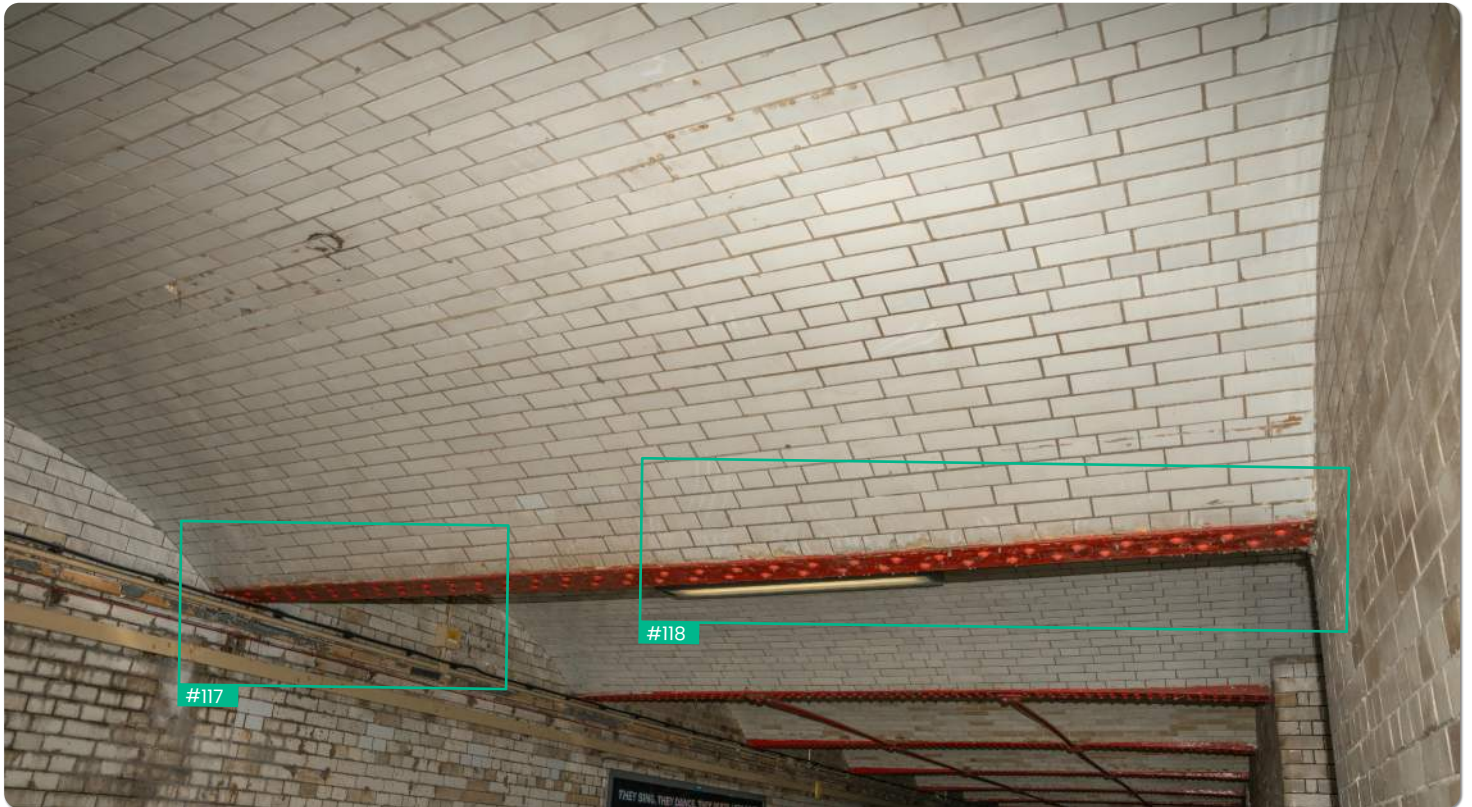
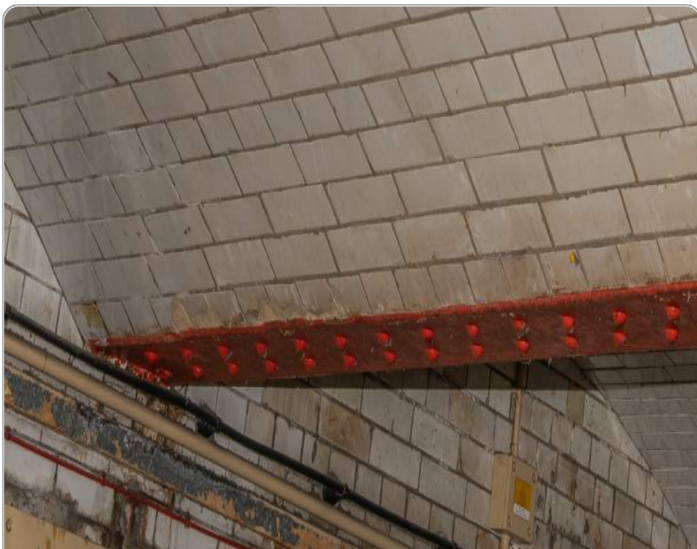
#117

The horizontal steel beam across the ceiling shows extensive surface coating deterioration along the lower face. The red paint exhibits patch loss exposing darker base metal underneath, particularly around bolt heads and weld seams. Residue and soiling are visible around rivet locations, and the coating appears blistered in places, indicating breakdown through ageing rather than mechanical abrasion. Adjacent tiles directly beneath the beam show dark vertical streaking that aligns with the degraded areas of steel.

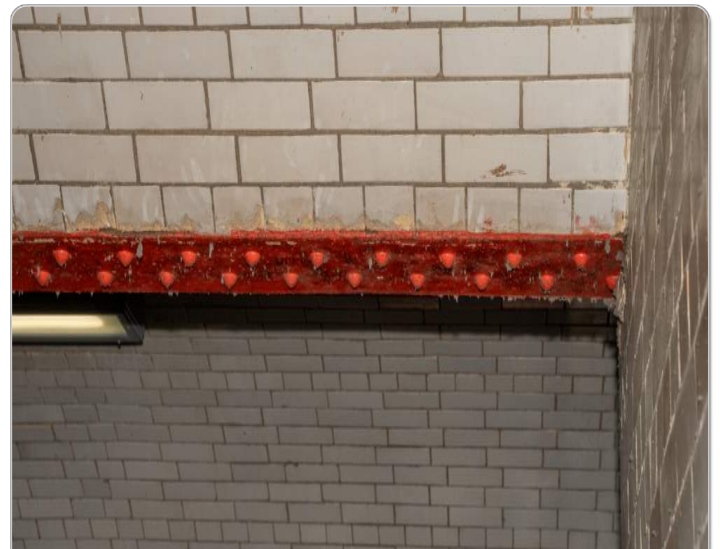
#118

The underside of the horizontal structural beam displays pronounced loss of paint along the lower flange edge, exposing bare metal across a broad strip. The original red coating is unevenly retained in isolated patches, while the exposed areas appear dull, darkened, and textured. The adjacent tiles on the ceiling exhibit widespread staining in irregular patterns consistent with prolonged ageing and possible historic moisture above.

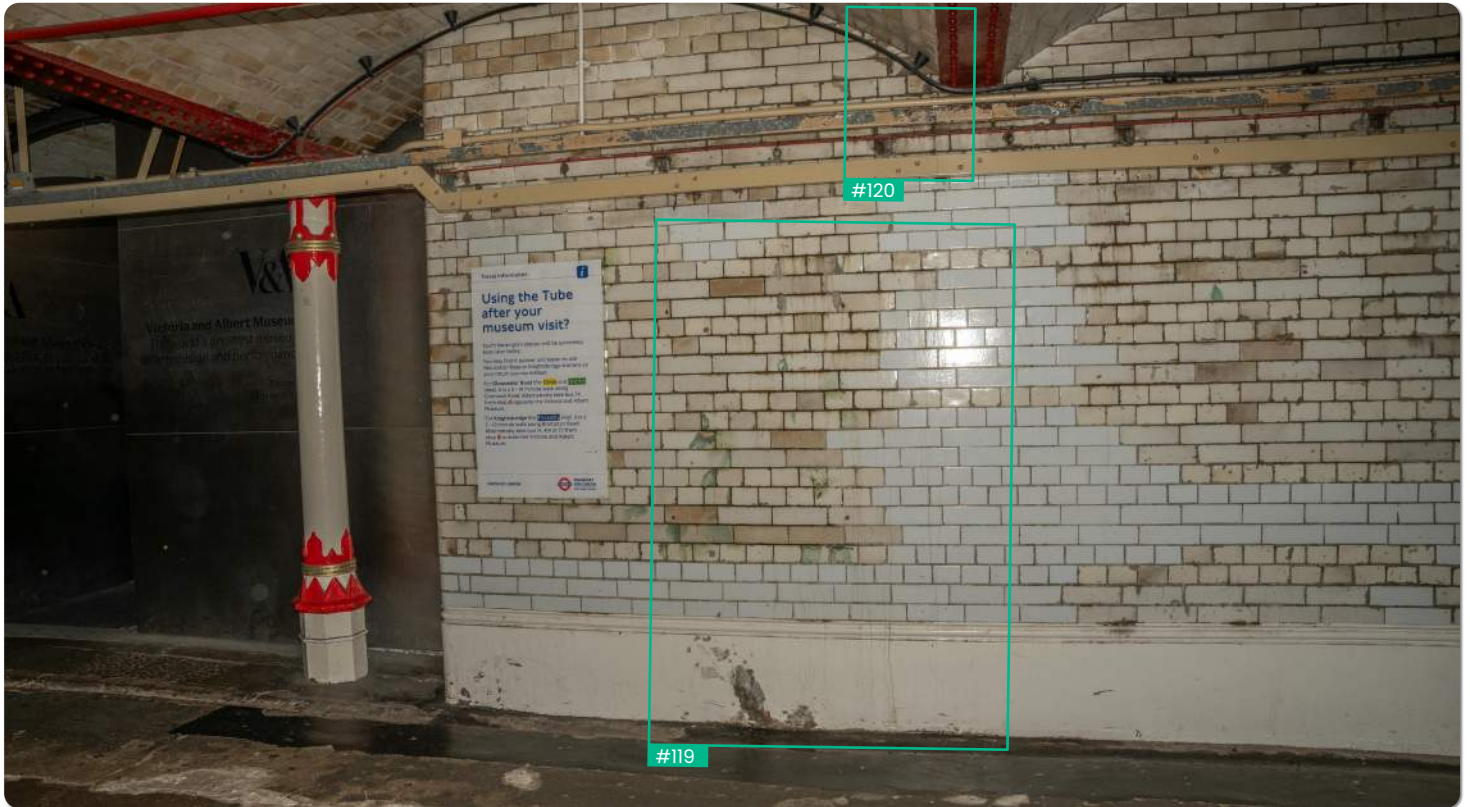
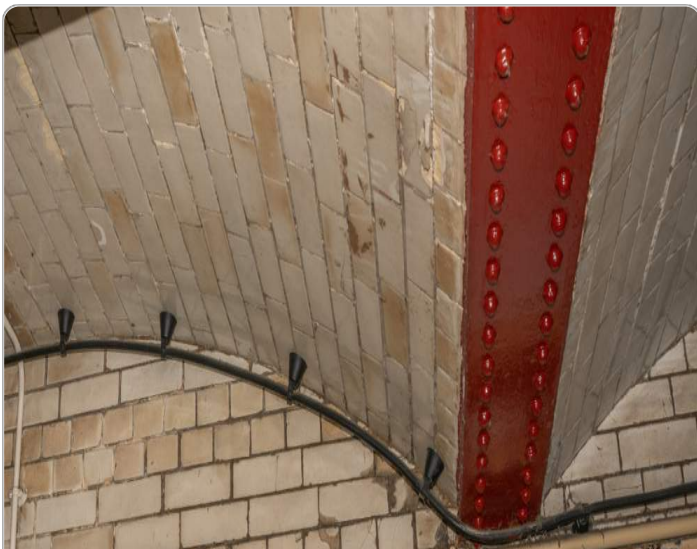
#120

The brick tiles exhibit widespread surface deterioration with uneven staining, faded glaze, and discolouration across multiple courses. The finish appears worn and porous, with darker streaks. Mortar joints are recessed and eroded in several areas, with localised loss of joint material rather than cracking. Tile edges show minor wear and chipping consistent with ageing. The deterioration is concentrated beneath overhead services, indicating staining and long-term environmental exposure affecting the original tiled finish.

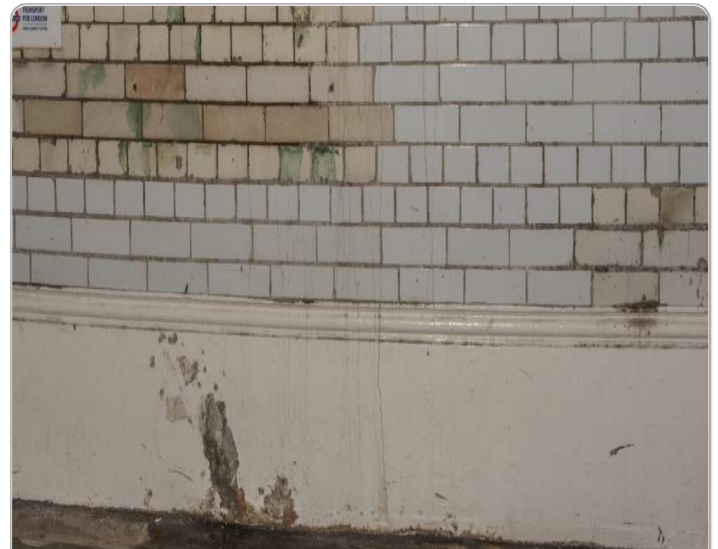
#119

The wall tiles exhibit widespread surface staining and discolouration, concentrated along the lower section of the wall near the skirting line. The staining appears to be dark brown and irregular in pattern, suggesting long-term exposure to moisture or run-off from the wall above. Tile faces appear dull and uneven in colour, with multiple tiles showing patchy surface erosion where the glaze has deteriorated. There are visible dark streaks trailing down vertically towards the skirting area, indicating water has repeatedly travelled down the wall over time.

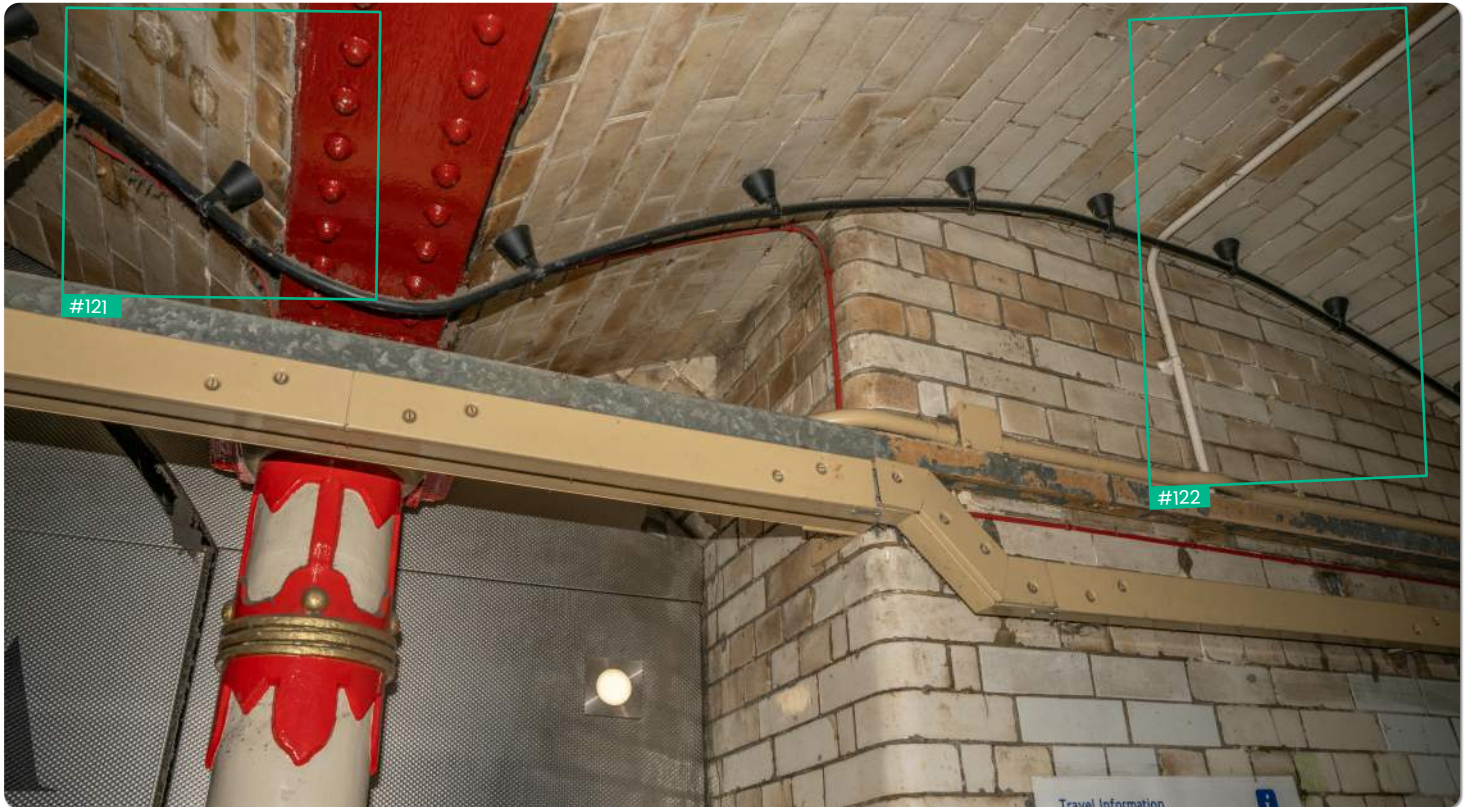
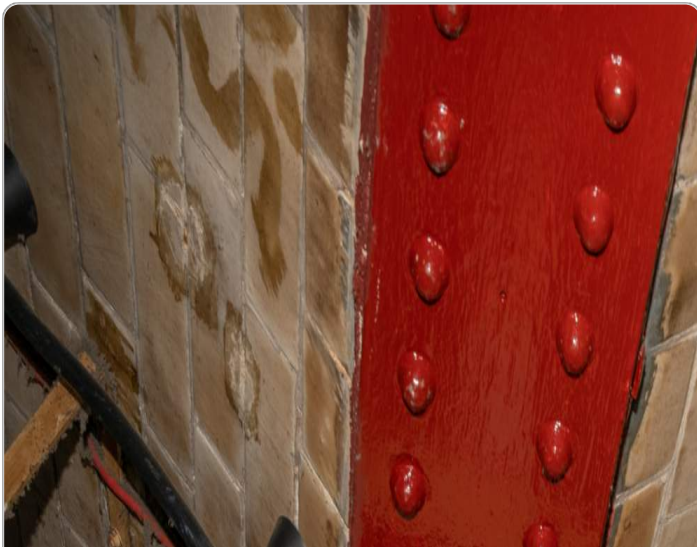
#121

Two distinct circular holes are visible drilled into the soffit tiles directly adjacent to the steel beam. These appear to be historic fixings that have since been removed, leaving exposed penetrations in the tile surface. The surrounding glaze is worn and discoloured, with slight chipping around the edges of each hole.

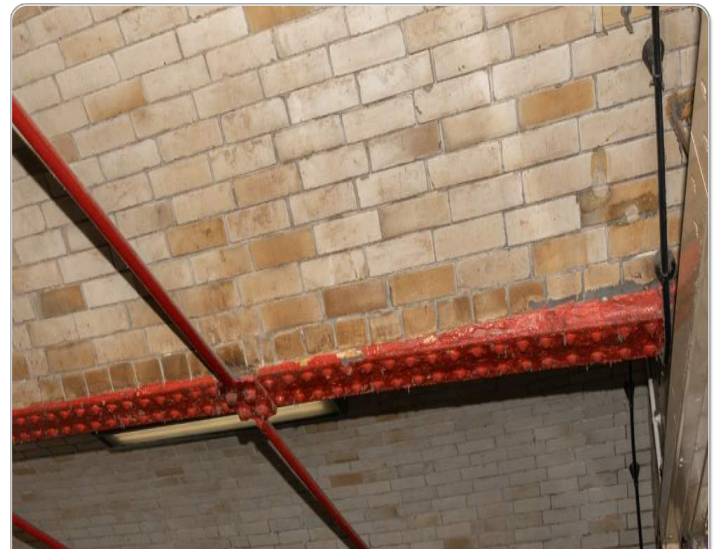
#129

The steel beam near the ceiling shows degradation of the protective red coating along both the beam face and flange edges. Paint has peeled away unevenly, leaving exposed metal which appears darker and weathered. A section of the ceiling tiling shows a clear instance of tile breakage, where an individual tile has fractured along its edge, resulting in a small portion of the tile being lost.
