Dilapidation Survey Report

NHM Exhibition Road Subway
15th November 2025

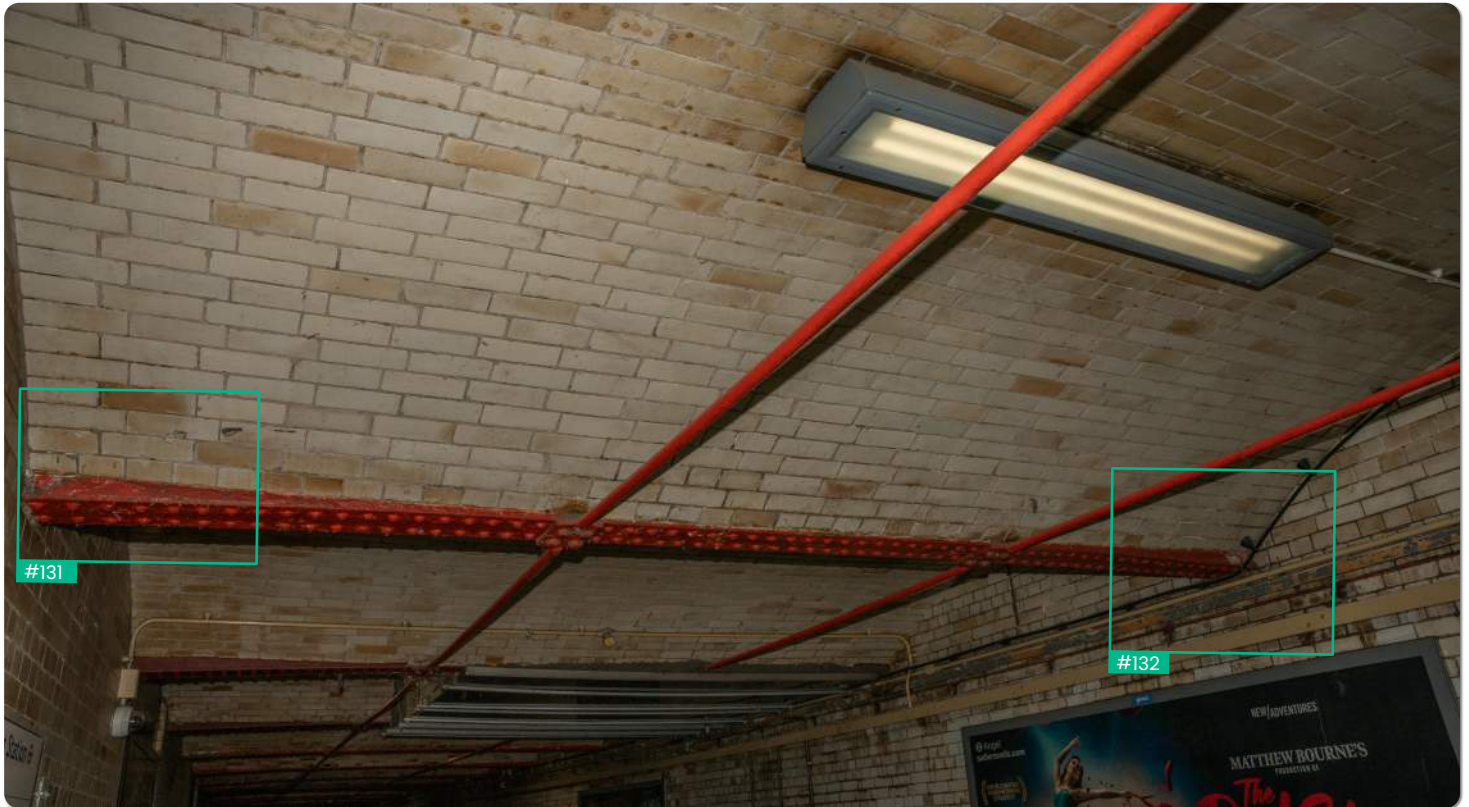
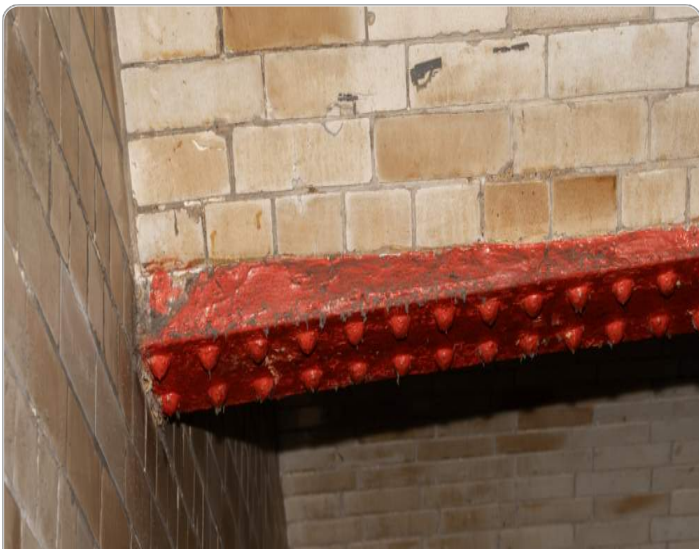
#130

The horizontal structural beam at ceiling level displays evident surface deterioration to the paint coating particularly along the lower edge and rivet positions. The red coating is patchy, faded, and missing in several areas, revealing underlying material.

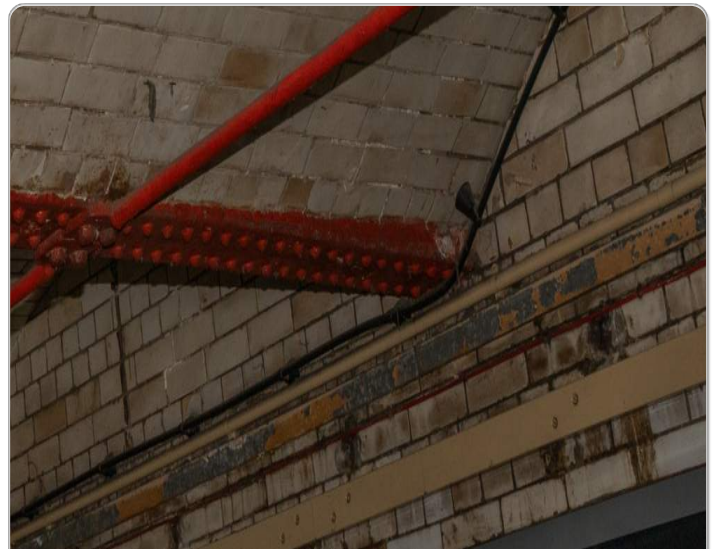
#131

The steel beam exhibits pronounced coating breakdown concentrated near the end of the beam where it meets the wall. Paint loss reveals uneven texture. Several rivets show accumulation of staining around their edges.

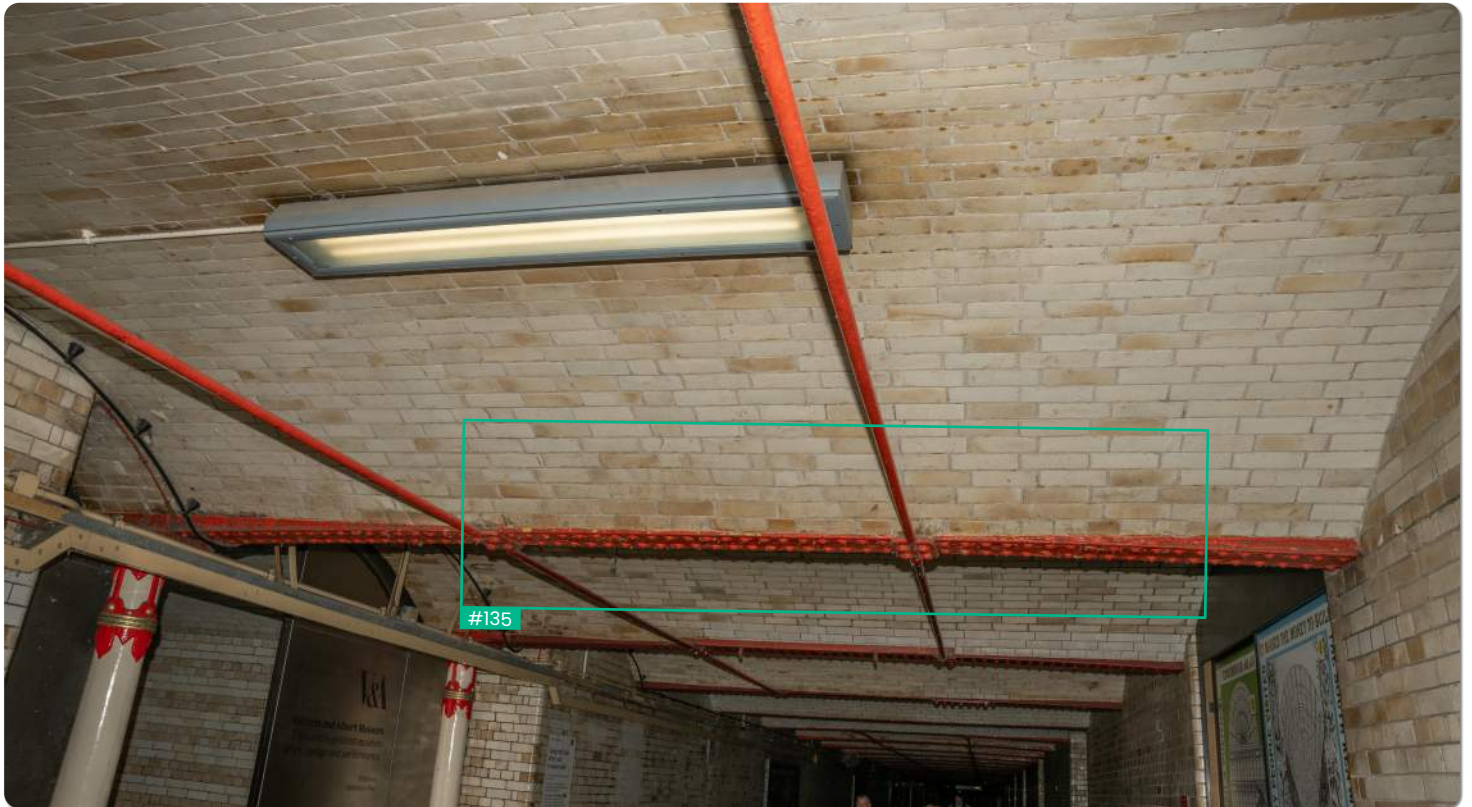
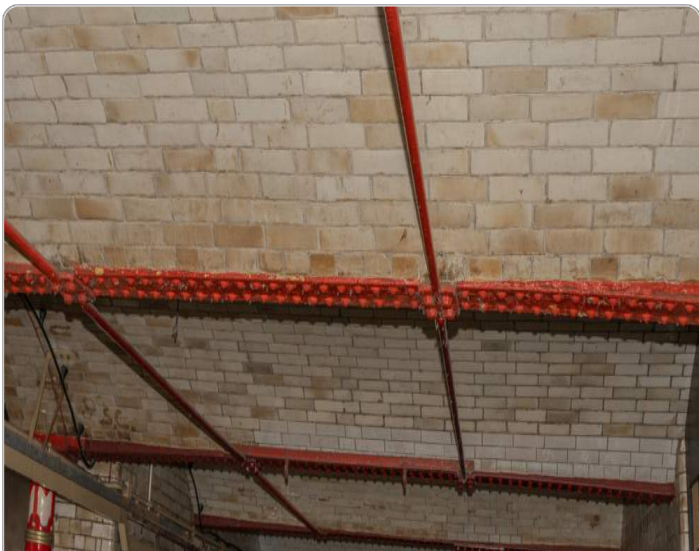
#132

The steel beam across the upper section of the wall shows continuous deterioration along the lower edge, with multiple areas of exposed metal where the red paint has peeled. Rivet heads are heavily stained and appear aged with uneven texture. The ceiling tiles directly above the beam also show patchy staining and discolouration, forming irregular narrow streaks that align with fixings and beam geometry.

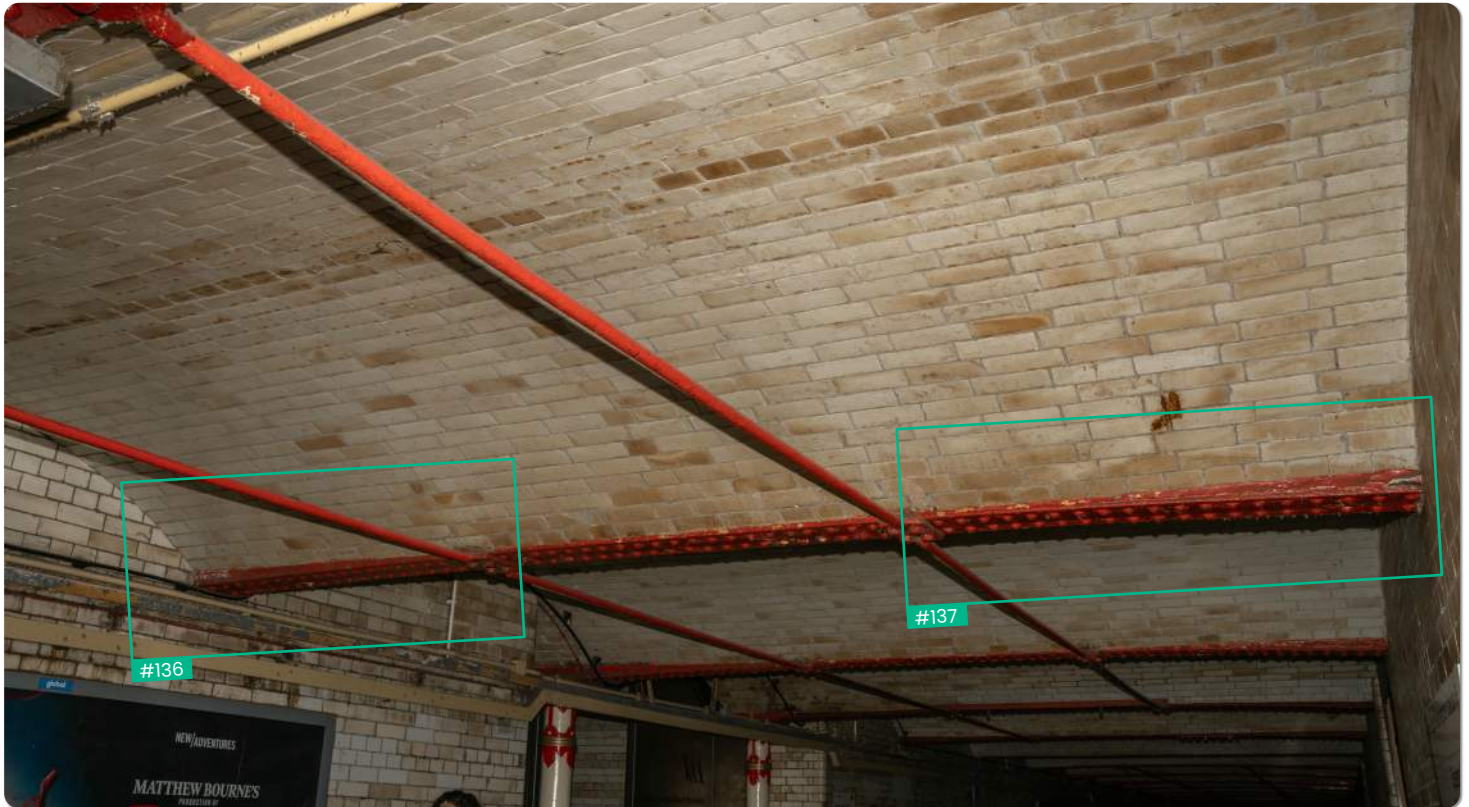
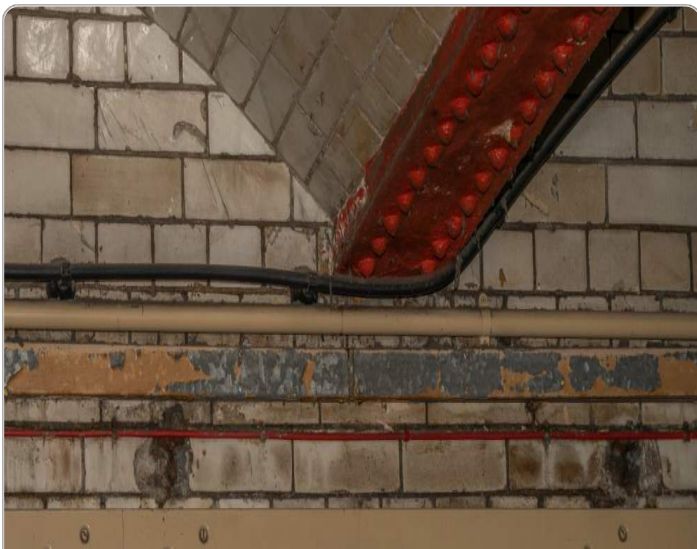
#135

Localised discoloration and sooting to the cream ceiling tiles immediately above and alongside the red primary beam. The beam flange itself shows breakdown of the red protective coating along its lower edge, with small areas of exposed metal and dark rust staining concentrated around rivet heads and the junction with the secondary cross-tie. Accumulated dust and debris are visible along the underside of the beam and at the tile-beam interface.

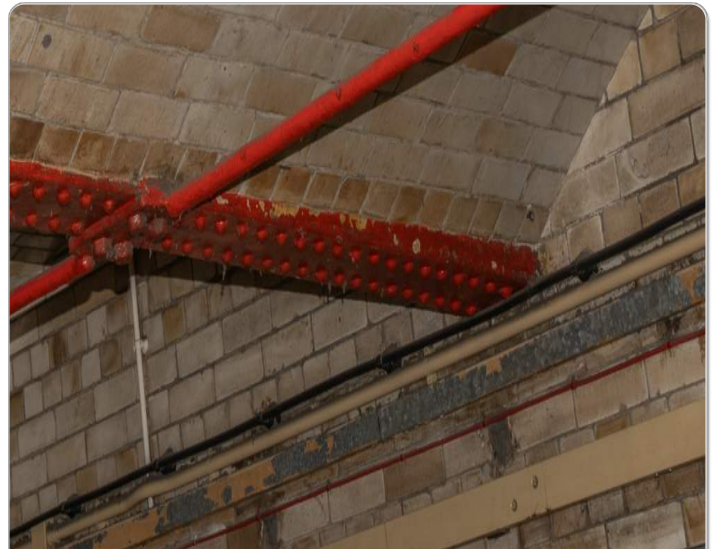
#143

At the beam end where it frames into the corner, the red coating has worn away along the underside edge, exposing a rough strip of darker substrate with rust-toned staining. The adjacent corner tiles show pronounced discoloration, with some units darker than the surrounding field, and mortar joints at the immediate beam interface appear smeared and irregular.

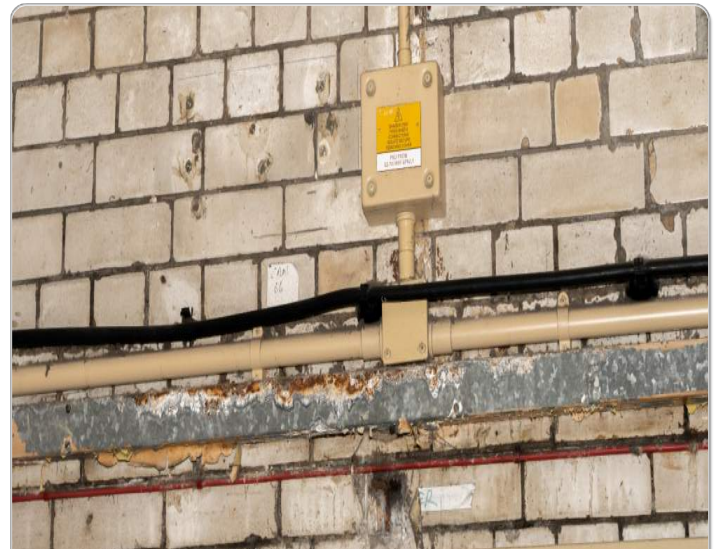
#148

The wall area below the red beam shows extensive surface deterioration of the cable trunking running horizontally above the tiles. The surface coating has peeled away in several long sections, exposing a rougher underlying layer. Tile surfaces beneath this strip display staining and dark streaking. The mortar joints across this section appear varied in tone, with some darker, recessed lines visible.

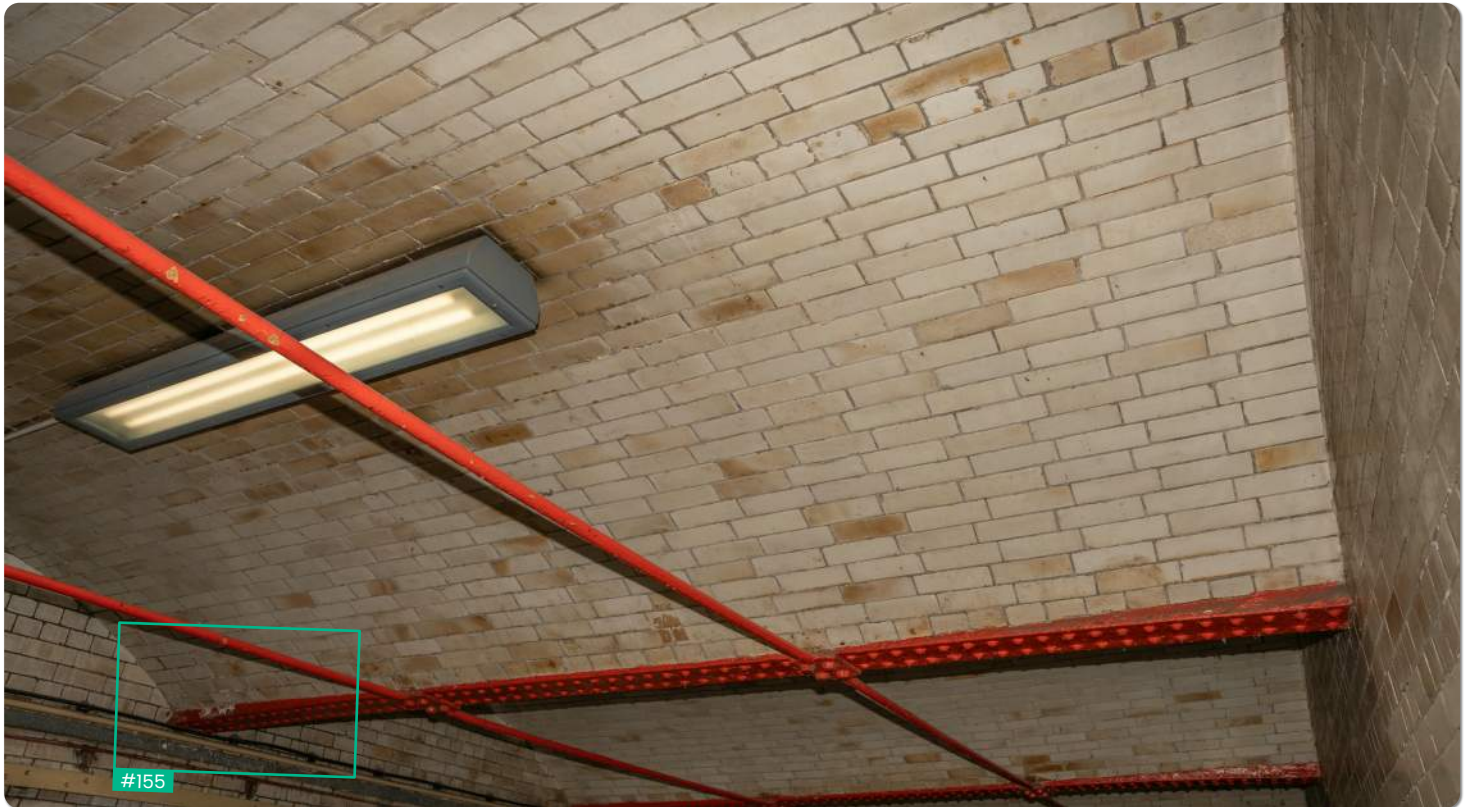
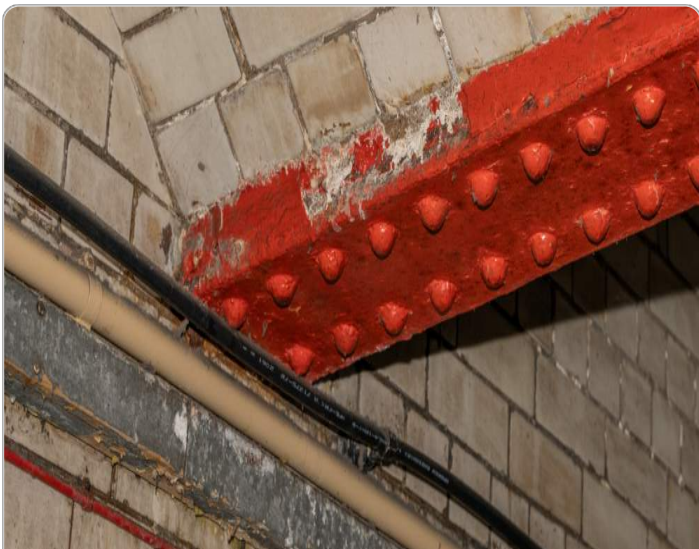
#154

The steel beam along the ceiling shows flaking paint and exposed darker surface beneath, particularly concentrated along the lower edge and near the beam-to-wall interface. Adjacent ceiling tiles display patchy discolouration with darker rectangular areas. Mortar joints appear inconsistent, with some recessed and stained sections visible near the beam line.

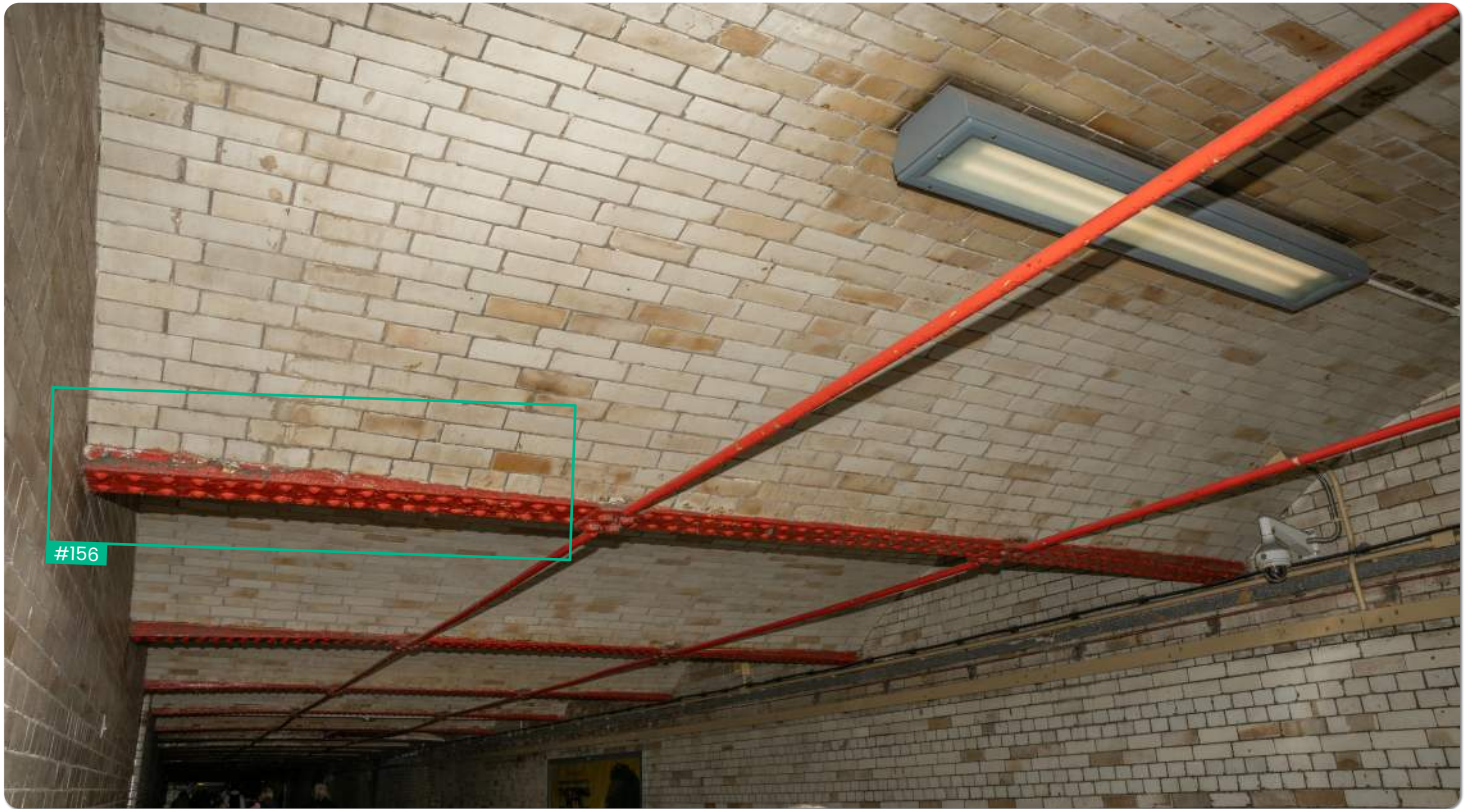
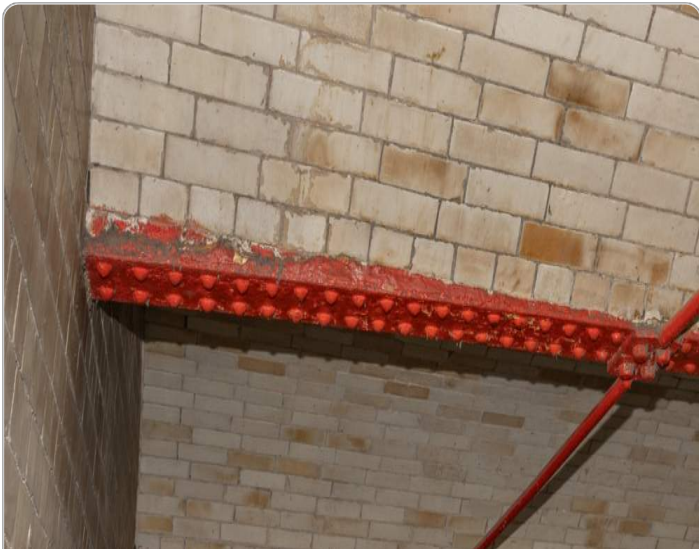
#155

The steel beam shown is painted red and exhibits notable surface deterioration along its lower edge and flange. There is visible paint breakdown, with flaking and uneven coating exposing darker underlying material in places. Along the interface where the beam meets the wall tiles, there is a build-up of residue and discolouration, with streaking extending downward across both the beam surface and adjacent tiles. The surrounding tiles directly above and beside the beam display patchy staining and discoloured grout lines, differing from cleaner tile areas further along the wall.
